## **Reservoir Safety and Refurbishment Works at Severn Trent Water's Howden, Derwent and Linacre Reservoirs**

S.A.ROBERTSON, Jacobs Babbie, Glasgow, UK.

### **SYNOPSIS.**

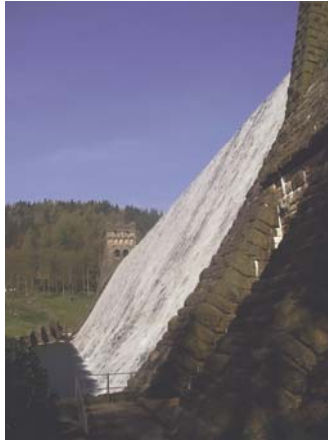
Figure 1 : Howden's central crest weir

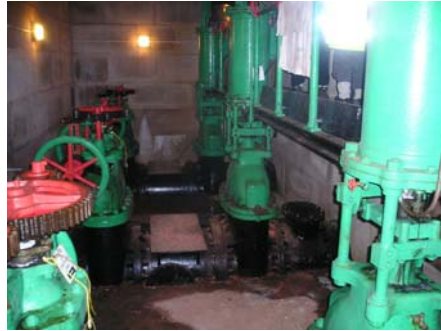
Inspecting Engineer, Mr Alex Macdonald, of Jacobs Babbie (JB), carried out a routine 10-year inspection of Howden and Derwent Reservoirs, under Section 10(2) of the Reservoirs Act 1975. Whilst confirming that both reservoirs had adequate provision for emergency draw-down, he was concerned about the effects of cavitation on the duty scour valves and the inability of some of the valves to be operated through their full travel.

Figure 2 : Derwent Valves

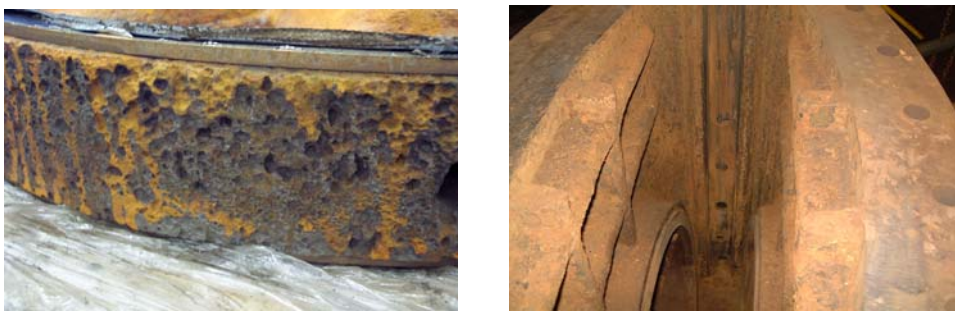
In July 2005 Norwest Holst commenced construction work with subcontractor Blackhall Engineering. A comprehensive valve condition report was issued by NWH for each valve as it was dismantled. The pre-tender assessment of proposed works were found to be a good estimate and refurbishment was initiated at Blackhall Engineering's factory. Typical valve condition found following stripping can be seen in Figures 3 and 4 : wedge cavitation and scored channel guides. Work during refurbishment can be seen in Figure 5 : view showing the wedge and guide brushes

Figures 3 and 4: Wedge Cavitation and Scored Channel Guides

Due to the apparent success of the previous valve refurbishment, it was recommended that repairs to the areas affected by cavitation be carried out.

It was specified that both the body and bonnet would have guides dressed, minor damage repaired and damage to any corroded retaining pins replaced. If sustained damage had occurred to the guides, in particular at the body/bonnet interface, a filler material would be required to allow full refurbishment.

The wedges once removed completely from the body of the valve were to be shot blasted and painted with their faces dressed and any minor damage repaired. The associated new bush, pin and roller sets would be manufactured and installed to suit body guide sizes or if shoes, these would be dressed and minor damage repaired.

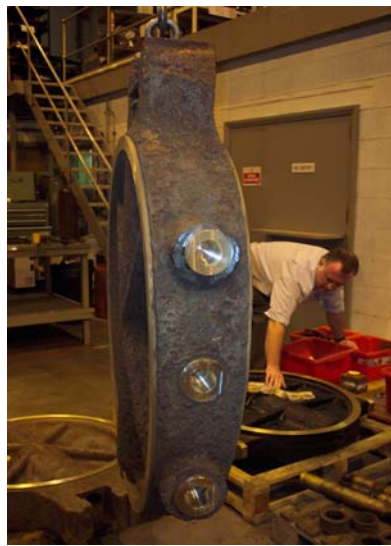
Figure 5 : View showing the wedge and guide bushes

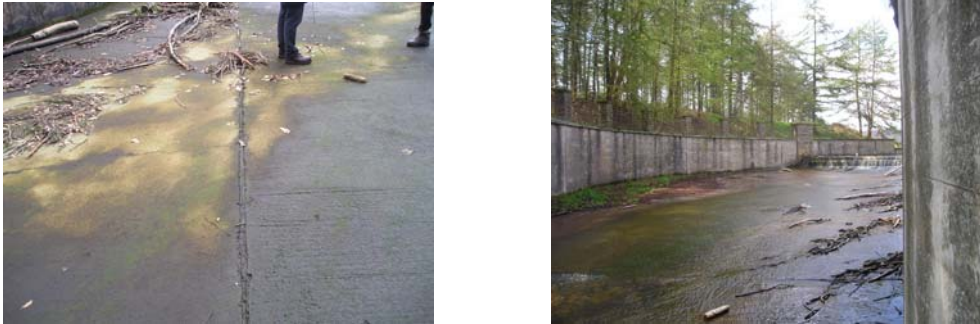
The works for this element of the project were considered at first to be relatively straight forward. The scope of work required general repairs in the spillway channel retaining walls and repairs to damaged concrete and joints in the bed of the channel. A site visit early in the project with STW, JB and NWH identified the extent of work referred to in the Inspecting Engineer's Report. (Ref Figures 6 and 7 : Typical floor joints prior to repair and spillway channel)

Cracks on the surfaces of the concrete walls and floors were to be repaired with a concrete waterproof repair mortar. The joints were to have the existing material removed and replaced with a gun grade sealing compound. Once on site NWH's suspicions regarding the existing joint filling material were aroused. The material was easily broken when removed. All work in spillways channels was stopped and a sample of the joint filling material taken away for analysis. It was found that the material contained approximately 15% asbestos!

Figure 6 and 7 : Typical floor joints prior to repair and spillway channel

As part of the developing risk assessment of the planned work it was considered that leaving the asbestos in place could be safer than removal. However it was decided that the risk of leaving the problem asbestos to others in the future was not an acceptable solution and a specialist and licensed contractor was employed to remove the 156 linear meters of jointing material before work could re-commence on the spillway channels.

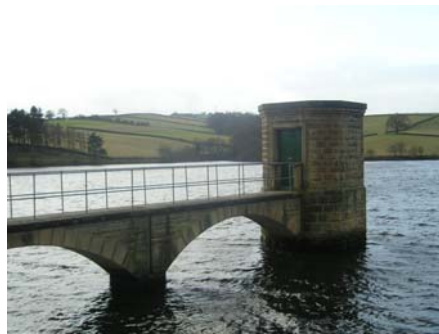
The provision of a scour guard valve at the Upper Reservoir was requested by the Inspecting Engineer as there was no 'secondary' valve on the scour outlet.

Figures 8 : Upper Linacre valve tower

The feasibility review of the required works considered various alternative locations. With the tower being relatively small in diameter and with numerous pipes and valves already accommodated a suitable location at higher level was opted for. Figures 8 : Upper Linacre valve tower shows the internal and external views of the tower.

Once the reservoir water level was sufficiently drawn down, work commenced on cutting the existing pipework for the addition of the valve and spindles. Actuators were provided and located at the top of the valve tower giving STW Operations a safer means of operation.

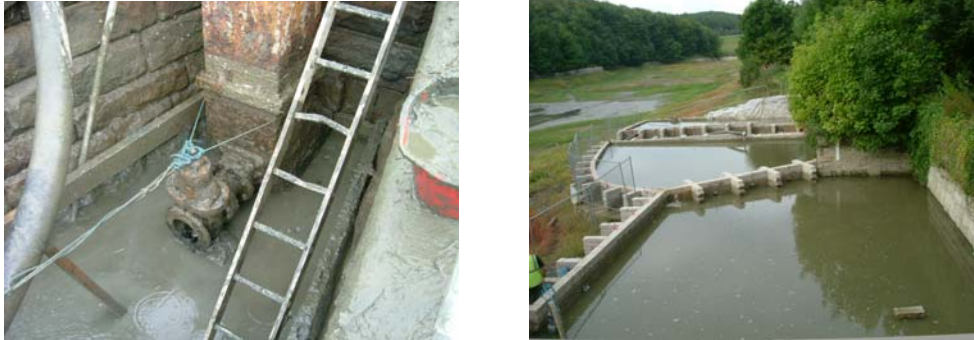
The scour work also included the feasibility and construction of an operable scour guard valve. The existing valve, refer to Figure 9 : Lower Linacre existing guard valve, was currently only accessible by divers as it was located in 9m depth of water. Reasons for this arrangement were only speculative.

Figure 9 and 10 : Lower Linacre , Existing Guard Valve and Lagoons

The discharge waters, containing silt, were considered to have a potential impact on the downstream river life if uncontrolled. Early interaction with the Environment Agency by NWH assisted the smooth progress of the works. Many options were considered including bringing to site stilling tanks, with the addition of coagulating chemicals, to the more practical option of using the existing spillways channels to removed any silt. The latter solution was developed, by NWH, into a workable method. The reservoir waters were pumped into a series of lagoons which were constructed at the top of the spillway channel (ref Figure 10 : Lower Linacre lagoons) before flowing down the channel through a series of straw bales. This method was adopted and implemented successfully for the removal of the final 2 metres depth of reservoir water which contained a large amount of silt.

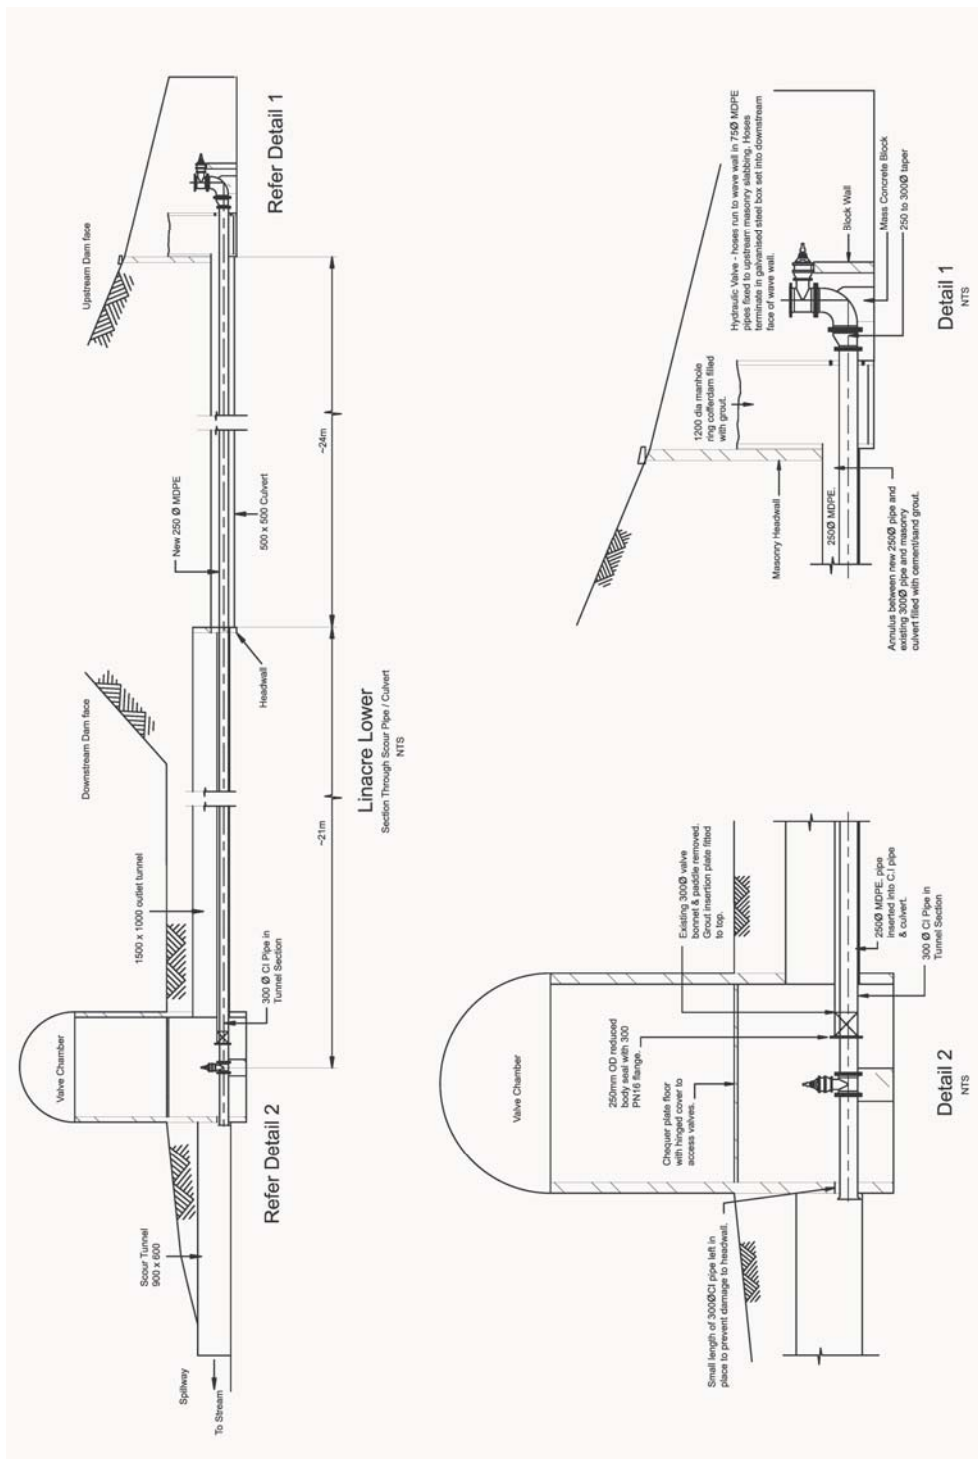
To compound issues there were no existing record drawings of the Lower Linacre reservoir and pipework in STW's archives. This proved to be significant. The scour pipe was considered to be continuous through the dam but, following a CCTV survey to assess the condition of the scour pipe, it was discovered that the pipe stopped near the centre line of the embankment, possibly in the area of the clay core and bulkhead, and continued to the upstream side of the dam and scour valve via a 500mm x 500mm square masonry culvert as shown in Figure 11 : section through Linacre Lower Reservoir. A further CCTV survey was carried out to assess the condition of the culvert from the upstream side. Although the reservoir was empty at the time of the survey there was evidence to suggest that water could percolate through the structure. The reasons for pipe leakage was not through pipe wall corrosion but through the culvert. Leakage through the bulkhead wall remained unresolved. After much consideration it was agreed with the Inspecting Engineer that the 300mm diameter cast iron scour pipe and culvert would be lined with a 250mm diameter continuous polyethylene pipe. The annulus between pipes and culvert was filled with grout.

Figure 11 – Section through Linacre Lower Reservoir

Calculations estimating the drawdown capacity assisted in arriving at the lining solution. Comparing a new 250mm diameter polyethylene pipe to a 300mm diameter heavily encrusted cast iron pipe confirmed that there would be an improvement in the current drawdown capacity.

Despite early pigging problems clearing the heavily encrusted 300mm diameter cast iron pipe, the polyethylene pipe was pulled through, tested and grout fill injected. Work was completed in early February 2006.
