## **Some problems at small dams in the United Kingdom**

J.L.HINKS, Halcrow Group Ltd.

**SYNOPSIS.** The UK has a large number of small dams with diverse problems. Some have capacities of less than 25,000 m<sup>3</sup> and therefore fall outside the ambit of the Reservoirs Act, 1975. Many were constructed in the eighteenth and nineteenth centuries to impound ornamental lakes for stately homes. Whilst these reservoirs often require rehabilitation to meet modern safety standards the available funds are frequently tightly constrained.

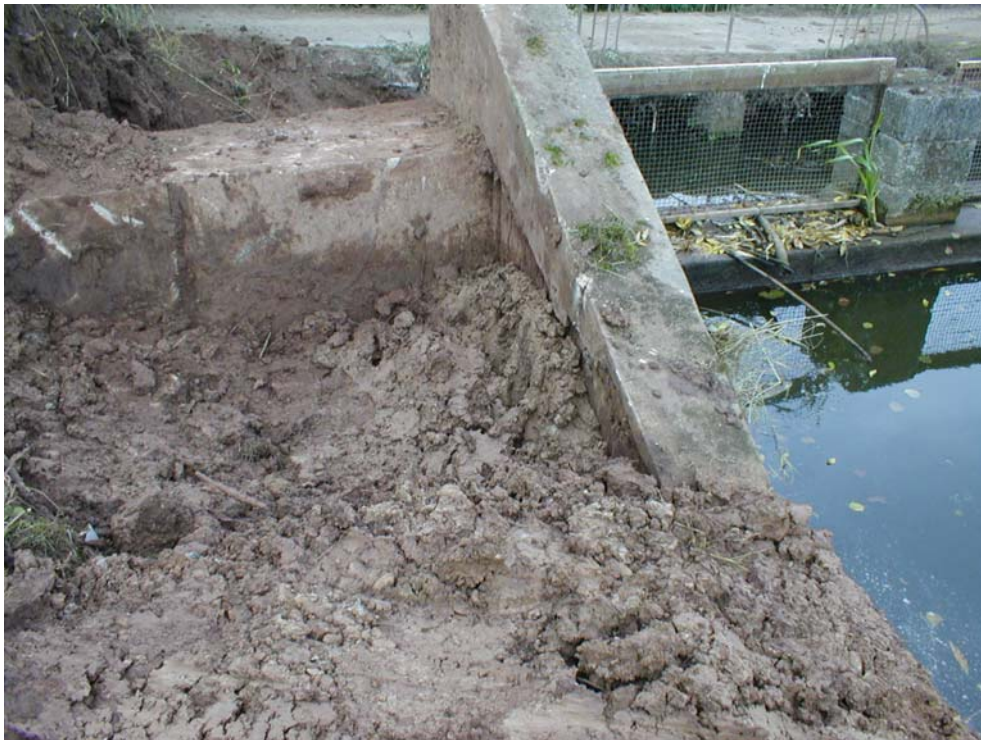
Upper Hartleton Farm reservoir has a capacity of 59,000 m<sup>3</sup> and a catchment area of 11.5 km<sup>2</sup>. It was constructed in 1972 at the same time as Lower Hartleton Farm reservoir immediately downstream. The dams were built of silty clay and performed satisfactorily except for the regular appearance of cavities and internal erosion behind the spillway walls. The cavities appeared at the Lower reservoir in 1979 and 1998 and at the Upper reservoir in 1978, 1995, 2000 and 2003. Since the dams have shown no problems along most of their length it is thought that poor compaction of material adjacent to the spillway walls was the cause of the difficulties.

Figure 1. Axial wall on left side of spillway at Upper Hartleton Farm – leakage was taking place beneath the bottom of the wall.

in 2004 be brought forward to 2003. The Inspecting Engineer was concerned about the repeated appearance of cavities over the years and about possible serious problems if heavy leakage were to coincide with the passage of a flood since the river passes through a town in a small culvert a few kilometres downstream of the dams. Consequently he recommended that the fill behind both spillway walls be dug out and replaced with well compacted clay. This was done in October 2003; during the work leakage channels were found in the excavation. At the time of writing there has been no further leakage.

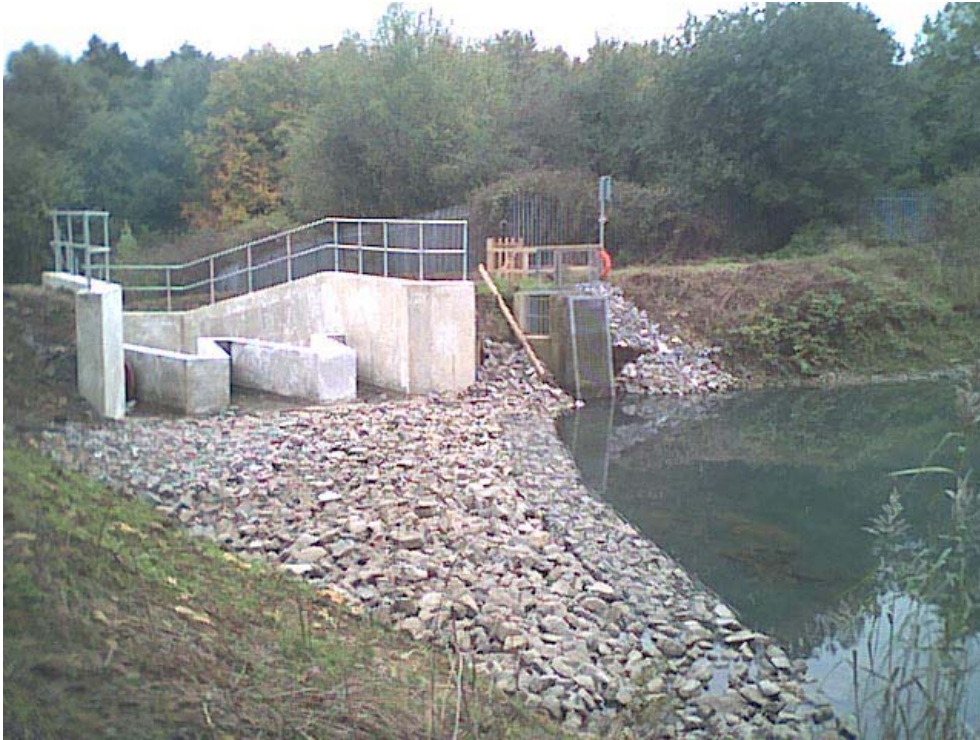
The reservoir filled almost to the crest in November 2000 and this prompted the Undertaker to seek an opinion from an All Reservoirs Panel Engineer. The inspection was made on 2 February 2001. The Inspecting Engineer expressed the opinion that the reservoir was a large raised reservoir and that a spillway was needed to pass the PMF (since there were houses downstream). He also said that the spillway should be designed and built before the autumn of 2001.

Figure 2. New Labyrinth Spillway at Weldon Lagoon

As well as a new spillway a clay filled cut-off trench was proposed for a length of 50 m along the axis of the dam to a depth of 1.2 m to cut off leakage. Because a spillway would increase the discharges at short return periods the Environment Agency withheld permission for the new spillway under Section 23 of the Land Drainage Act, 1991. However it was pointed out that under Section 23(6) permission is not required for works being carried out in pursuance of another Act of Parliament or any order having the force of an Act. However, everything possible was done to address Environment Agency concerns and, with this in mind, a labyrinth spillway was constructed so that the spillway sill could be set as high as possible.

There was uncertainty at the time of design regarding the validity of estimates for extreme events obtained using the Flood Estimation Handbook ( MacDonald and Scott, 2000 ). Consequently the 10,000 year outflow, at which there was to be 400 mm wave freeboard, was calculated as 16.5 m<sup>3</sup>/sec assuming a rainfall depth, in 83 minutes, half way between that in the Flood Studies Report ( 125 mm) and that in the Flood Estimation Handbook ( 213 mm ). The 10,000 year rainfall depth obtained from the Flood Estimation Handbook was 73 % greater than ¼ world maximum ( 123 mm ) and was thought to be excessive - this view subsequently gained support from another paper by Messrs MacDonald and Scott ( MacDonald and Scott, 2001 ). The PMF outflow, at which there was to be nominal wave freeboard, was calculated as 25.8 m<sup>3</sup>/sec.

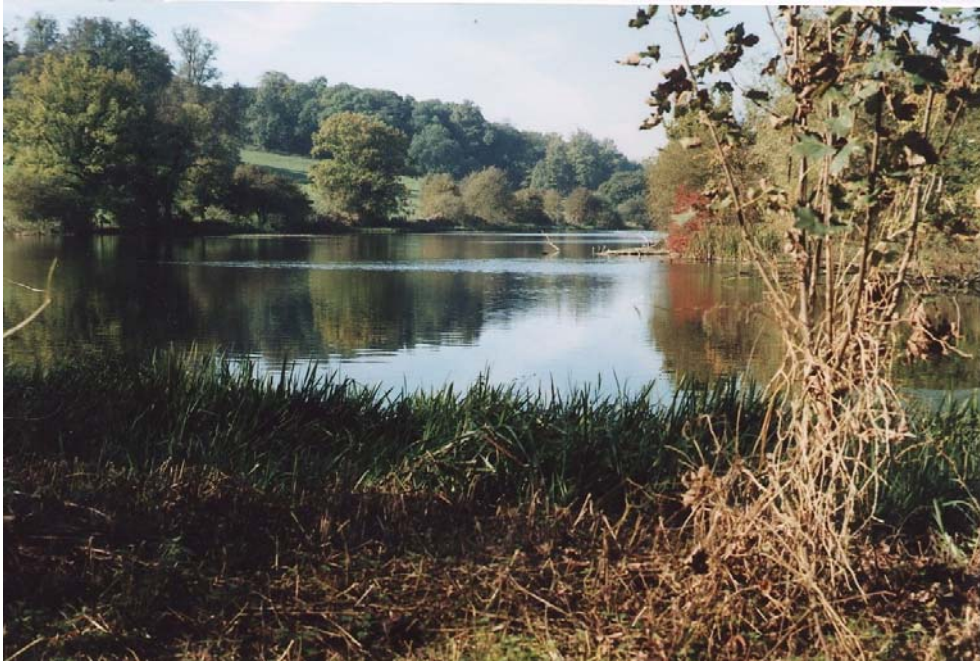
Figure 3. Shardeloes Reservoir

Shardeloes reservoir has a capacity of only 50,000 m<sup>3</sup> but a catchment area of 49.8 km<sup>2</sup>. Only 1 mm of runoff would suffice to fill the reservoir from empty. The reservoir is remarkable for having a spillway capacity of only 1 m<sup>3</sup>/sec. Because the catchment is largely chalk this has been sufficient to ensure the survival of the reservoir since it was built in the early eighteenth century although it is thought that the dam must have been overtopped in the floods of March 1774 when boats could be rowed along the streets of the town downstream.

Because of the town downstream the dam is assigned to Category A as defined in the Institution of Civil Engineers booklet “Floods and Reservoir Safety” (ICE, 1996). The PMF is calculated at 186 m<sup>3</sup>/sec for a saturated catchment. Strengthening the dam to withstand the passage of the PMF would however have been expensive and detrimental to amenity, recreation and wildlife conservation.

However the capacity of the reservoir is less than 1% of the volume of the PMF (5.65 Mm<sup>3</sup>). This being so the failure of the dam in a major flood would not make a significant difference to flood levels downstream. It was therefore decided to apply American methodology as described in the article in Dams and Reservoirs on ‘Small Reservoirs on Large Catchments’ (Hinks, 2003).

Mathematical modelling was first carried out to determine flood levels downstream with and without dam break. A sunny day dam breach was expected to release water at a peak rate of about 11 m<sup>3</sup>/sec. Coming on top of a flood of 3.5 m<sup>3</sup>/sec the incremental flood depth in the town was calculated as 300 mm. This is considerably less than the figure of 600 mm permitted by American methodology and was therefore judged acceptable.

The new spillway is now being designed with a capacity of 3.5 m<sup>3</sup>/sec.

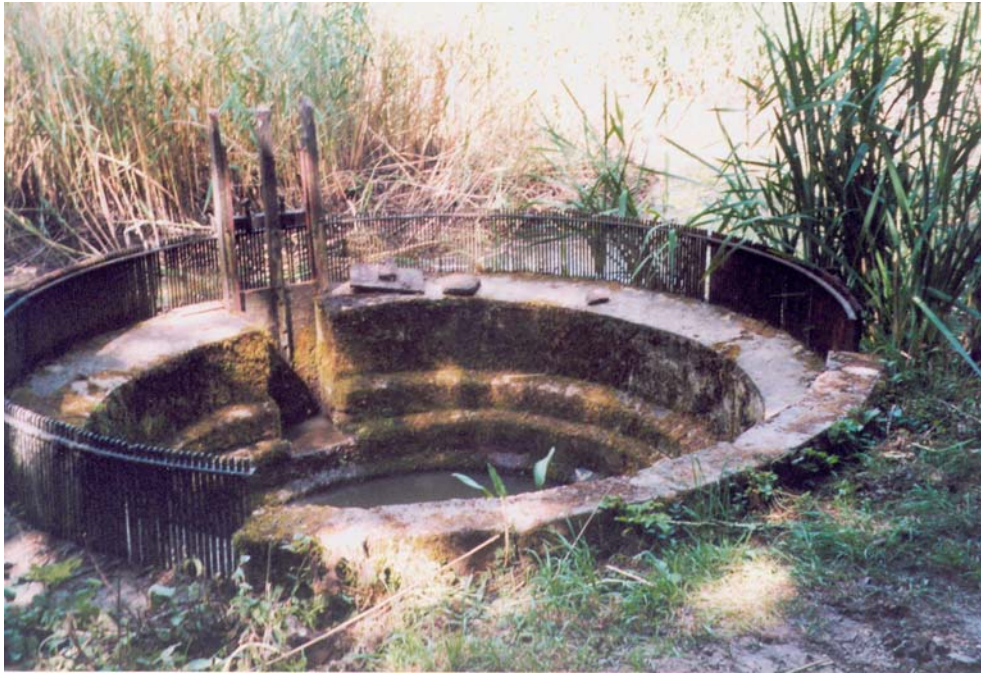
The dam was quite regularly overtopped and leaks develop fairly frequently.

Figure 4. Glory Hole Spillway at Marston Pond prior to lowering by 450 mm.

In order to pass the 150 year flood of  $5.25 \text{ m}^3/\text{sec}$  without overtopping of the dam the higher of the two spillways was lowered by 450 mm so that it was the same level as the other. After some debate it was decided to allow the owner to install stoplogs between 1 April and 30 September each year. This concession, which is subject to the instructions of the Supervising Engineer, will reduce the capacity of the spillway from  $5.25 \text{ m}^3/\text{sec}$  to  $3.3 \text{ m}^3/\text{sec}$  during the summer months but is expected to have a very beneficial effect on amenity, recreation and wildlife conservation in line with the Department of the Environment letter of 26 February 1986.
