## **Hydraulic and operational safety evaluation of some existing Portuguese large dams**

**SYNOPSIS.** The Portuguese Regulations for Safety of Dams came into force in 1990, after being published as a Decree-law. Since then some rules and guidelines concerning the different stages of the life of dams have also been published, to complete and to help the application of the law.

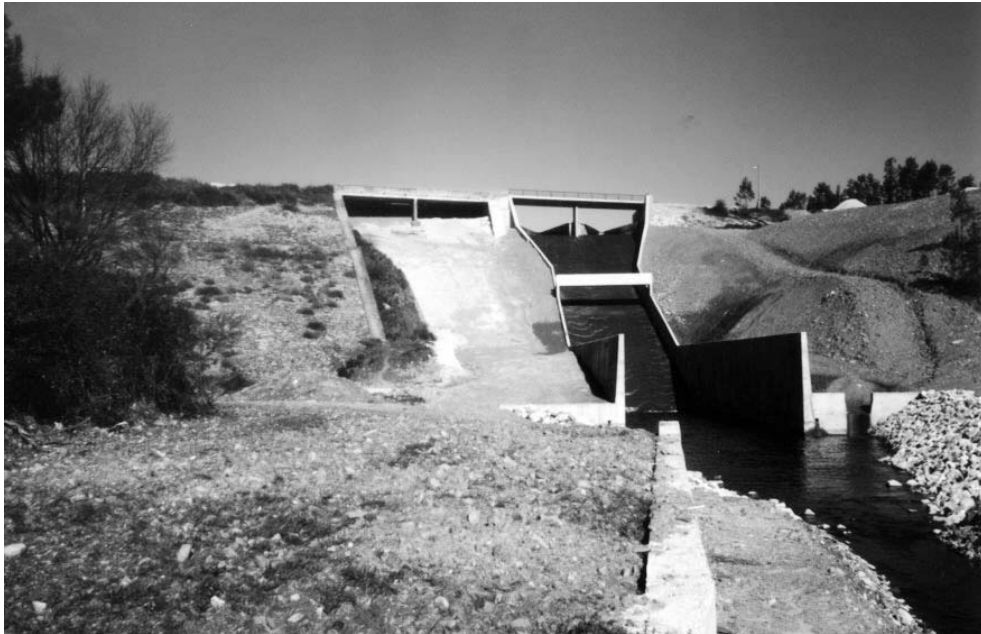
Due to heavy rainfall in December 2000 the spillway of Pisco dam suffered huge damages that threatened the dam itself and motivated emergency intervention. After some remedial work was performed in the spillway, so as to make it endure a small flood, a designed for a new spillway and bottom outlet was made by the consultants involved in the safety studies. Afterwards works were awarded to a contractor and construction now is completed.

Figure 2. New spillway of the Pisco dam alongside the old one.

Fig. 2 depicts an intermediate phase of the works, with the new spillway completed alongside the old one. Afterwards, a new intake tower and intake and bottom discharge tunnel were constructed at the old spillway section, and the earth fill was remade.
