Investigation and Rehabilitation of Chardara Dam Spillway

J H Meldrum, Mott MacDonald Limited

SYNOPSIS. A reported vibration problem with 40 year old spillway outlet gates turned out to be a hydraulically poorly designed structure with cavitation and hydraulic impact problems requiring alterations to the structure as well as replacement of the gates. Vibration surveys, hydraulic model testing and diving surveys were all employed successfully to investigate the cause of the problem and to assist with the design of the remedial works. Dewatering of the structure was required to carry out the remedial works and as there were no provisions to do so in the existing structure a caisson gate was designed that could be floated into the site and then positioned by flooding watertight compartments.

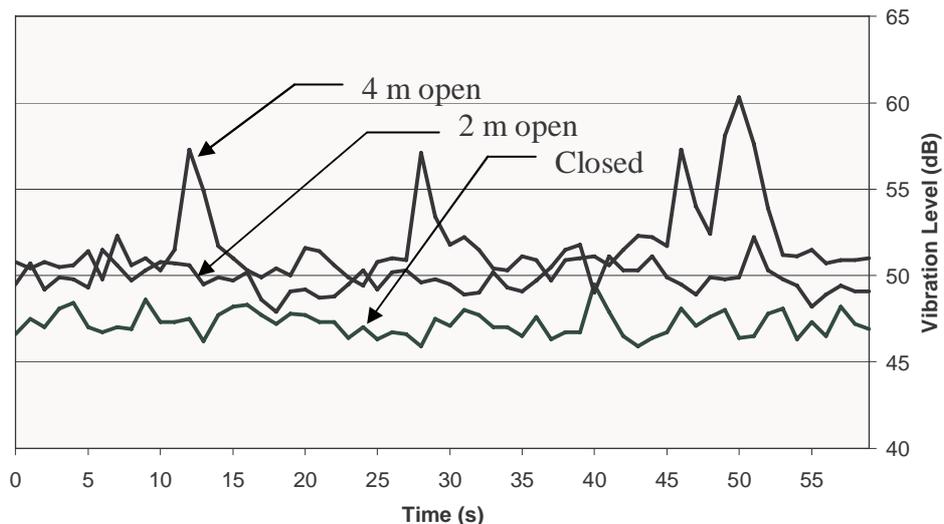
Figure 3: Vibration Survey Gate vibration Y-axis (flow direction)

- there was no significant variation in gate vibration with increasing gate opening except at 4.0 m, when there were distinct irregular peaks (Figure 3);

- that there was a distinct pressure fluctuation in the gate operating area at 4.0 m opening;
- that it was not possible to see a depression in the flow line after the gate on the upper part of the slope and the flow was hitting the underside of the slab from about 2.5 or 3.0 m opening.

- the hydraulic jump was forming from the upper part of the sloping section (probably due to baffle blocks being too large);
- at 4.0 m opening the venting airflow was being closed off by the jump meeting the slab causing pressure variations behind the gate with resulting vibration;
- flow was impacting on the basin walls after being diverted off the baffle blocks and this was likely to be causing vibration.

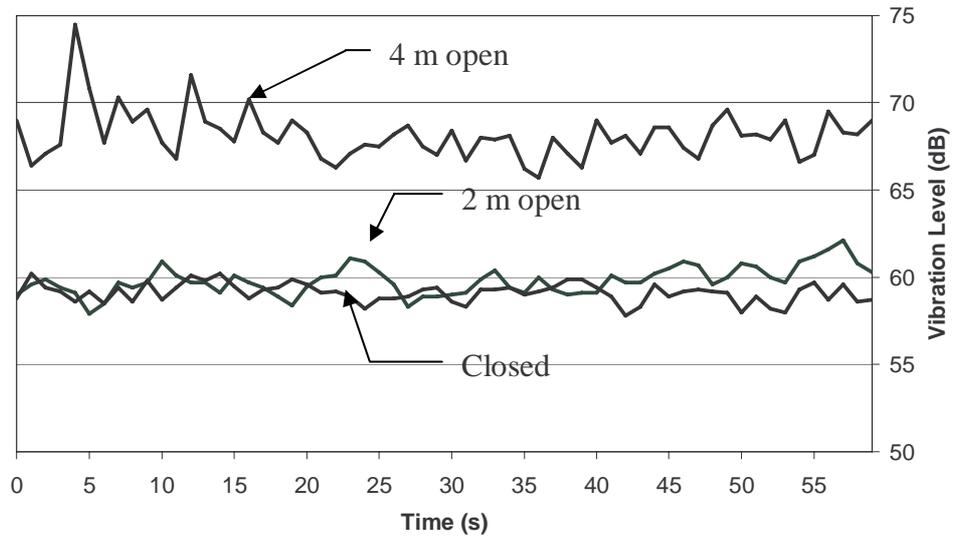
Figure 4: Vibration Survey Slab vibration Z-axis (vertical)

- there was a distinct increase in vertical vibration of the slab over the sloping part of the basin from a gate opening of 2.5 m (Figure 4);
- there was noticeable increase in lateral vibration adjacent to the baffle blocks (Figure 5).

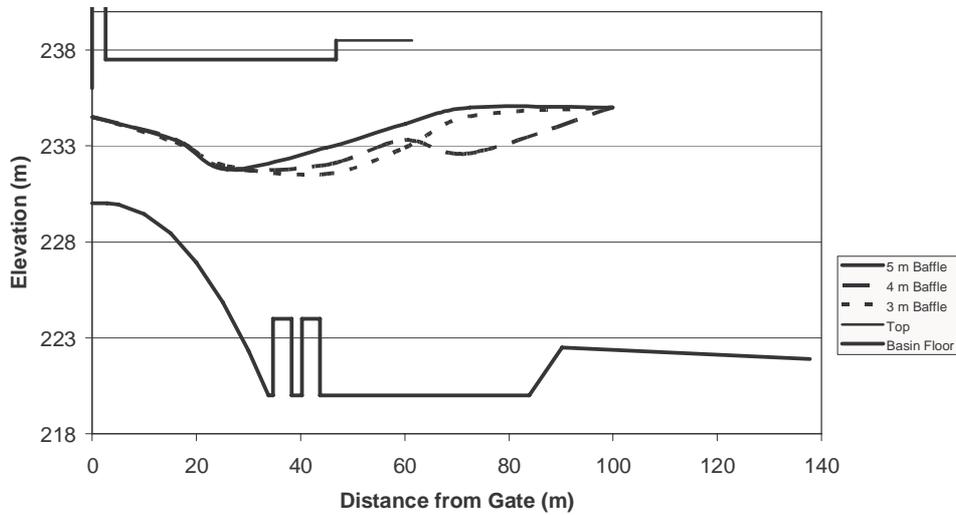
Figure 6: Model Test Results. 75% gate opening and current tailwater level

- negative pressures occur at the top of the sloping section;
- hydraulic conditions are improved with re-profiling the sloping section and infilling the walls;
- an adequate and less intense jump forms further down the basin with reduced height of the existing blocks;
- the water surface will overtop the side walls of the structure with reduced (future) tailwater levels, if the baffle blocks are not reduced in height.

Longitudinal hydraulic profiles for 5 m (existing), 4 m and 3 m blocks for current and future tailwater conditions are shown in Figures 6 and 7 respectively.

- the profile of the stilling basin floor was causing cavitation and the proposed positive pressure profile was appropriate;
- infilling of the partial splitter wall and columns improved hydraulic conditions;
- the existing (5 m high) baffle blocks needed to be reduced in height as they were forcing a hydraulic jump/causing too much disturbance in the upstream part of the basin resulting in the flow hitting the slab above the basin and causing gate vibration through pressure variations behind the gate as the air flow is temporarily occluded;
- adequate stilling could be achieved in the basin if the blocks were reduced to 3 m in height;
- the impacting flow on the side walls from deflection off the baffle blocks was causing vibration of the side walls, and this could be reduced by changing the profile of the outer part of the block face.
