Remedial works at Sutton Bingham Reservoir

J WELBANK, Wessex Water
R SOLOMAN, Wessex Water
J L HINKS, Halcrow Group Limited
G GREEN, Halcrow Group Limited
R PHILLIPS, Halcrow Group Limited

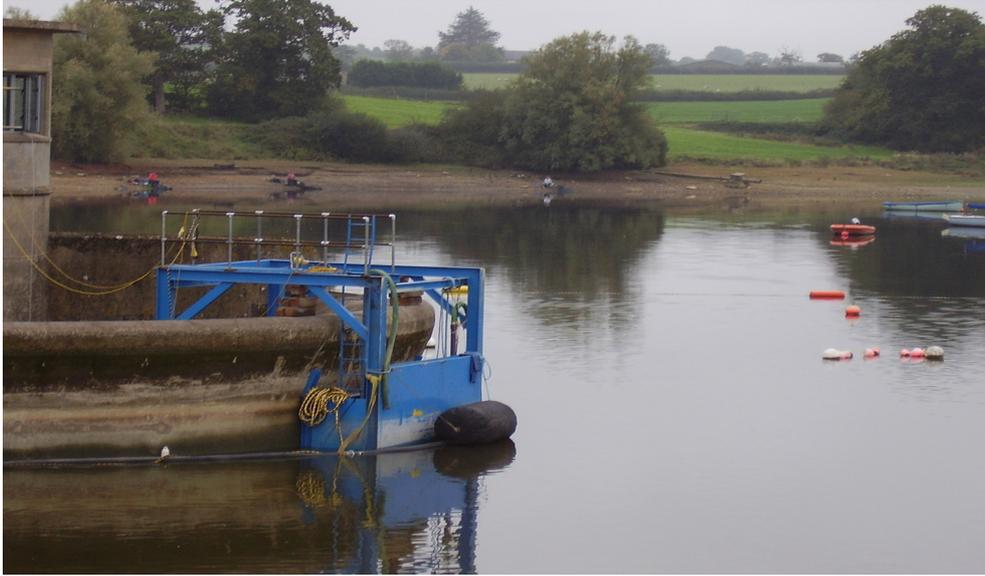
Twin 700 mm diameter holes were first drilled through the 3 m thick concrete wall of the bell mouth into a temporary steel limpet type cofferdam which had been installed on the outside of the spillway wall. The 600 mm diameter pipes were then inserted and grouted in. The installation of the valves was completed later with the reservoir level drawn down.

Figure 1- Limpet type cofferdam

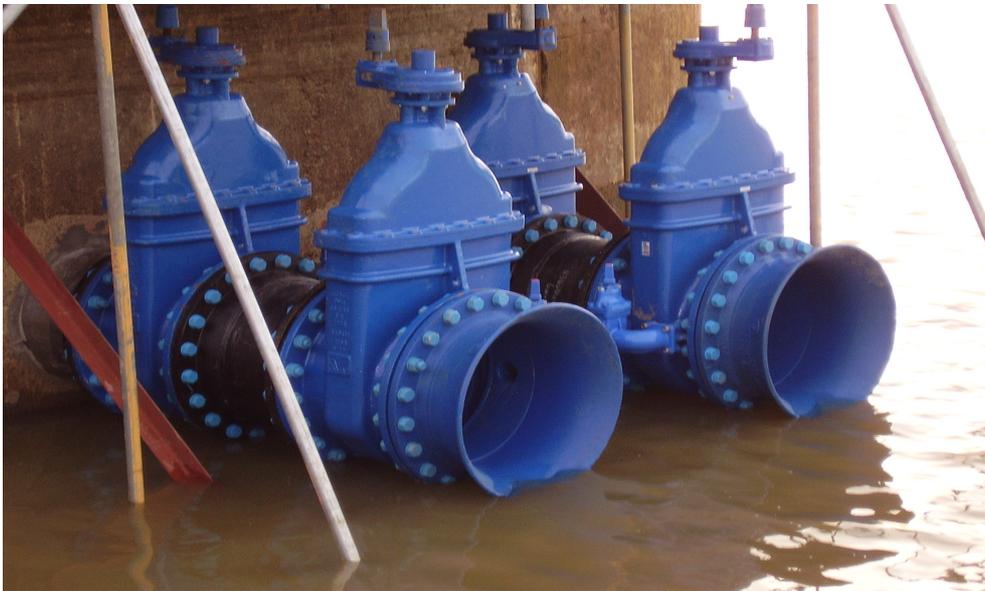
The 600 mm diameter valves each weighed 0.77 tonnes so there was a need for a steel platform bolted to the spillway to support the four valves. This structure was provided with impressed current cathodic protection.

Figure 2 - New bottom outlet valves

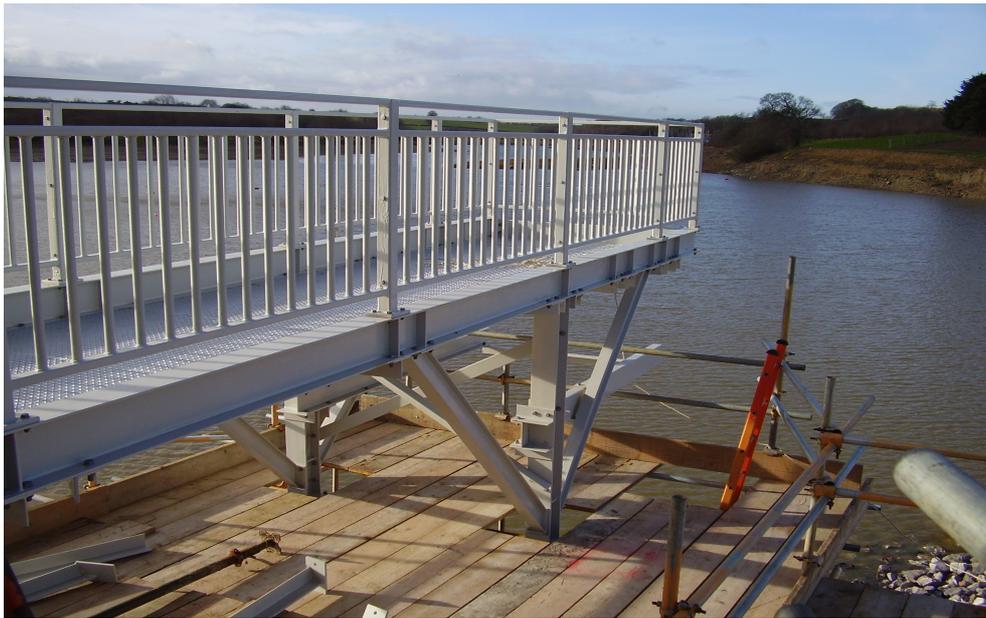
The north-west side of the spillway shaft has settled since construction and, in 2006, it was 38 mm lower than the south-east side. It is therefore unfortunate that the weight of the valves, platform and access bridge had to be carried on the north-west side of the shaft. There was no obvious alternative. However analyses suggested that there will be negligible acceleration of the tilt of the shaft. This will need to be kept under observation in the future.

Figure 3 - New bridge providing access to valve spindles and actuators

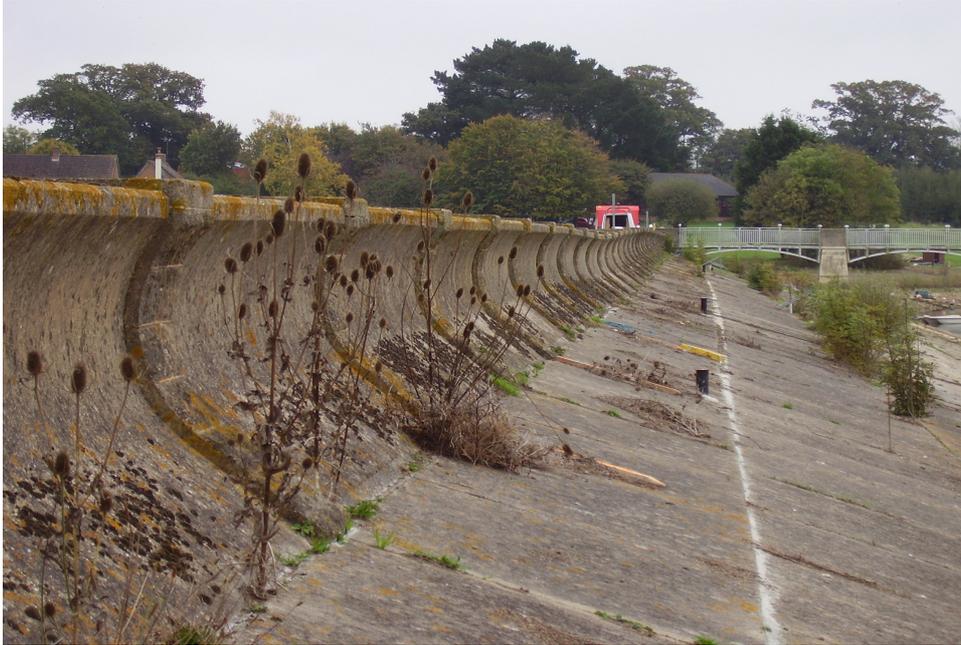
Figure 4 - Wave wall and concrete slabbing prior to the start of the works

The subsequent installation of inclinometers showed the depth of the slip surface to be close to that predicted by these early analyses. However the analyses do not explain why the concrete slabbing on the upstream face of the dam had apparently slipped about 100 mm down the face overturning the toe beam. It would appear that this was an independent phenomenon although probably also related to the low shear strength of the Forest Marble.

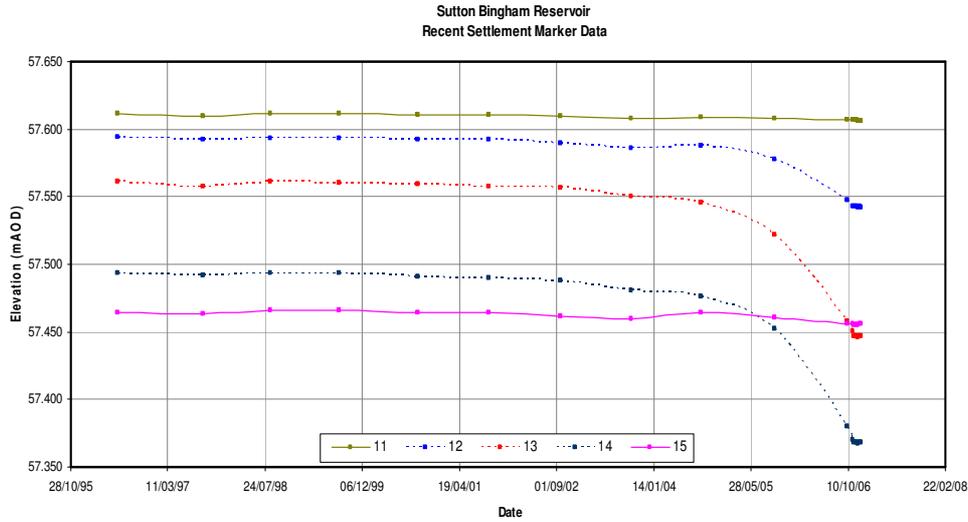
Figure 5 – Settlement at selected monitoring points

Recent settlement data is shown on Figure 5. An unanswered question is why significant settlement was only observed in 2005 (when it caused little concern) and in 2006. The reason that there was negligible settlement in previous years is still unexplained although the appearance of cracks immediately downstream of the wave wall in 2006 (and possibly also in 2005) might possibly offer an explanation.

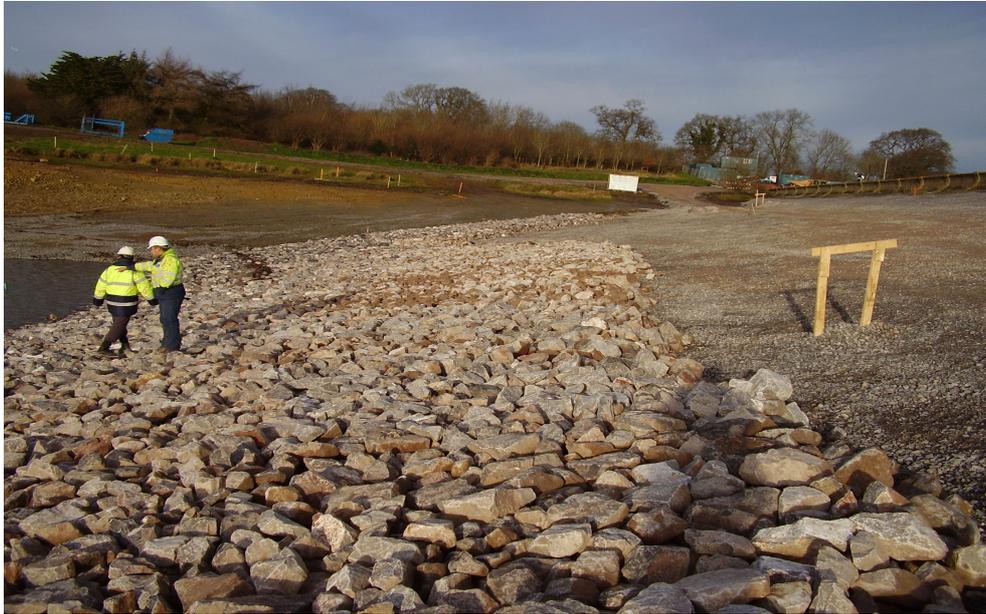
Achieving the correct grading for the rip-rap proved extremely demanding. First the quarry sent material that was much too small and when this was rejected they supplied material that was far too large. Many loads had to be sent back to the quarry and even when the stones were in place some had to be dug out and replaced.

Figure 6 - Recently placed rip-rap Underwater Works

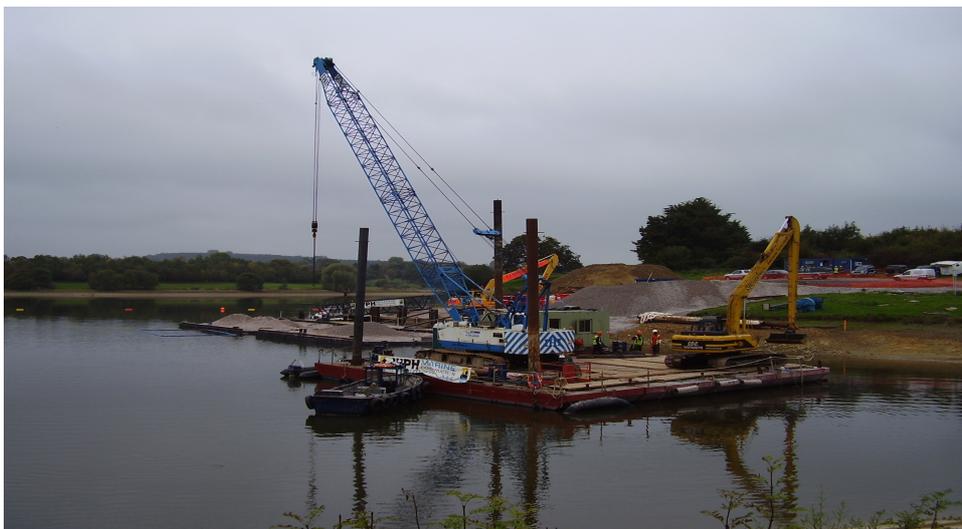
Fill at the upstream toe of the dam and part way up the slope had to be placed under water. This required the establishment of a temporary wharf on the left bank of the reservoir and the importation of barges and a pontoon.

Figure 7 - Plant and barges for underwater work
