Behaviour of embankment dams in earthquakes

J. L. HINKS, Halcrow Group Ltd, UK

SYNOPSIS Severe earthquakes have occurred in recent years in various countries including China, Indonesia, Haiti, New Zealand, Chile, Pakistan and Japan. These have led to catastrophic events including tsunamis, severe damage and heavy loss of life.

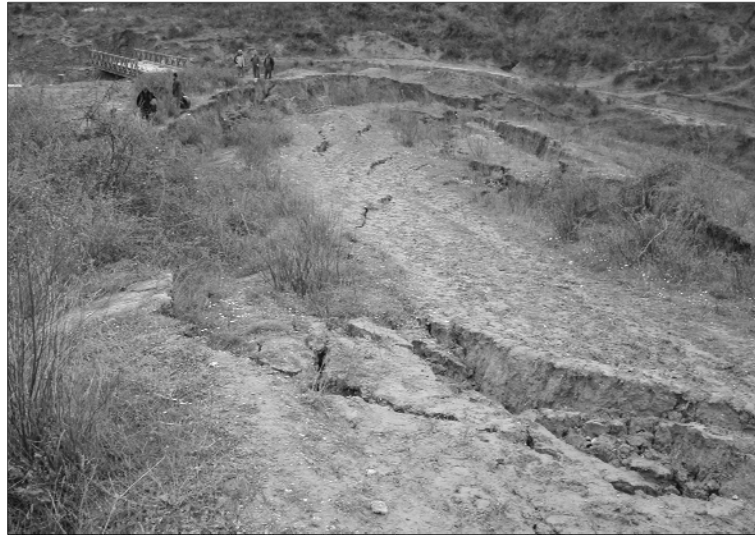
Another dam that was damaged in an earthquake with a fairly low PGA at the site was the 24m high Sharredushk dam in Albania. This was damaged by a Magnitude 4.1 earthquake on 18 March 2009. The reservoir was full at the time of the earthquake and the epicentre was only 9.5km from the dam site. Freeboard was reduced from 1.5m or 2.0m to only 0.1m but the contents of the reservoir were not lost. The focal depth was 10km and the peak ground acceleration at the site was estimated as 0.07g.

Figure 1. Sharredushk Dam in Albania after earthquake of 18 March 2009.

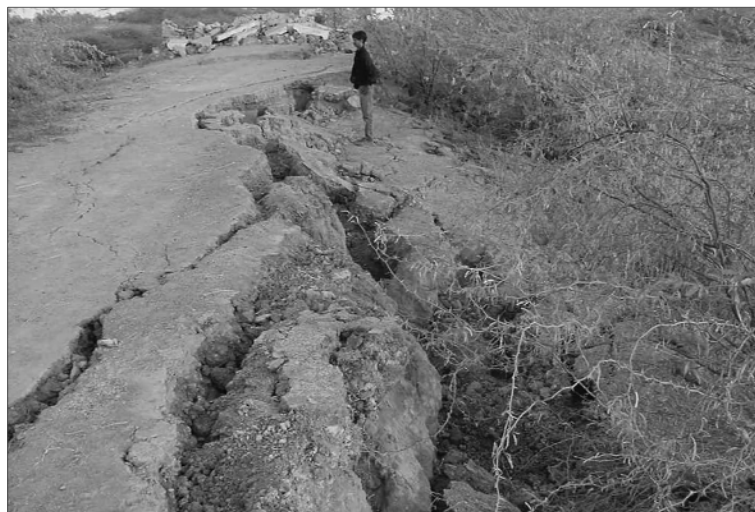
A total of 245 dams were damaged in the Bhuj earthquake in India on 26 January 2001. The earthquake had a surface wave Magnitude M_S of 7.9 (M_S =Surface Wave Magnitude). Major damage was ascribed almost entirely to liquefaction and occurred for PGA exceeding 0.2g with SPT results of $N < 20$.

Figure 2. Cracks in earthfill dam following Bhuj earthquake of 26 January 2001

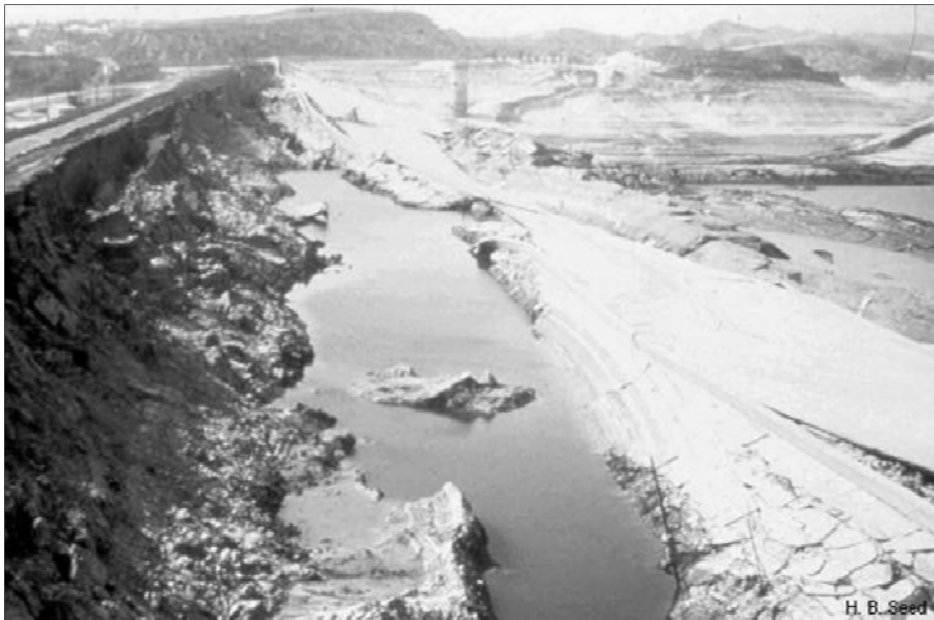
The San Fernando earthquake in California on 9 February 1971 had a Magnitude of 6.6. The relatively modern earth dams in the area performed well but the 40m high Lower San Fernando Dam, which was constructed of hydraulic fill, was severely damaged by the motion which was estimated to have a peak ground acceleration of 0.55g to 0.6g. Failure seems to have

been initiated by liquefaction of the hydraulic sand fill in the lower section of the upstream shoulder.

The earthquake caused a major slide in the upstream shoulder of the dam taking out the crest and the upper 9m of the downstream slope. Failure seems to have been initiated by liquefaction of hydraulic sand fill in the lower section of the upstream shoulder.

It was fortunate that the water level in the reservoir was about 10m below the crest at the time of the earthquake. After sliding, only about 1.5m of badly cracked material remained above the water level. Some 80,000 people living downstream of the dam were evacuated until the water level was reduced.

Figure 3. Lower San Fernando Dam after the 1971 earthquake.

This incident at the Lower San Fernando Dam illustrates the dangers of using poorly compacted sand fill in dams that may be subject to earthquakes. The most easily liquefiable sands have a particle size distribution between 0.07mm and 0.6mm.

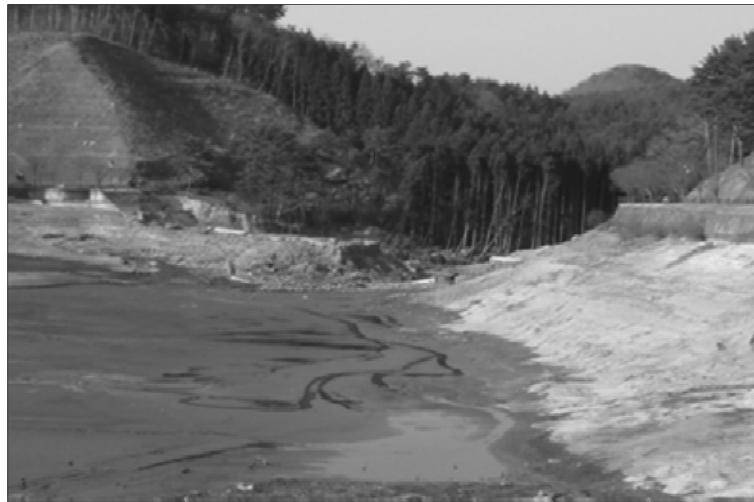
The effects of the Tohoku earthquake and tsunami in Japan on 11 March 2011 are well known. The cause was a Magnitude (M_w) 9.0 thrust earthquake at a depth of 32km about 70km east of the coast of Japan. The event caused heavy loss of life and a number of nuclear accidents at the Fukushima 1 Nuclear Power Plant. In all 252 dams were inspected after the earthquake. The 18.5m high Fujinuma irrigation dam in Sukagawa failed completely 20 to 25 minutes after the earthquake despite efforts by locals to repair leaks. At least eight people were killed.

Figure 4. Fujinuma Dam after Tohoku earthquake of 11 March 2011.
