Tackling the Thorny Issue of Spillway Capacity in Yorkshire

J. N. BOOTH, Yorkshire Water, Bradford, UK

SYNOPSIS. This paper will illustrate by example a number of cases where the problem of insufficient spillway capacity has been dealt with in ways other than just increasing the size of spillway channels. It will also illustrate the benefits of physical modelling and a number of problems associated with the environment and planning restrictions.

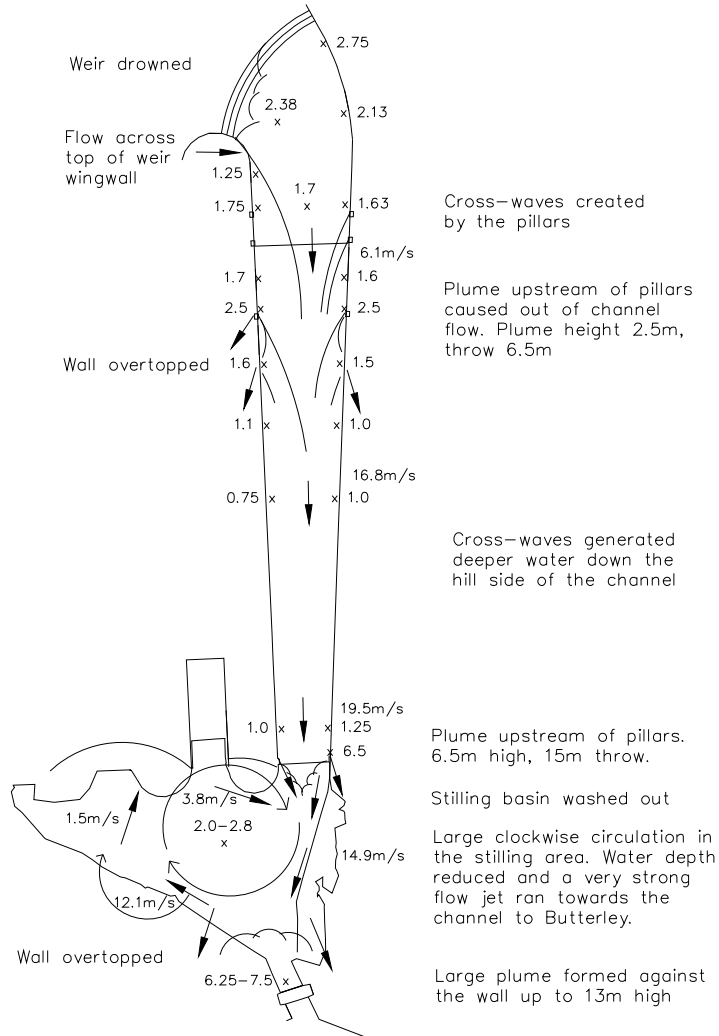
Through the modelling process it was concluded that there were several areas of concern with the existing spillway system that would need to be addressed via physical works. These concerns included: at PMF the still water level was above the watertight element of the dam; the architectural pillars within the channel caused significant plumes of water which impacted on the surrounding ground surface; velocities as high as 20m/s were observed in the lower reaches of the channel; water was impounded by the retaining wall and earth embankments downstream resulting in flows against the toe of the dam. The results of model test at PMF are shown in Figure 2.

The peak still-water flood rise was found to be above the top of the clay core and marginally above the crest level in places. As this could be addressed by raising the clay core and crest it was therefore included in the list of required works.

Figure 2. Model test results at PMF – existing situation

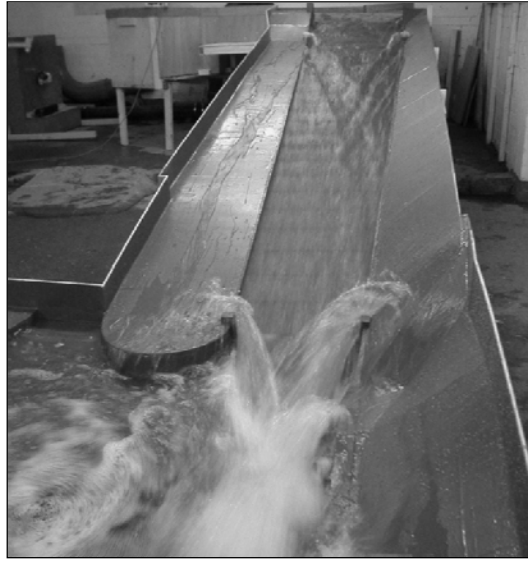
The effect of the architectural pillars was unfavourable and it was agreed that these should be modified such that they did not protrude into the channel. These effects can be seen in Figure 3.

Figure 3. Effect of the architectural pillars

was the need to remove the architectural pillars, which was achieved by employing stone masons to dress back the masonry face to ensure a solution sympathetic to the existing structure.

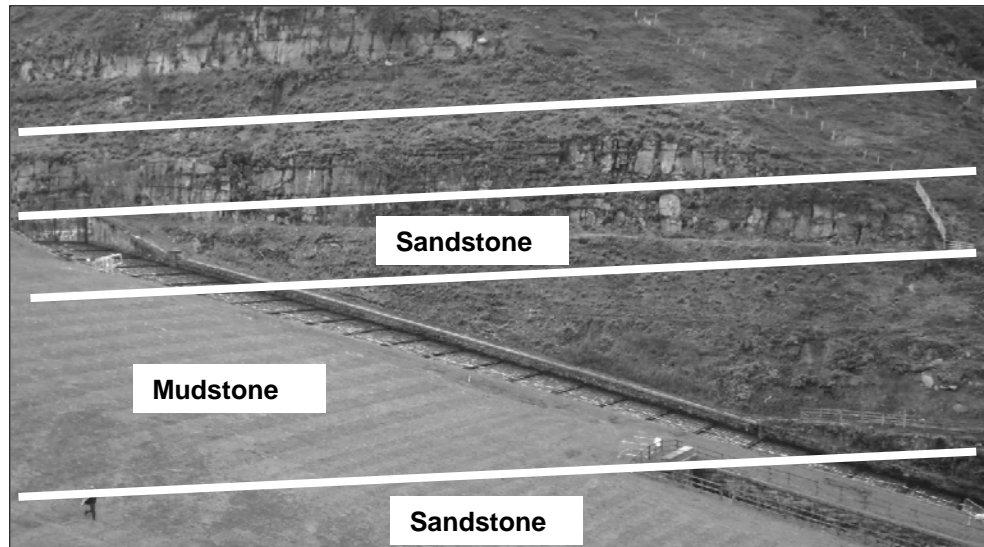
To enable the cut-off wall option to work it was important to carry out ground investigations to determine the nature and suitability of the underlying material to allow its construction. The left abutment rises steeply and rock outcrops can be seen dipping towards the axis of the dam, as is shown in Figure 4.

Figure 4. Left hand side abutment showing outcropping rock head

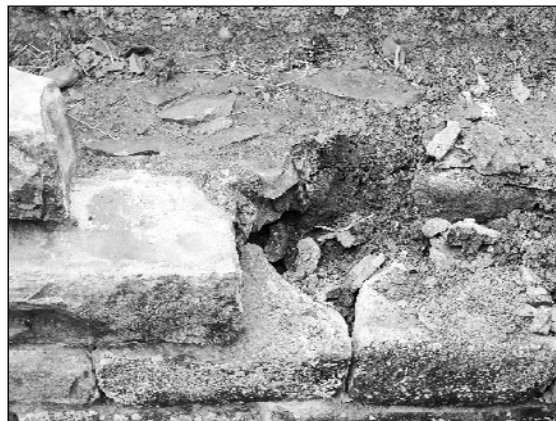
The work on site was started in April 2011 and the early stages involved the removal of the defective concrete invert and raking out of the mortared joints to allow re-pointing. During this process it became evident that there were several sections of wall which were of poorer construction, and further investigation, involving the removal of the copings, highlighted that the masonry skin to the walls was not backed with concrete as earlier investigations had suggested. The original wall construction is shown in Figure 5.

Figure 5. Showing the original wall construction

The information was passed to the QCE and the core team involved with the project and initial discussions were had regarding alternative solutions. A full section of the spillway wall was removed and the construction of the wall was examined – this was confirmed as a masonry facing course, backed

with rubble bound in mortar, with a further backing layer of puddled clay to the batter of the original excavation. The spillway invert was known to be masonry underlain with concrete which was founded directly on the excavated left hand abutment.

The original design was modified thus: the reinforced concrete invert slab was connected via dowels to the footing of the spillway wall; the walls were taken down and the masonry face was rebuilt; the backing rubble and puddle clay was replaced with mass concrete and the wall copings were replaced. The design also now incorporated raising of the left hand side wall where the model test indicated out of channel flow. This raising was achieved using local stone sourced to match the existing.

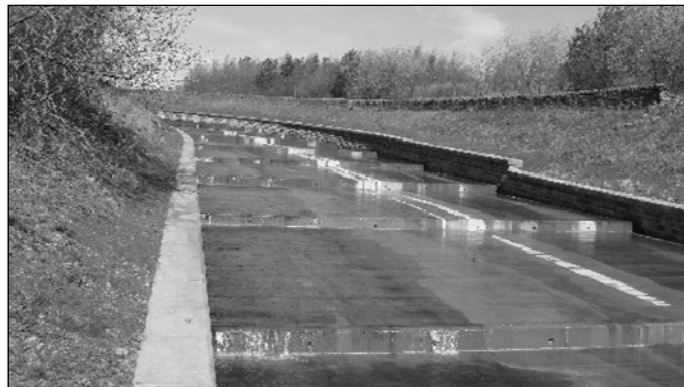
Figure 6. The completed spillway at Ingbirchworth

The completed scheme allowed for a channel that was visually unchanged (Figure 6) and was granted permitted development by Barnsley Metropolitan Borough Council's planning department.

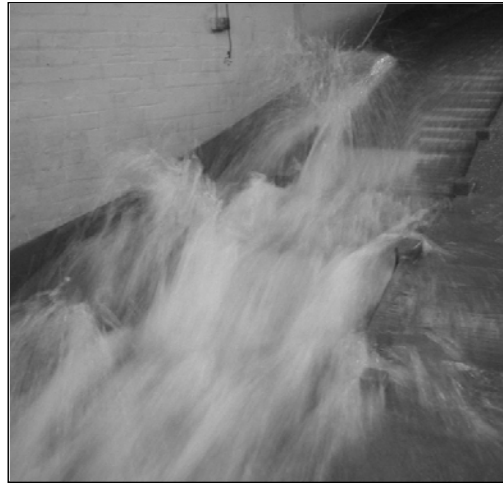
- Significant out of channel flow on the right hand hillside.
- Plumes of high velocity water caused by the architectural pillars.
- Separation of the flow from the masonry invert at the cascade sections.
- Significant out of channel flow on the left hand side impacting on the tunnel outlet channel.
- Velocities reached a maximum of 17.2m/s.

Figure 7. Model test results at PMF – effects of the architectural pillars

- *The major 'steps' near the base of the spillway need to be removed by smoothing out the profile between the channel upstream and downstream of the steps. The new base can be formed as a stepped channel as per the rest of the channel.*
- *The base of the channel needs to be replaced as a reinforced concrete base either as a smooth base or as a stepped channel as per the existing*
- *The walls need to be made higher from reinforced concrete. A masonry facing to the floor or walls could be removed in the high velocity flows likely to be experienced which could cause damage or blockage.*
- *The pillars need to be cut back flush with the walls.*

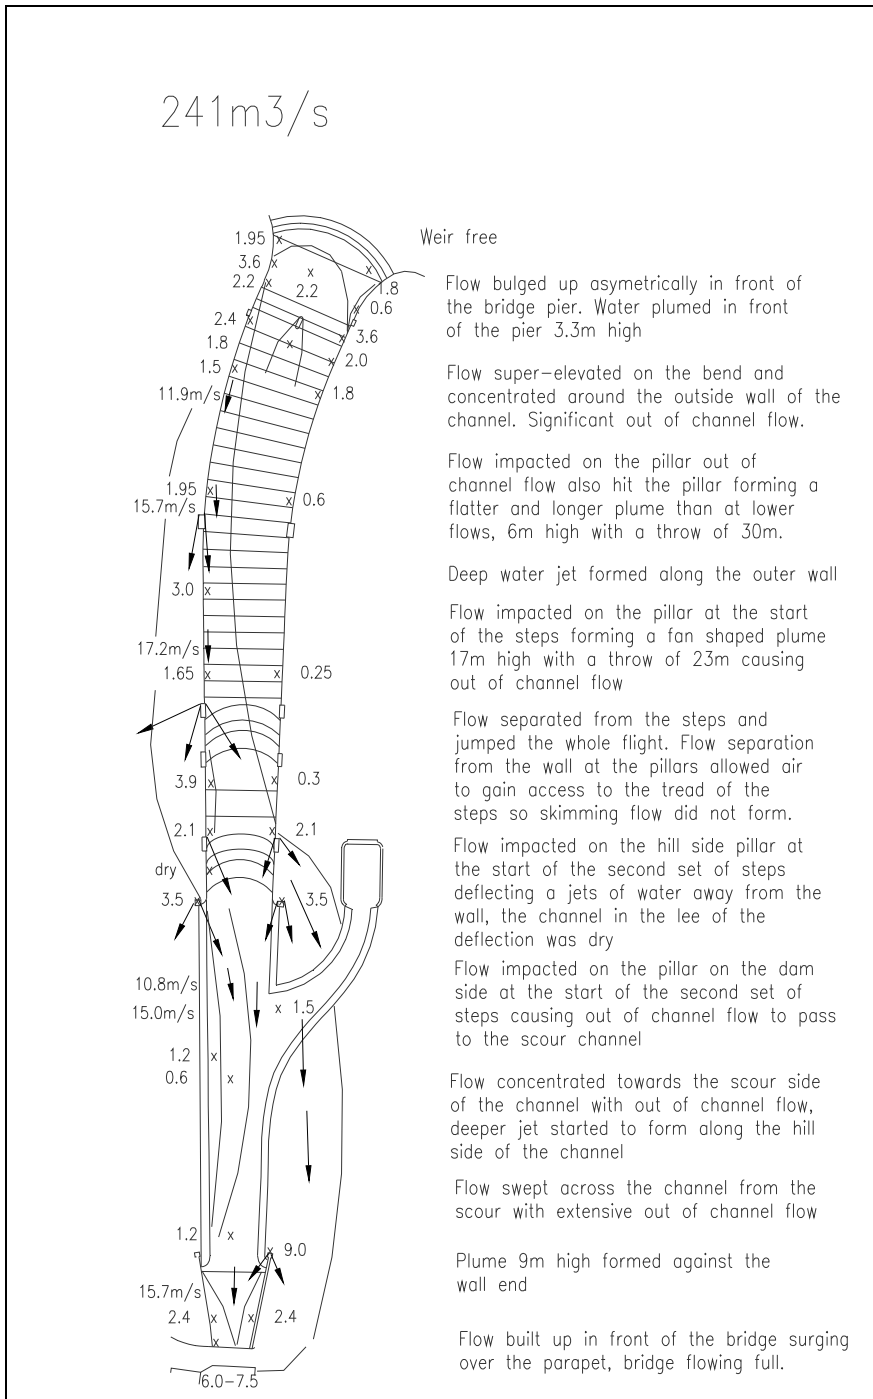
Figure 8. Model test results at PMF – existing situation

- The masonry invert to be replaced with a structural concrete slab; this would replicate the series of small steps currently present.
- The walls to be replaced and heightened using reinforced concrete with a form lined finish.
- The existing masonry copings to be retained.
- The architectural pillars to be replicated in concrete; however they will be set flush with the channel walls.
- The steep stepped cascade section to be levelled through, such that the spillway will have a constant grade from top to bottom.

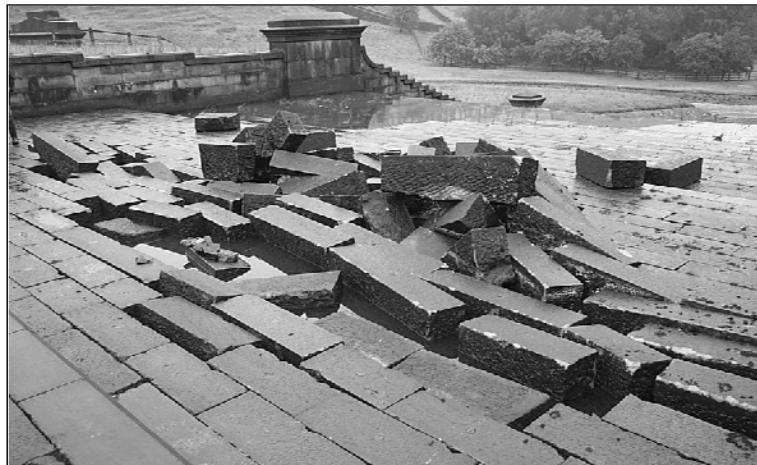
The models have also been used to investigate historical impacts upon the spillway. In July 2002 a flood occurred which resulted in a strong overflow of water at Butterley IRE; anecdotal records indicate that the overflow was in the order of 300mm head over the spill weir. Significant damage occurred to the lower spillway system, with masonry blocks being plucked from the invert of the channel (Figure 9).

Figure 9. Spillway damage at Butterley IRE

modest 13.7m³/s. It could be observed that even at this low flow, velocities reached 7.7m/s and strong plumes of water were generated by the architectural pillars. The area of masonry plucked from the invert was where the plume impacted and it was concluded that this was a contributing factor to the failure of the masonry steps
