Physical Testing of a Stepped Masonry Spillway

P. D. DOWN, Mott MacDonald-Bentley, Leeds, UK

M. WEARING, CRM Rainwater Drainage Consultancy, Bolton, UK

SYNOPSIS Many of the dams that have been constructed in the UK incorporate stepped masonry spillways. In recent years, a number of incidents have highlighted the risk of damage to these types of spillways during flood events resulting in a potential risk to reservoir safety. This was particularly evident during the incidents at the Boltby and Ulley reservoirs.

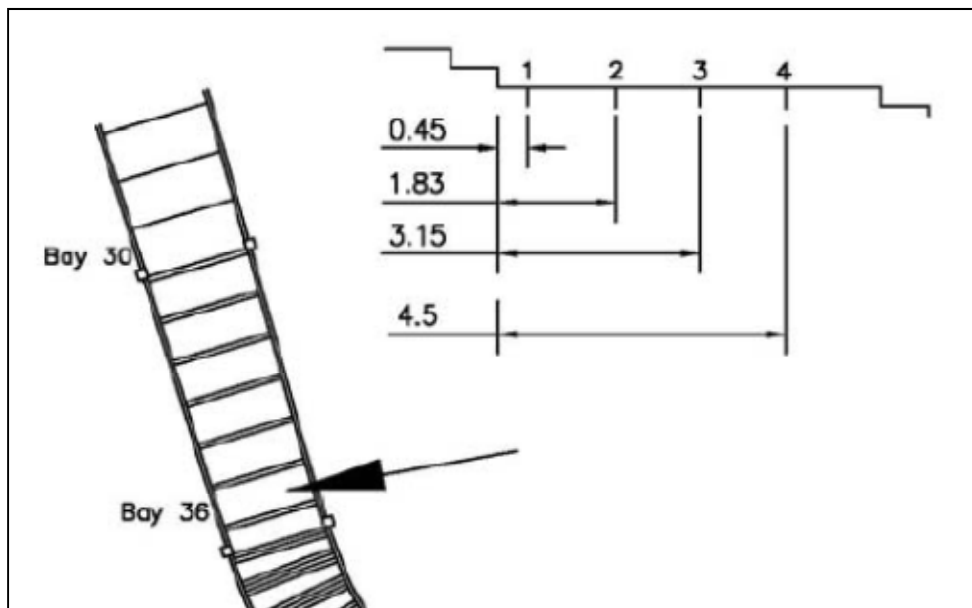
Figure 2. Pressure measurement locations in physical model

In an attempt to further estimate the pressures within the spillway the 1:30 scale physical model built to determine the spillway operation also incorporated pressure tapping points at Bay 36 (Figure 2). It was recognised that, due to the small scale of the model, the ability to accurately establish the peak pressure changes on the step was likely to be limited. The maximum pressure difference recorded and scaled from the model was equivalent to just over 5m head of water (49kN/m²). The pressures recorded for the 0.5 PMF model flow were very similar.

The estimated pressures obtained by theoretical calculation and the physical model results are markedly different. Test carried out by CRM as part of the Defra/Environment Agency study showed that low and high pressure areas could be very localized. To ensure these are picked up, a large number of pressure tapping locations would be required. This was not practical on a small scale model constructed for the broader purpose of assessment of the overall chute hydraulics.

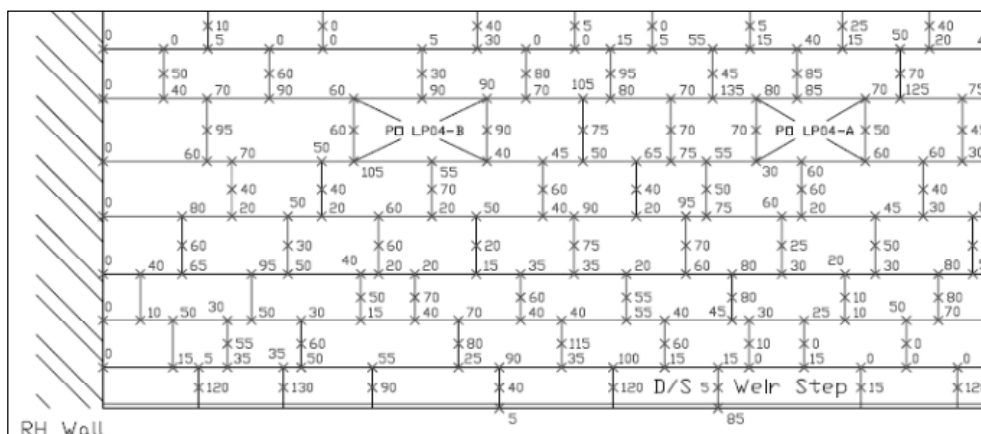
Figure 3. Depths of missing/eroded joint mortar at bay 42 (in mm)

At the downstream section of the spillway erosion of the mortar joints was more apparent. This was particularly evident in the vicinity of the step, stepped cascade due, presumably, to the increase in velocities, energy and turbulence of the flows.

At bay 42, immediately downstream of the cascade, the missing/eroded mortar appeared the most extensive with depths up to 100mm being common and up to 180mm occasionally recorded (Figure 3). Within this bay, some areas appeared to suffer greater erosion than adjacent sections. This may be indicative of differing mortar batches used during construction. Much greater depths, occasionally in excess of 300mm, occurred at the joints in the steps at the ends of the bay.

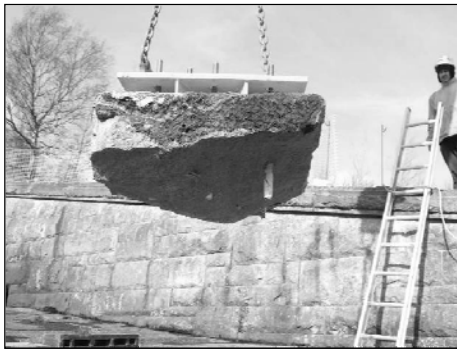
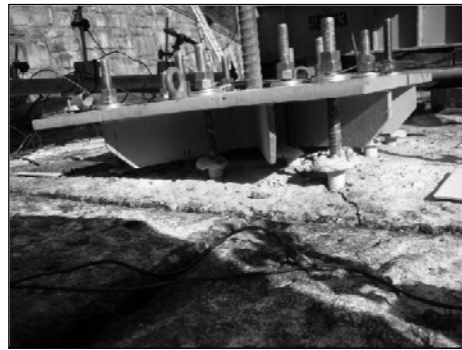
Figures 5a & 5b. Failed blocks at test locations LP03-A and LP04-A

At locations LP03-A and LP04-A, the extent of missing/eroded mortar at the side joints was generally greater than at the previous test locations. During load testing, failure of the test blocks was recorded at 431kN and 420kN respectively. At LP03-A, the test block failed in tension. The section into which the dowels were fixed separated from the rest of the block which remained in-situ (Figure 5a). For LP04-A, the test block split apart around the dowels resulting in failure of the dowel bond to the stone (Figure 5b).

At test locations LP03-A and LP04-A it was found that the tensile strength of the material forming the individual blocks could be more of a limiting factor particularly where missing joint mortar has reduced the bond to the adjacent invert blocks. Up to the loads where the sandstone block failure occurred (equivalent to 610kN/m² and 462kN/m² respectively), the channel invert appeared to behave in a similar manner to the previous test locations.

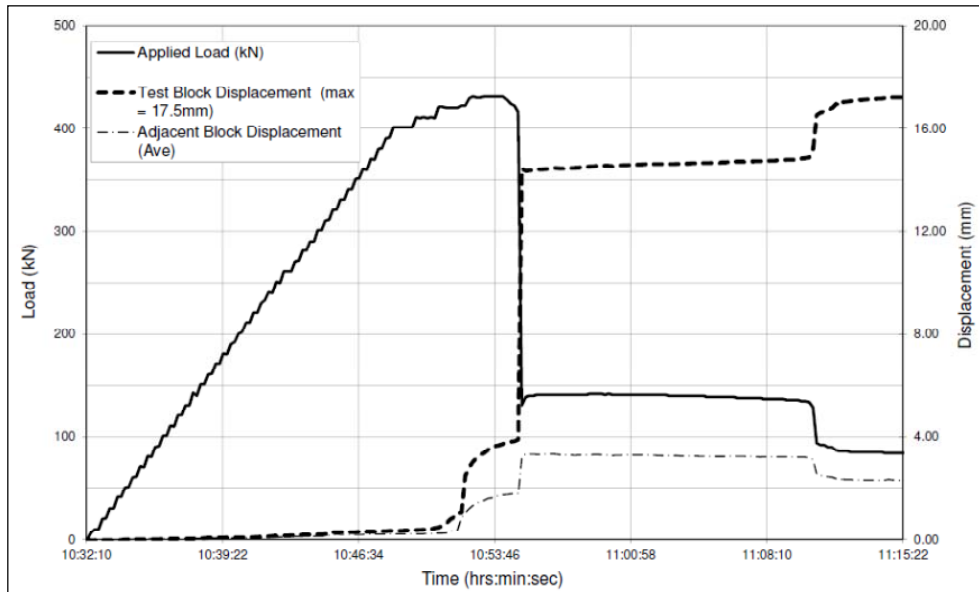
Figure 6. Load test results for block ref. LP03-A

Movement of the test blocks in excess of 0.1 mm was noted to commence at a load of 221kN at LP03-A and 201kN at LP04-A. At LP03-A, a gradual vertical movement was noted up to a load of 420kN before significant failure of the test block occurred (Figure 6). The results for LP04-A were more difficult to interpret. However, a 1.02mm vertical movement of the test block was recorded at 400kN before failure of the dowel bond to the block occurred. In both cases, corresponding displacements were noted in the adjacent blocks during the movements at the test block.

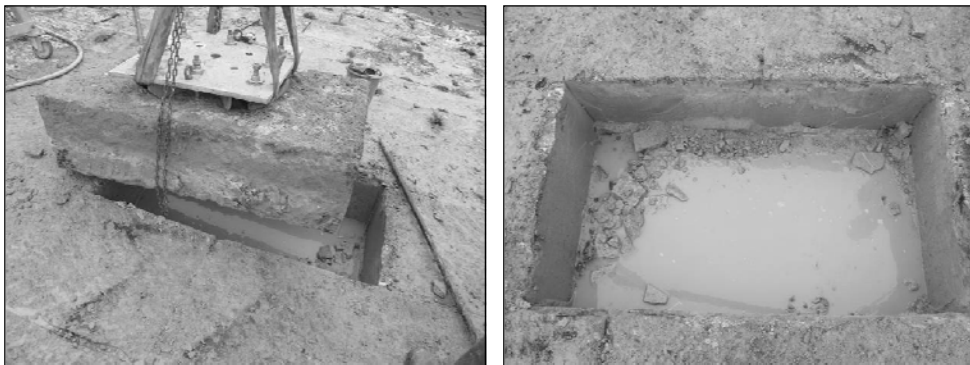
Figures 7a & 7b. Extracted block at test location LP05

At test locations LP05 and LP06 the blocks were restrained by their bond to the concrete bed alone. Test block failures were recorded at 181kN and 192kN respectively. Inspection of the blocks and the remaining void indicated a relatively clean failure plane (Figures 7a & 7b). This appears to indicate failure of the mortar bonding the block to the bed.

At test locations LP05 and LP06, failure of the bond between the test blocks and their bond to the concrete bed occurred at loads of 181kN and 192kN (equivalent to 174kN/m² and 248kN/m²) respectively. This seems to indicate an average bond strength of the blocks to the concrete bed of approximately 200kN/m². This also appears to correspond with the loads required to move the blocks in the previous tests by 0.1mm.

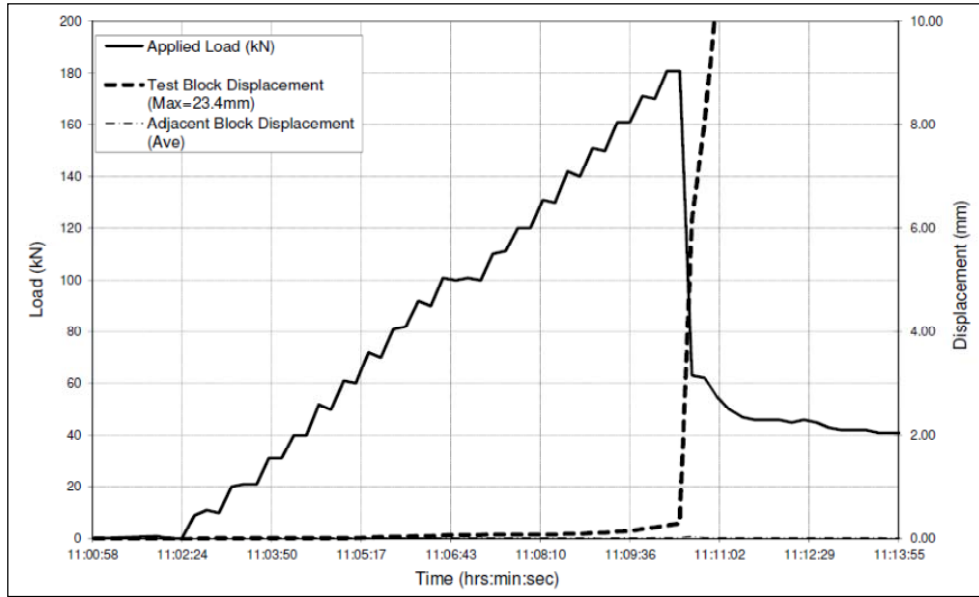
Figure 8. Load test results for block ref. PO LP-05 with saw cut joints

The load was progressively applied until a sudden movement of the block occurred, in both cases, before the block had deflected by 0.1mm. The load test results for location LP05 are given in Figure 8.

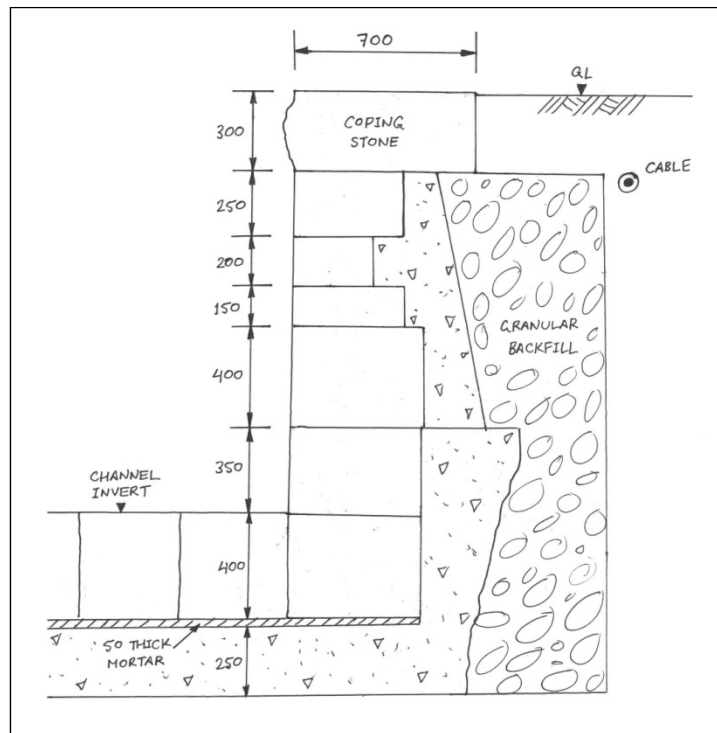
Figure 9. Section of left-hand spillway wall at investigation site

A section of the existing spillway wall to the left-hand side of the channel was dismantled to prove the overall construction and structural integrity. It was found to be of typical construction for the period comprising masonry ashlar blocks forming the inner face backed with concrete (Figure 9). Behind the wall is a granular backfill which provides a drainage function. The wall was dismantled with some difficulty and this further indicated the high standard of the original construction.
