The discontinuance of Baystone Bank Reservoir and restoration of Whicham Beck

SYNOPSIS. Baystone Bank Reservoir was constructed in 1877 to supply water to the village of Millom, Cumbria. By 1996 the reservoir yield was not required for water supply purposes and in 2002 the reservoir was also identified as having inadequate spillway capacity. Following an assessment of possible options the North West's regional water company United Utilities took the decision to discontinue the dam and restore Whicham Beck to its pre-impoundment condition. This paper describes the reasons for the discontinuance, the design process and subsequent construction.

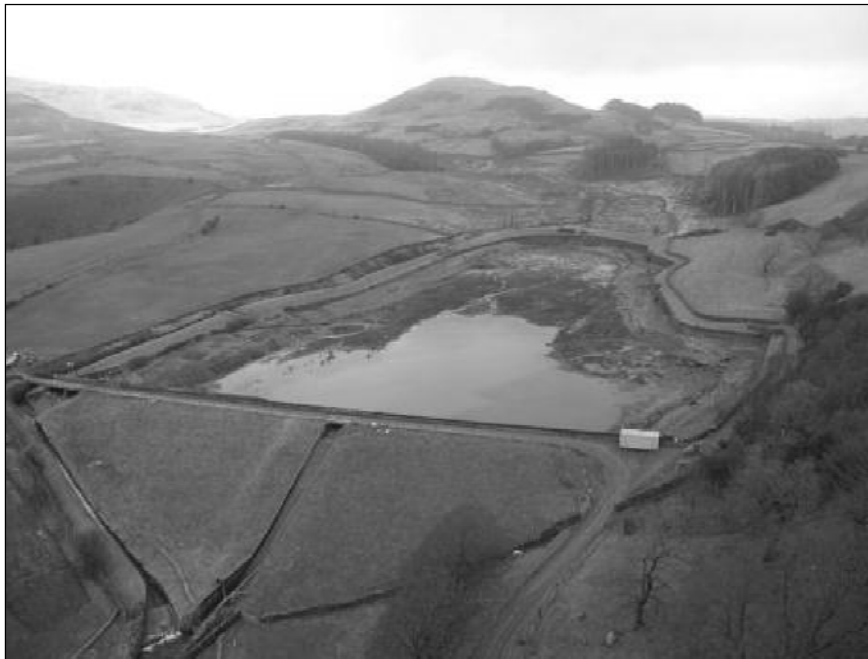
Figure 8. Baystone Bank Reservoir – before

As shown in Figures 8 and 9, Baystone Bank Reservoir has been successfully discontinued, and the Impounding Licence has been revoked (under Section 13(2) of the 1975 Reservoirs Act). Whicham Beck has been restored to its pre-impoundment conditions reconnecting the upstream and downstream reaches of Whicham Beck, allowing movement of migratory and resident fish, whilst minimising ecological impact in delivering these works.

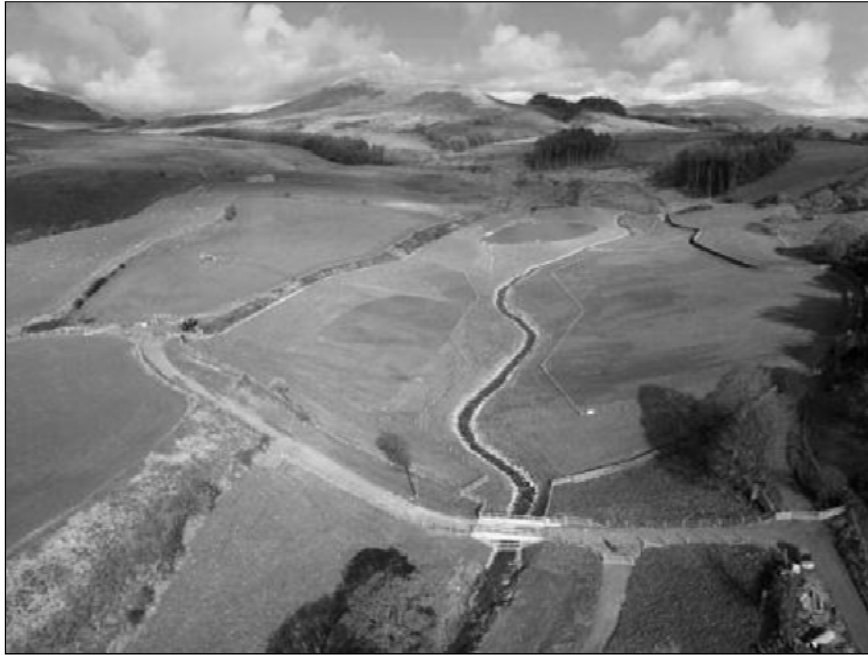
Figure 9. Baystone Bank Reservoir – after

As the vegetation has become established the location of the former dam and reservoir basin has become very difficult to identify, with the new watercourse/ground profile blending seamlessly into the landscape. The new river channel has continued to evolve over time, as sediment is moved within the channel. Gravel has accumulated, moved and eroded, adding further natural variability. Evidence of otters using the pond has also been identified. Overall the project has been well received by all parties, including the Environment Agency and the adjacent landowner.
