## **Coldwell Lower Reservoir - Weighted Filter, Wave Wall and Overflow Improvements**

**SYNOPSIS.** An improvement project has recently been completed on a United Utilities dam at Coldwell Lower Reservoir in Lancashire comprising:

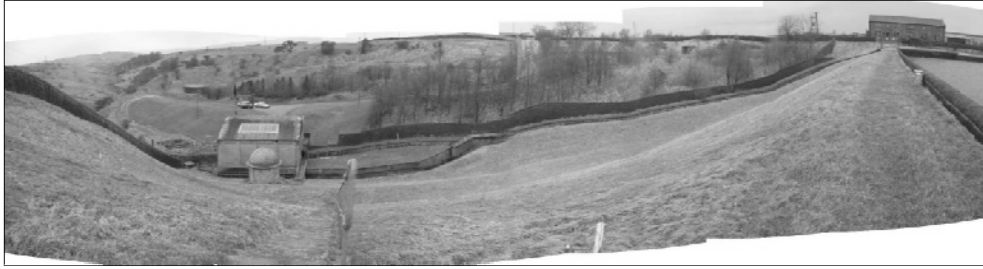
Figure 1. Panoramic view of the existing embankment with lower Coldwell Reservoir to the right and the existing pump house at the toe of the embankment.

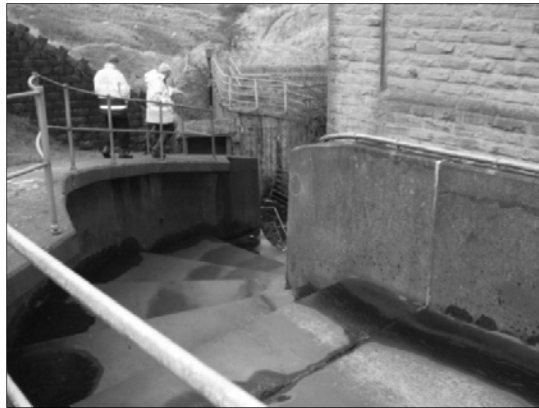
Figure 2. View of the existing spillway winding around the pump house.

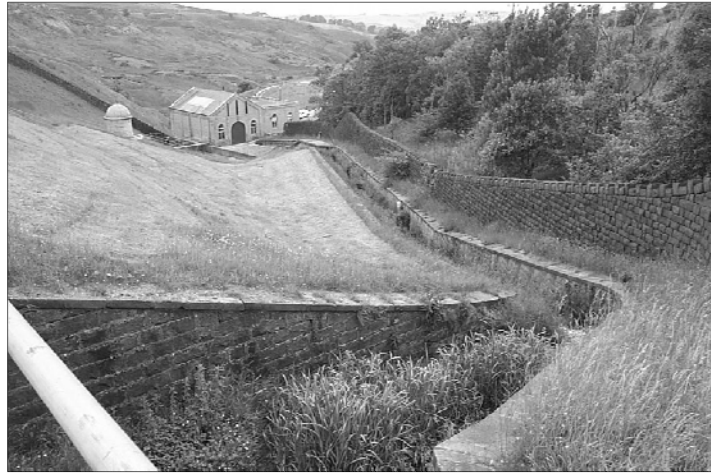
Figure 3. View from the overflow weir showing the existing spillway falling down the embankment to the pump house.

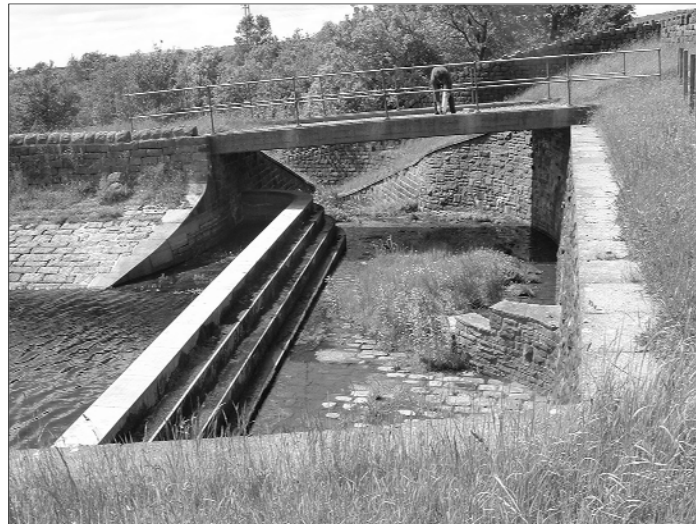
Figure 4. View of existing overflow and bridge over embankment crest

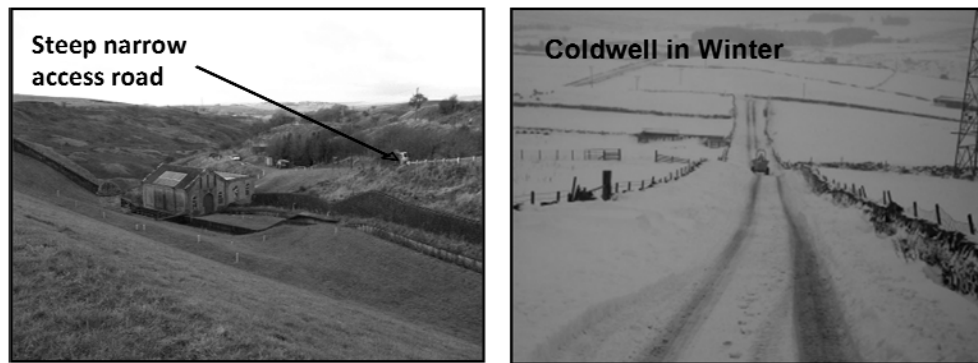
- would demonstrate to the client that the scheme could be constructed at a site location where the topography, existence of historical landslips, presence of existing structures and width and gradient of site access would pose safety and logistical constraints during construction (Figure 5).

Figure 5. Access Constraints

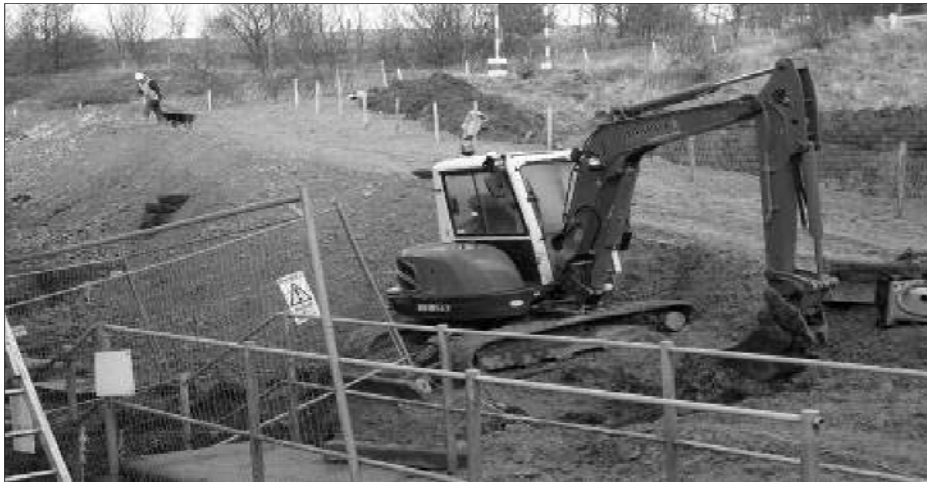
Figure 6. Construction of temporary access track across embankment

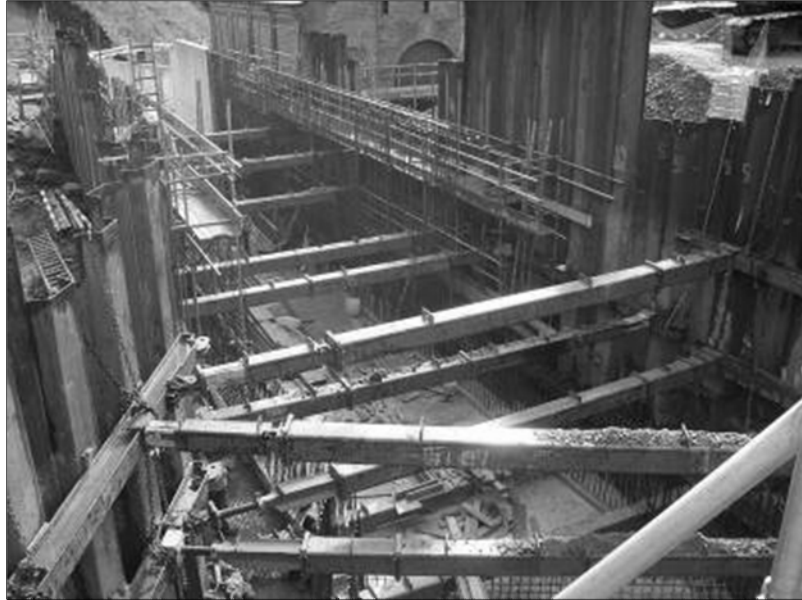
Figure 7. Phase 1 Temporary works adjacent to pump house

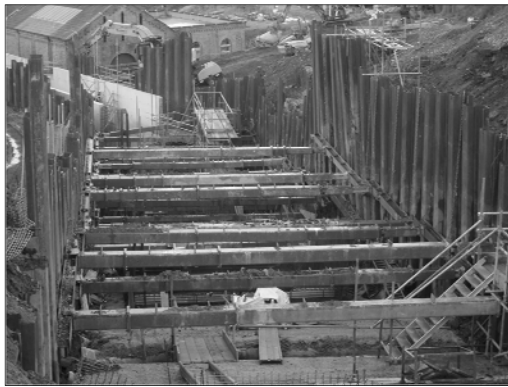
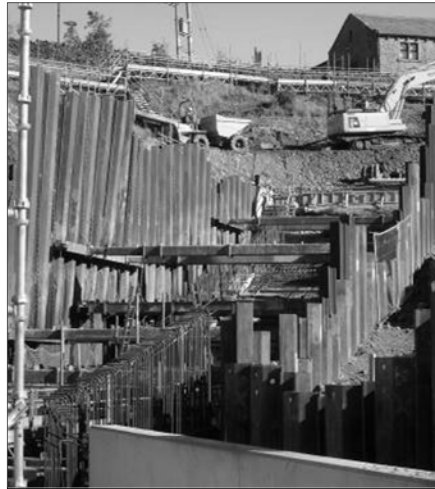
Figure 8. Phase 2 Temporary Works along new spillway chute

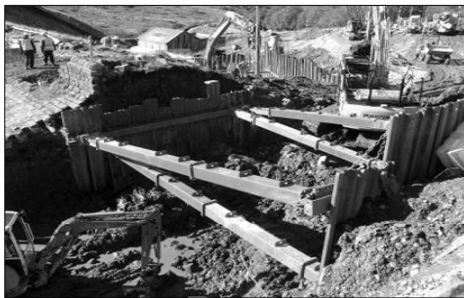
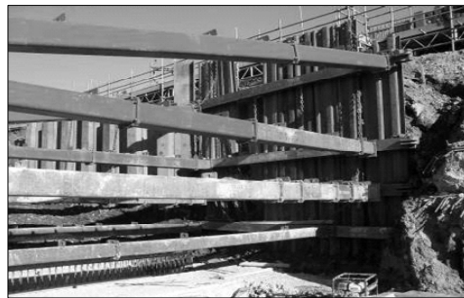
Figure 9. Phase 3 Temporary Works for crest bridge and tumble bay

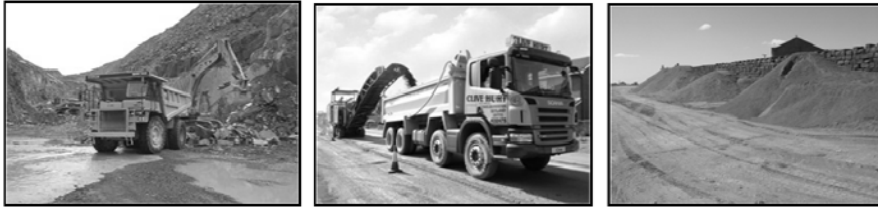
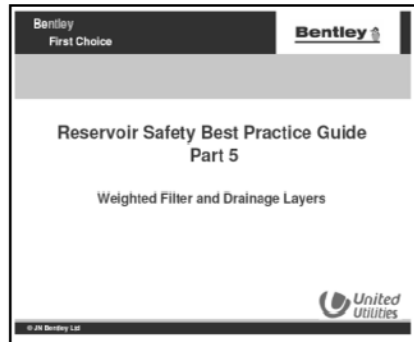
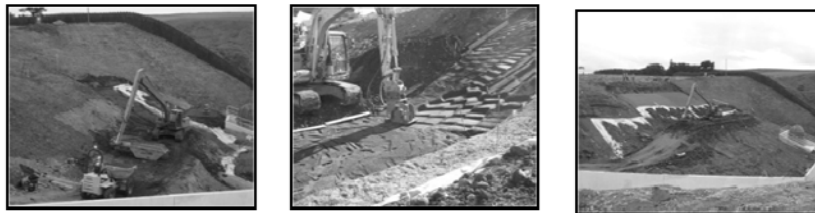
Figure 10. Placing Filter and Embankment Stability Works

Having safely completed construction of the overflow channel, work commenced on modifications to the downstream embankment shoulder. This required close control on the placement of granular filter and drainage materials, of bespoke and narrow grading, which were sourced from a site in mid-Wales. Construction of the filter arrangement entailed the sequential placement of filter and drainage layers against the existing slope gradient of around 1V:2H, prior to covering with a protective separating geotextile layer and overfilling with general embankment fill to the design profile. The existing embankment shoulder fill had to be protected from the elements at all times, to prevent deterioration of the sub-grade, and this placed a significant constraint on the working area available at any time. To ensure that this was achieved to meet the required performance the site team developed a Filter and Drainage Layer Reservoir Best Practice Guide and a Total Management Plan for completion of the operations from source selection to final installation (Figure 10).

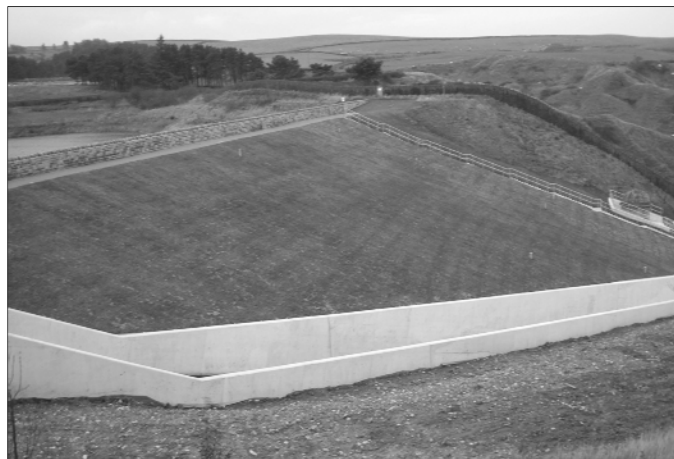
Figure 11. Completed Works

Representatives from all parties visited the proposed sources of materials and evaluated production and quality control methods that would ensure a consistent product be supplied to site. The site materials storage approach incorporated storing the filter and drainage materials in separate skips to ensure no cross contamination. A trial placement of the filter layer was undertaken and attended by all relevant parties to ensure that this critical element of the works would perform as designed. The trial proved that the selected filter material could be compacted on the slope using Ho-pac compacting plates attached to a long reach backactors which allowed placing of the filter and drainage layer to progress up the slope followed closely by the placing of the general stabilising fill won from the reservoir basin to complete the works successfully. J N Bentley opted to defer the embankment modification works until after the winter season and this was agreed with United Utilities. The embankment modification works were completed in spring 2011 and the Qualified Civil Engineer issued a 10(6) certificate, confirming completion of the ITIOS action (Figure 11).
