Remedial grouting works at Upper Rivington Reservoir

P. J. RIGBY, United Utilities Engineering, Warrington, UK
K. D. GARDINER, United Utilities, Warrington, UK

SYNOPSIS In January 2002 a serious leak into the culvert below the Yarrow embankment of Upper Rivington led to a rapid drawdown of the reservoir being required. Subsequently a grouting programme was undertaken during which a defect in the puddle clay core was identified. A geophysical survey was undertaken which revealed that the grout curtain had successfully sealed the original leak but that other seepage paths existed around the curtain and beneath the dam.

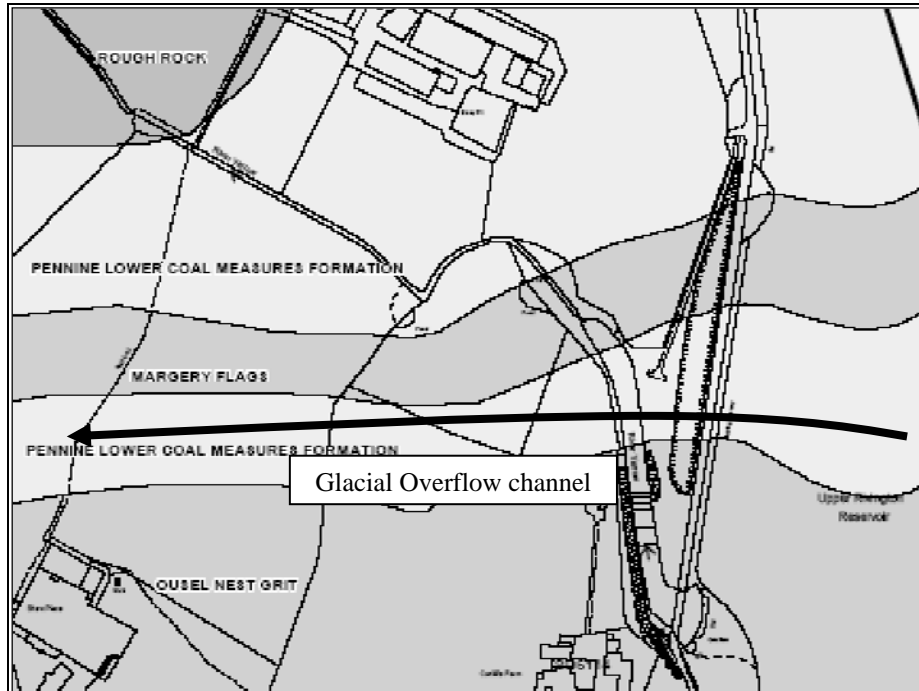
Figure 1. Plan showing solid geology and line of Glacial Overflow channel

Rock at the site comprises Lower Coal Measures Strata, typically coarse-grained yellow Sandstone (Ousel Nest Grit), underlain by mudstone, shales and occasional flagstones. Rock outcrops within the spillway channel and is evident on the adjacent valley sides. A review of the drawings and borehole information suggests that this is a small rock cliff forming a bench feature extending to the line of the drawoff culvert before dipping steeply towards the former stream levels at the centre of the dam, approximately 24m below embankment crest level. The geological maps for the area show a glacial overflow channel which is aligned approximately north to south, through Anglezarke, Upper and Lower Rivington Reservoirs, typically following the line of a north west/south east trending fault (Figure 1).

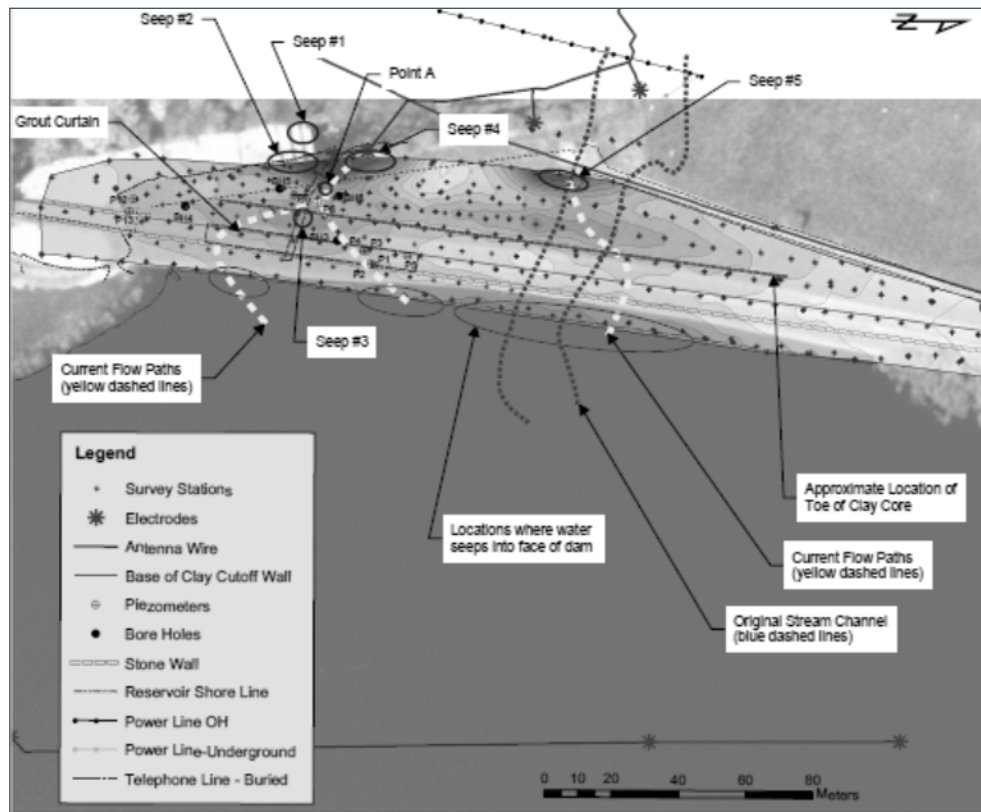
The survey identified high and low conductivity areas relating to five small seepages across the embankment. Two major flow paths were identified (Figure 2), one located on the southern part of the dam centred over the drainage culvert with a second coinciding with the alignment of the original stream channel. These flows were noted to act independently of each other and were highly influenced by an increase in reservoir level resulting in increased flows. The footprint of these flows beneath the dam indicates that they are fairly wide, suggesting sheet flows rather than concentrated flows. The remaining seepages were reported to be minor, again influenced by raised reservoir levels and focused around the southern abutments at elevated levels within the embankment. This was in line with the piezometer readings. The survey also indicated that the previous grouting works undertaken in 2002 had been successful with seepages shown to flow around this grouted zone.

Figure 2: Willowstick interpretation of potential flow paths

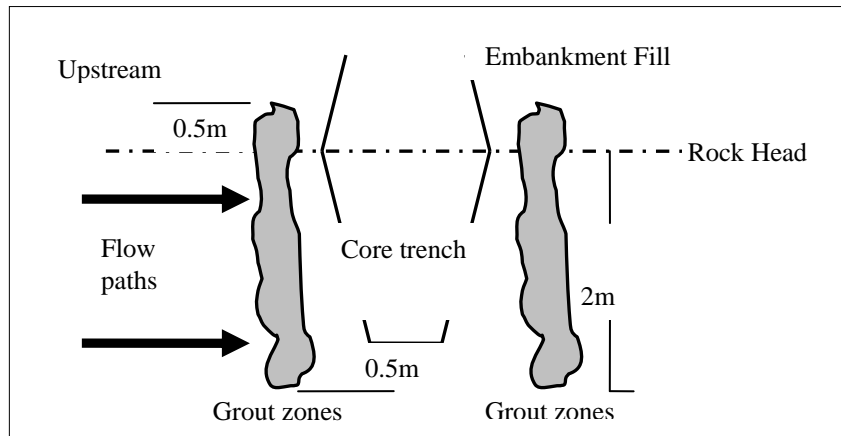
The event tree mechanisms were reassessed assuming that grouting would be undertaken to seal the area of the core trench within the rock (as per Figure 3). This resulted in revised probabilities of failure within the ALARP region (Table 3) which was considered acceptable by the RET.

Figure 3. Proposed grouting works within the foundations.

The proposed solution to meet the ITIOS requirement was to form two grout curtains, upstream and downstream of the core, extending from a minimum of 0.5m above rock head to 0.5m below the base of the core trench.

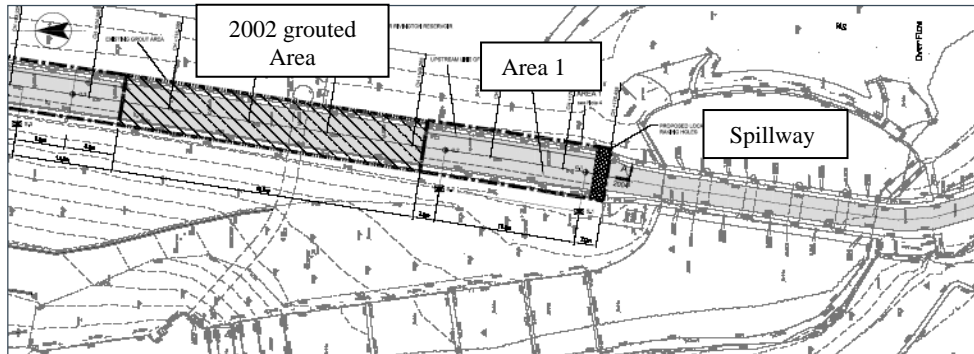
This has led to problems with the initial sleeve grouting of the TAMs which have taken significant quantities of grout, locally in excess of 5000 litres, indicating some infilling of the rock fractures. Significantly lower takes, typically 300 litres, were recorded on the downstream rows of Area 1 following upstream grouting works, which supports the theory that sleeve grout, has migrated through the fractures from the upstream TAMs to the downstream face.

Figure 4. Area 1 grouting between 2002 grouted area and Spillway

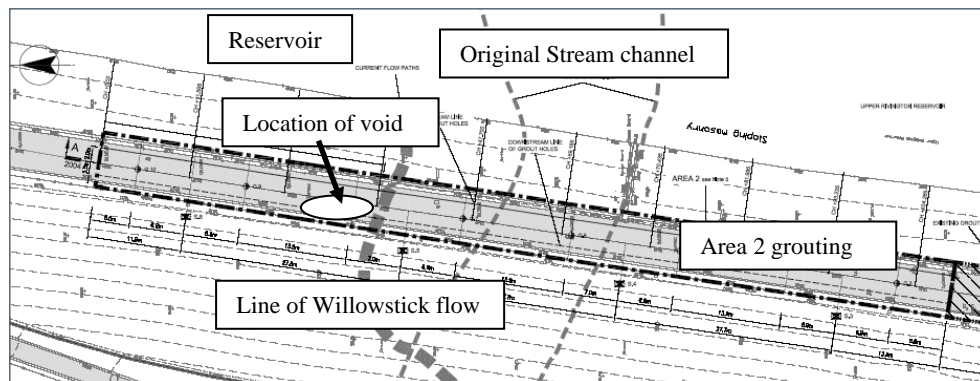
A number of standpipe piezometers were installed downstream of the core and proposed grout holes and were sealed at a level consistent with the zone of rock to be grouted. These are being monitored daily and it is hoped that water levels within these holes will show some reduction in level once grouting works are completed. Settlement monitoring pins were installed along the crest and monitored twice daily to ensure that surface movements could be assessed and appropriate measures taken should movements exceeding 4mm occur. It has proved difficult to ensure that these remain intact given the site constraints imposed by the restricted working area on the narrow crest. The lack of working space is also proving challenging for rig movements between Area 1 and Area 2 with TAM installation and injections being carried out at both locations to meet the required timescales. From the initial holes undertaken in both Area 1 (adjacent to spillway - Figure 4) and Area 2 (central part of the embankment - Figure 5) it was noted that the rock at its upper surface was highly fractured and broken.

Rock head in Area 2 lies at approximately 24m below embankment crest level and has proved to be highly fractured with significant sleeve grout takes recorded which supports the interpretation of sheet flows rather than concentrated flows beneath the dam.

Two adjacent downstream TAM holes, spaced at 1m centres, encountered a 5m difference in rock head level, possibly along the line of the glacial overflow channel in the locality. Further investigations, to ensure that the core trench within the adjacent core extended into the rock across this rock step, proved a 2m deep void 0.5m below the base of core trench level. This lies in the vicinity of the major flow path identified in the initial Willowstick survey (Figures 2 and 5) north of the previous stream channel. The extent of the void is currently being investigated and method statements developed to infill this area with grout incorporating both vertical and inclined holes.

Figure 5. Area 2 grouting showing line of original stream and Willowstick flow path

Currently all the TAMs have been installed within Area 1 and initial injections have recorded only limited grout takes within the rock at this locality. Works to install the TAMs in Area 2 are progressing although given the ongoing high sleeve grout takes alternative options, such as single packer grouting are being considered subject to approval by the AR Panel Engineer.
