Recent incidents at canal reservoirs

D. H. BROWN, Canal & River Trust, Warwickshire, UK

SYNOPSIS Two incidents at Cofton reservoir are described; the first relating to leakage of an old dam predominantly made of sand and the second being a problem with the draw-off pipes, which led to internal erosion in the body of the dam.

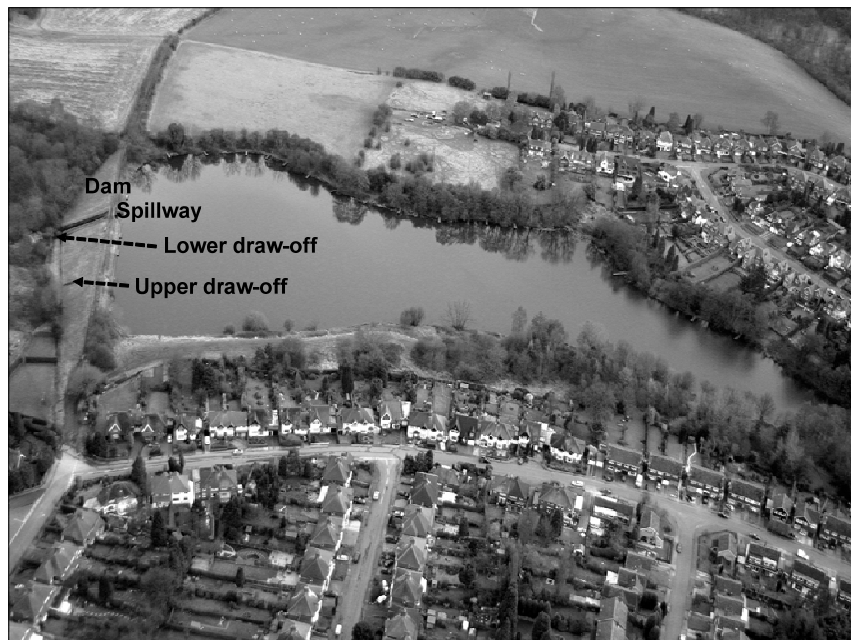
Figure 1. Cofton Reservoir from the air, showing the locations of the outlets and spillway.

In December 2006, significant leakage was identified towards the toe of the dam adjacent to the concrete spillway, which had been built over the centre of the dam in 1965. The Supervising Engineer, adopting the approach recommended in *A Guide to the Reservoirs Act 1975* (Institution of Civil Engineers (2000)), invited Rodney Bridle, an All Reservoir Panel Engineer and the previous Inspecting Engineer, to give an opinion as to the significance of the leakage and a view on whether a statutory inspection should be called. Mr Bridle had carried out his inspection only a few months before and considered that there was no need to have a new inspection but that the work should be carried out as though it were 'in the interests of safety'. He advised that the reservoir level be lowered as a precaution and that filter drains and a v-notch be installed for control of internal erosion and monitoring. The leakage stopped when the reservoir level was marginally reduced.

restored, the leakage problem was found not to have been resolved. It was identified that the leakage only occurred when the reservoir started to spill and it was deduced that the ingress was through cracks and joints in the concrete cascade. The leakage path was then underneath the structure, emerging towards the toe. The original spillway drawings were not detailed but showed no drainage layer beneath the structure. There was the possibility however of settlement of the dam beneath the concrete. The joints were sealed by 'pointing' and the leakage ceased for the time being.

The earlier surface sealing of cracks and joints in the spillway was not performing particularly satisfactorily. Voids beneath the concrete structure were filled by drilling and grouting at low pressure using cementitious materials. The cracks were sealed by polyester resin injection.

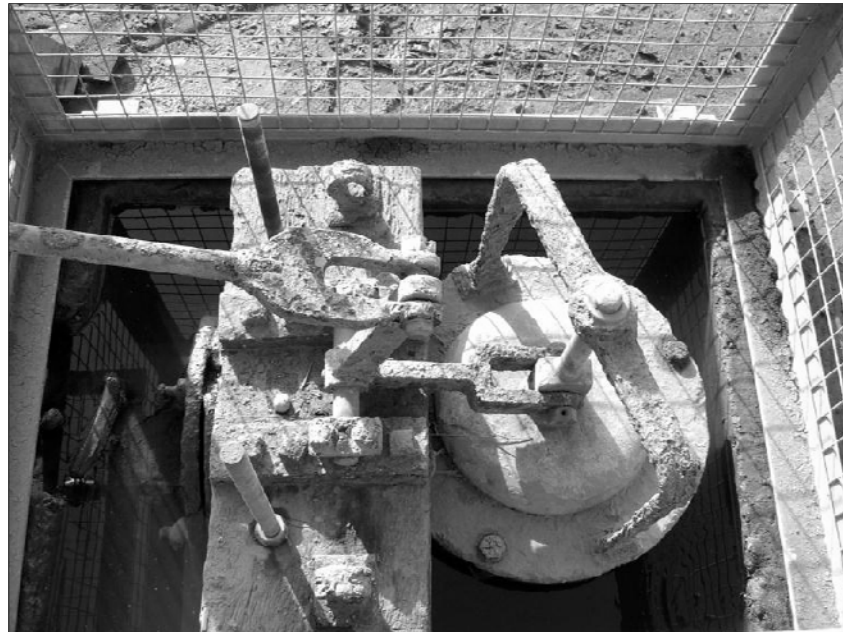
Figure 2. The upper 'tea pot lid' type valve at Cofton Reservoir before replacement.

During a routine valve test in June 2008, a defect was identified in the upper valve operating mechanism. It was decided that the water level would be reduced using the lower valve to allow the upper valve rodding to be repaired without the need for divers. There was no great urgency in carrying out the repair. The on-site emergency drawdown plan was revised to bring in additional pumping in the unlikely event of an emergency. Only when it was operationally appropriate, was the lower valve opened on Friday 1 August 2008. On the following Monday, routine surveillance identified that discoloured water and sand was being discharged from the

Rodney Bridle was again consulted. He recommended that the pipe be lined if possible and grouted up if not. The reservoir was completely emptied by means of siphons and pumps. Whilst the reservoir was empty, the fishing club moved the fish into a temporary home in an alternative pool. A piled cofferdam had been driven around the lower valve in 2005 and left *in situ*. It served to hold back the mud in the reservoir basin. Both the lower and upper draw-off pipes were lined with cured-in-place sleeves. These were pulled into the pipes with a winch, inflated with air pressure and cured using ultraviolet light. This system needed no craneage, unlike the hot water cured system and left no contaminated water to dispose of. The opportunity was taken to replace the upper valve, together with its operating mechanism and grille.

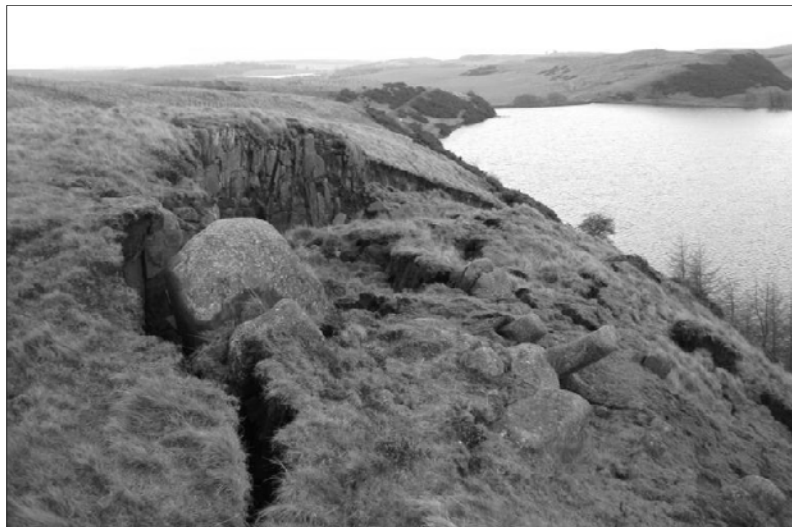
The geotechnical engineer who had carried out the earlier investigation was, by the time of the incident, head of Geotechnics. He attended the Supervising Engineer's site visit, which took place on 9 December. Horizontal and vertical displacement of the rock at the top of the steep slope was observed over a distance of some 50m about 25m above the reservoir. The earlier geotechnical study was invaluable in gaining an early understanding of the mechanism of the movement.

joints in the rock, originating during its cooling from a molten state, are exploited by chemical weathering. This leads to a breakdown and loss of strength of the rock, ultimately reducing it to sand. The spacing of the joints and the rate of weathering dictate the size of the un-weathered core-stones, which remain. Rounded stones on the surface of the rock face are liable to roll down the hillside. The weathering of the rocks had, over geological time, lead to the formation of voids within the rock mass and the consolidation of the core stones, giving rise to the vertical movements at the top of the slope.

Figure 4. Movement of the northern hillside above Lilly Loch looking towards the main dam.

It was thought that the horizontal movement might be a remnant feature of a past glacial episode in which a mass of rock was moved by ice flowing over the area.

The Supervising Engineer decided to consult an All Reservoir Panel Engineer for a second opinion before taking the decision that the water level could be restored. Accordingly, therefore on 10 May 2010, he arranged to meet Martin Hewitt, who was accompanied by a geotechnical specialist colleague, on site. The site inspection revealed shallow and outcropping dolerite, with a series of tension cracks opening up at the surface. The tension cracks appeared to be controlled by the near vertical jointing, the joints dipping into the hillside creating a 'toppling' type mechanism. Although the tension cracks were up to 2m to 3m in depth, there was no

evidence of deep seated overall slope failure potential. The failure mechanism appeared to be one of progressive erosion, creep and opening up of the tension cracks within the weathered zone of the hillside. It is possible that in the future, probably over a number of years; the upper 2m to 3m of the hillside could topple and fall indirectly into the reservoir, via the track.
