Remedial works at Sunderton Pool

SYNOPSIS In 2005 the Environment Agency exercised its reserve powers as the enforcement authority for the Reservoirs Act 1975 to commission an inspection of the privately-owned Sunderton Pool near Shrewsbury. The inspection found the dam structures to be in very poor condition. In particular, the masonry spillway was in a state of considerable disrepair and concerns were raised for the safety of the dam. This paper details the work carried out in identifying those legally responsible for the safety of the reservoir, taking enforcement action, assessing the likely impact in the event of a dam breach, and in planning and procuring design and construction services to improve the safety of the dam. The remedial works included the construction of a labyrinth spillway. A number of difficulties were overcome during the construction of the works. This paper discusses how the reservoir safety risks were identified, assessed and managed.

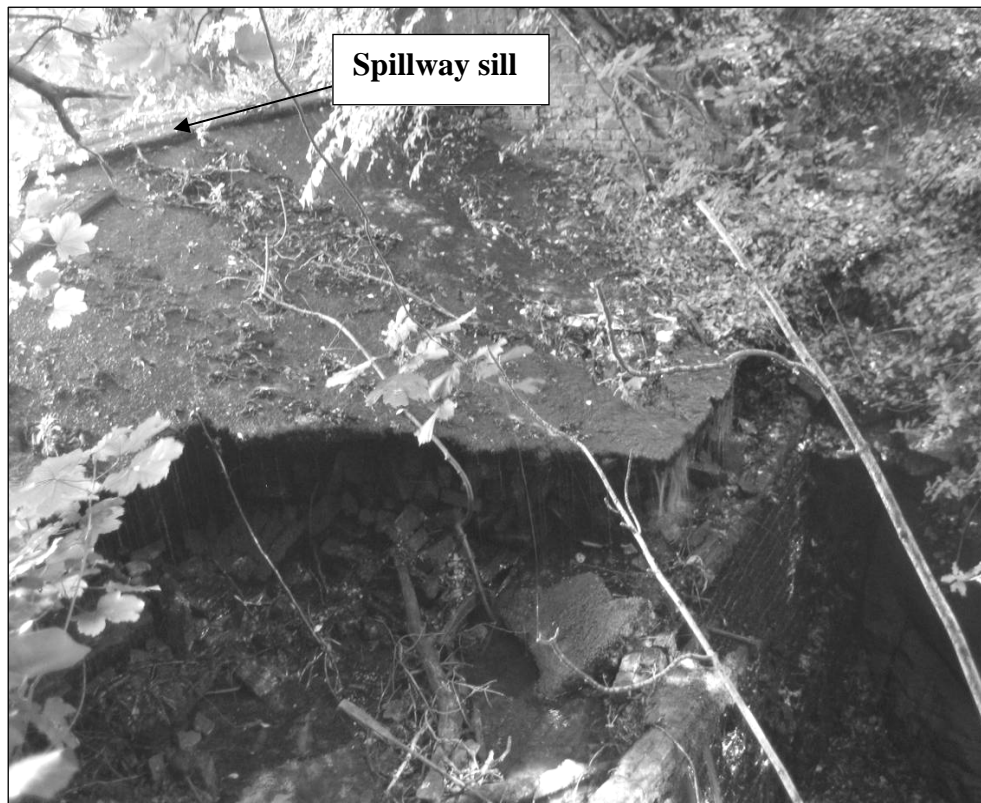
The masonry/concrete free overflow spillway at the left abutment was found to be in a very poor condition and at risk of collapse even under moderate flow conditions. The structure is well founded within a sandstone cutting through the left abutment. At some point in time it seems likely that the dam was raised using poorly-cemented rubble and covered over with a mass concrete slab. It is speculated that the slab became damaged during a flood and erosion within the underlying rubble fill led to a loss of support to the slab and progressive deterioration. The capacity of the spillway was also considered inadequate and there were concerns that the dam embankment might not survive being overtopped given the very narrow dam crest (less than 2m in places). The safety measures therefore focused on repair of the spillway, improvement of flood safety and improvement to seepage surveillance by preventing the high level pipe flow from feeding water into the morass.

Figure 1. The original spillway structure was found in poor condition

Following completion of the temporary works the top 1.8m rubble and concrete masonry section of the spillway was demolished. The larger rubble arising from the demolition activity was re-used as erosion protection in the channel downstream. Removal of the upper section of the structure revealed that the structure had been formed of clay fill with a masonry retaining wall on the downstream side with internal counterforts.

The design of the structure was slightly modified to account for the clay. A cutoff trench and geotextile was incorporated into the design to ensure that no erosion of the clay would occur with the weir in service. A 300mm reinforced concrete vertical wall was cast against the downstream face of the masonry structure with drainage provisions. The main base slab was then cast followed by the reinforced concrete wing walls and the labyrinth structure. A key challenge for the design was fitting the new reinforced concrete structure to an existing irregular structure. Despite having had detailed topographical information at the time of the detailed design, and the

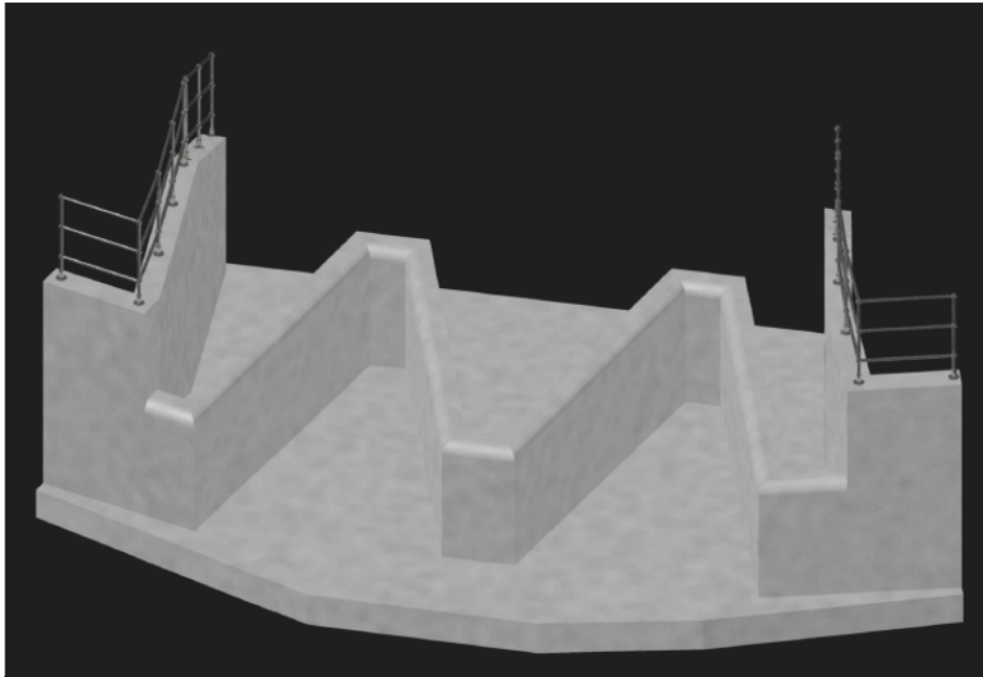
The design of the reinforced concrete labyrinth spillway features two cycles and an angle of 18° giving an effective crest length of 18.1m within an overall length of 8.5m in the dam crest. A 3D representation of the new weir is shown in Figure 2.

Figure 2. 3D CAD representation of the new labyrinth spillway weir

By reducing the reservoir top water level by 0.26m, the new labyrinth weir allows safe passage of the design flood rise (0.84m) plus wave freeboard allowance (0.3m) totalling 1.14m, within the improved available 1.2m dam freeboard.

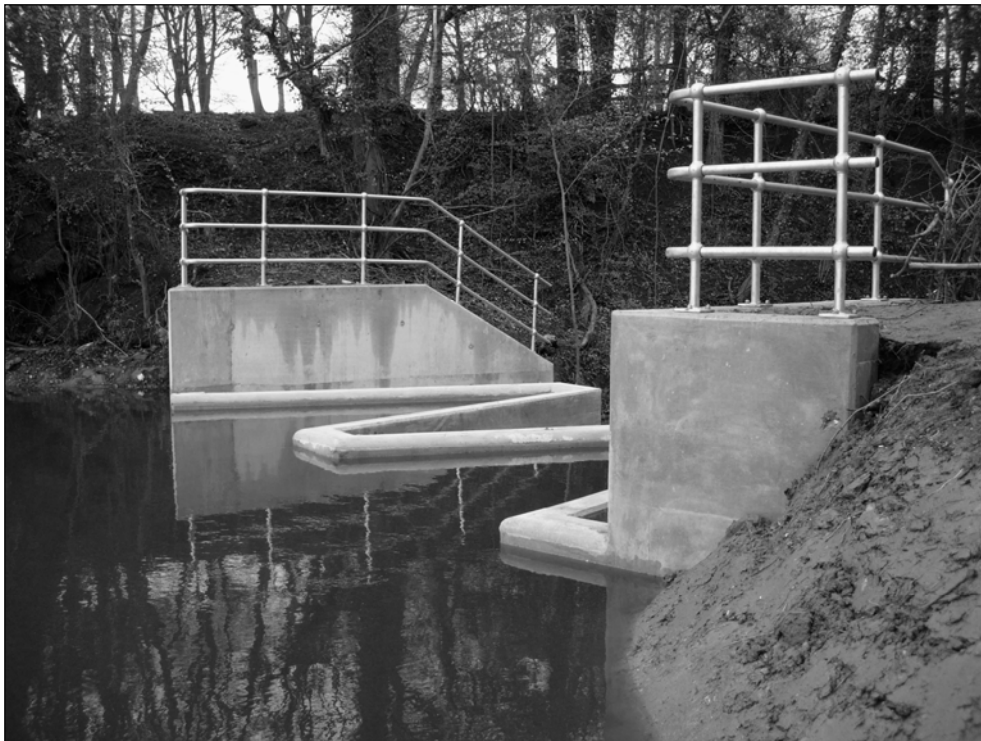
Figure 3. The completed labyrinth weir structure
