**The consequences of liquefaction on the failure of tailings dams with particular
respect to the upstream construction method**

***- preliminary reflections on the failure of the Brumadinho iron ore tailings dam
in January 2019***

The failure of Brumadinho Barragem No.1 on 25th January 2019

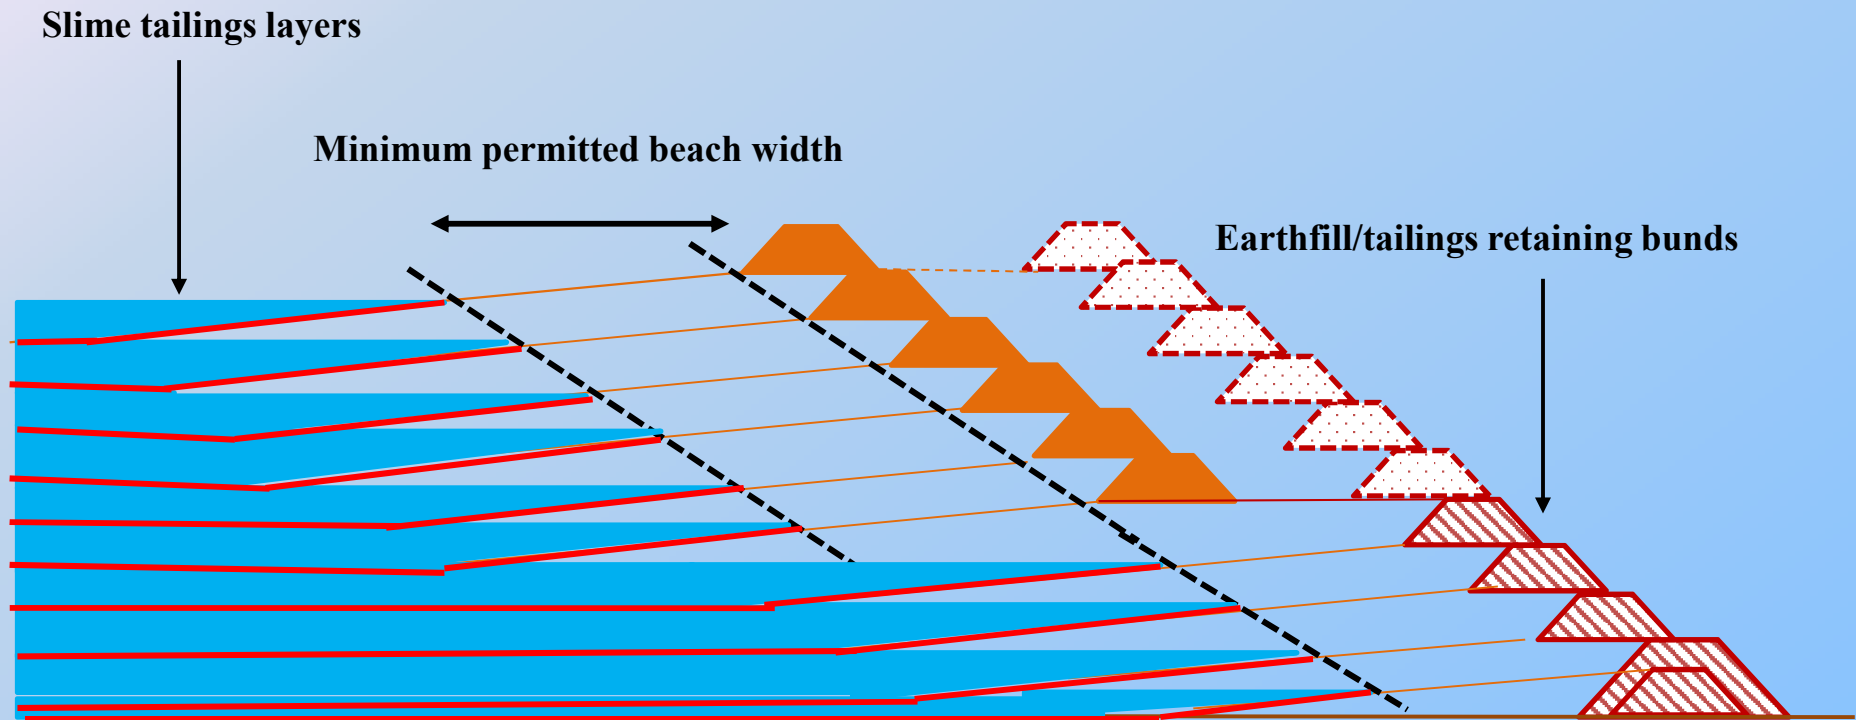
Brumadinho Barragem No.1 - modified design section

- **The lack of compliance with the original design/operating criteria would have led to the introduction of slime tailings into the embankment foundations.**

- **The poor consolidation of the basal materials will have resulted in part from a lack of formal drainage provision.**
- **The appearance of seepage on the downstream face after lift four led to modification of the section.**

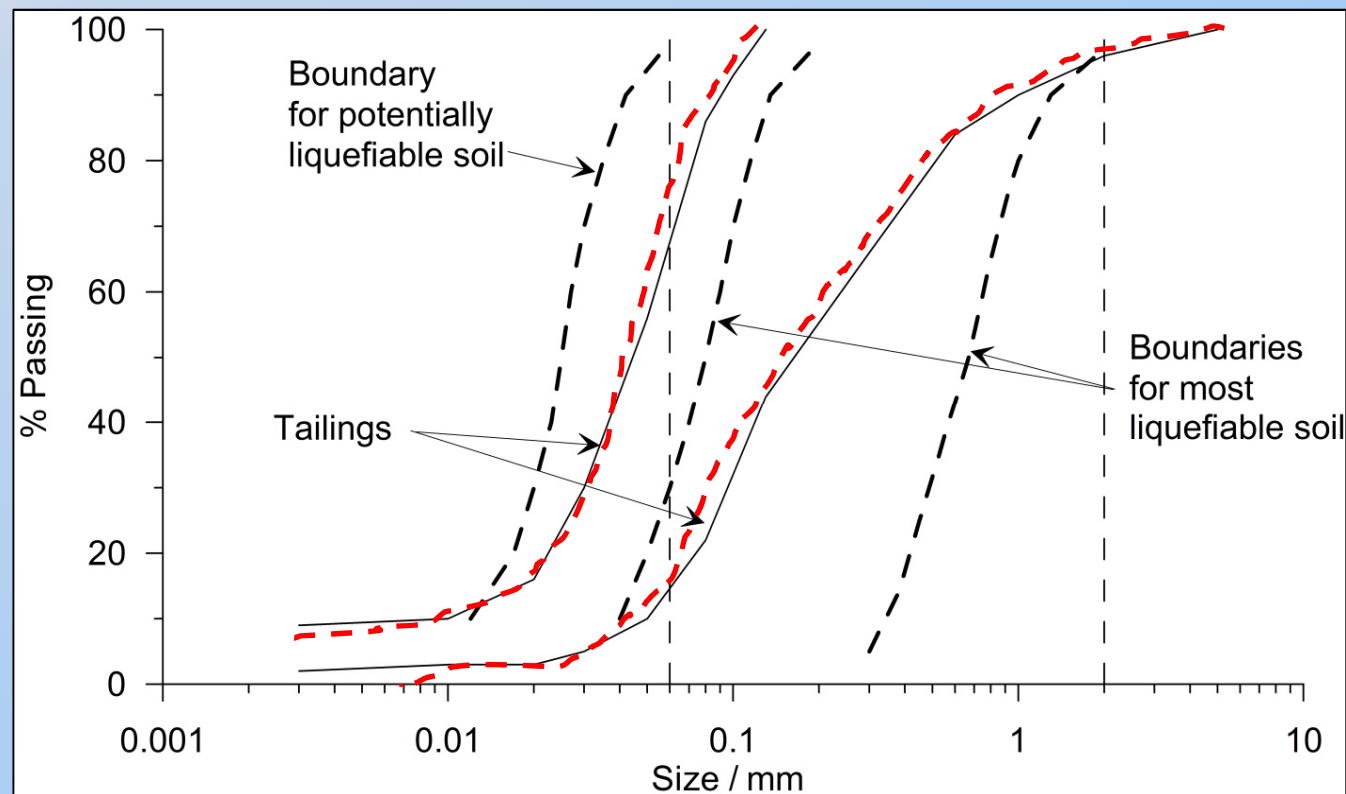
Brumadinho Barragem No.1 - summary results of the 2010 site investigation

Boundaries for liquefiable soils, after Tsuchida

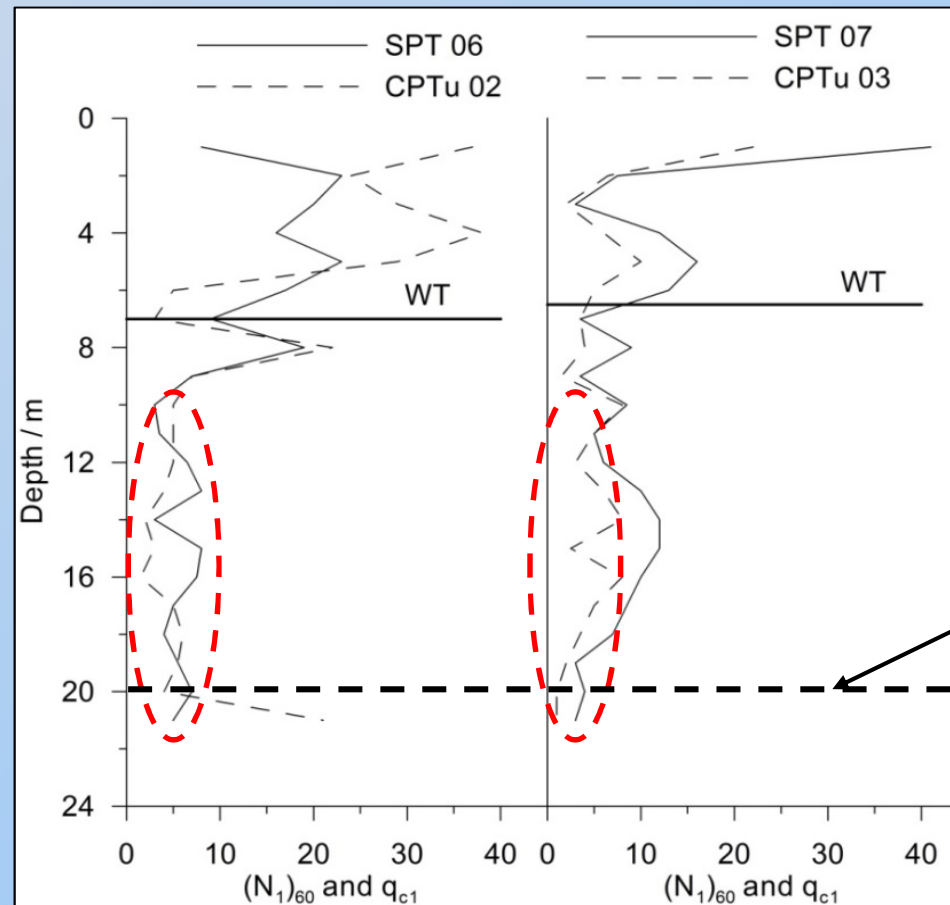
Brumadinho Barragem No.1 - summary results of the 2010 site investigation

CPT/SPT data from 2010 investigation

Conjectured foundation
level

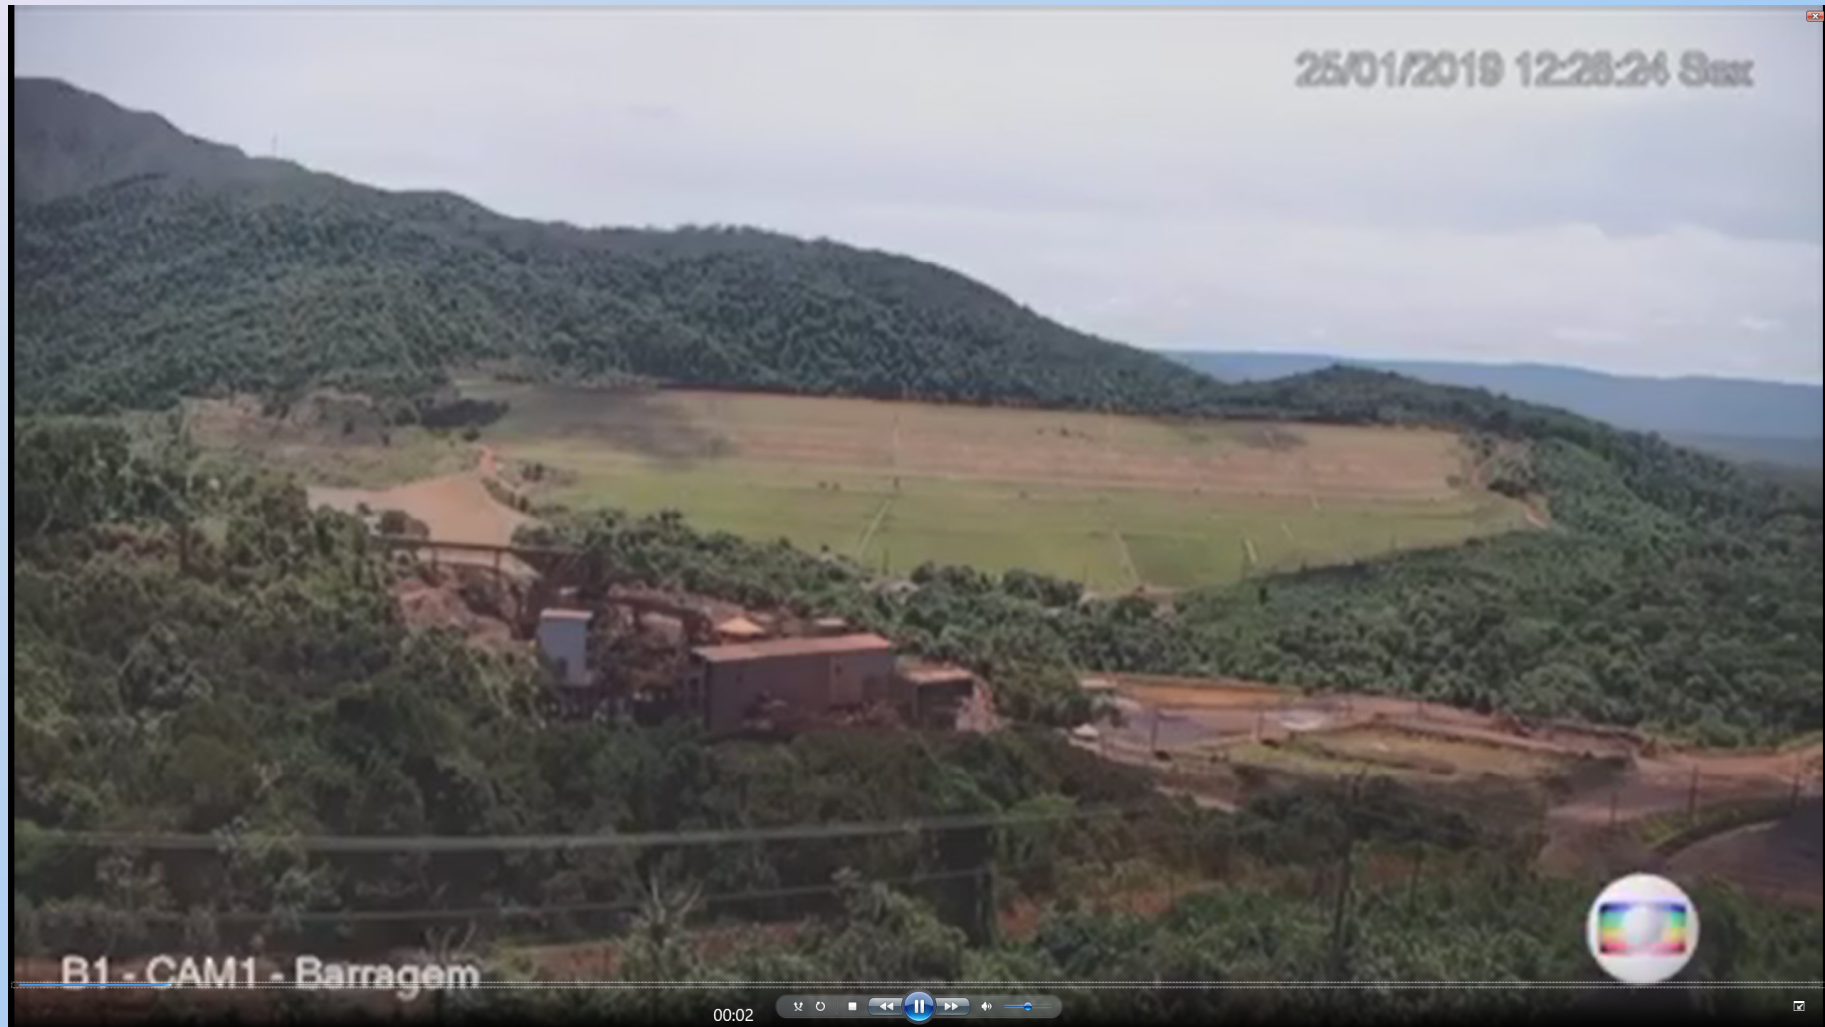
12.28.26

The failure of Brumadinho Barragem No.1 on 25th January 2019

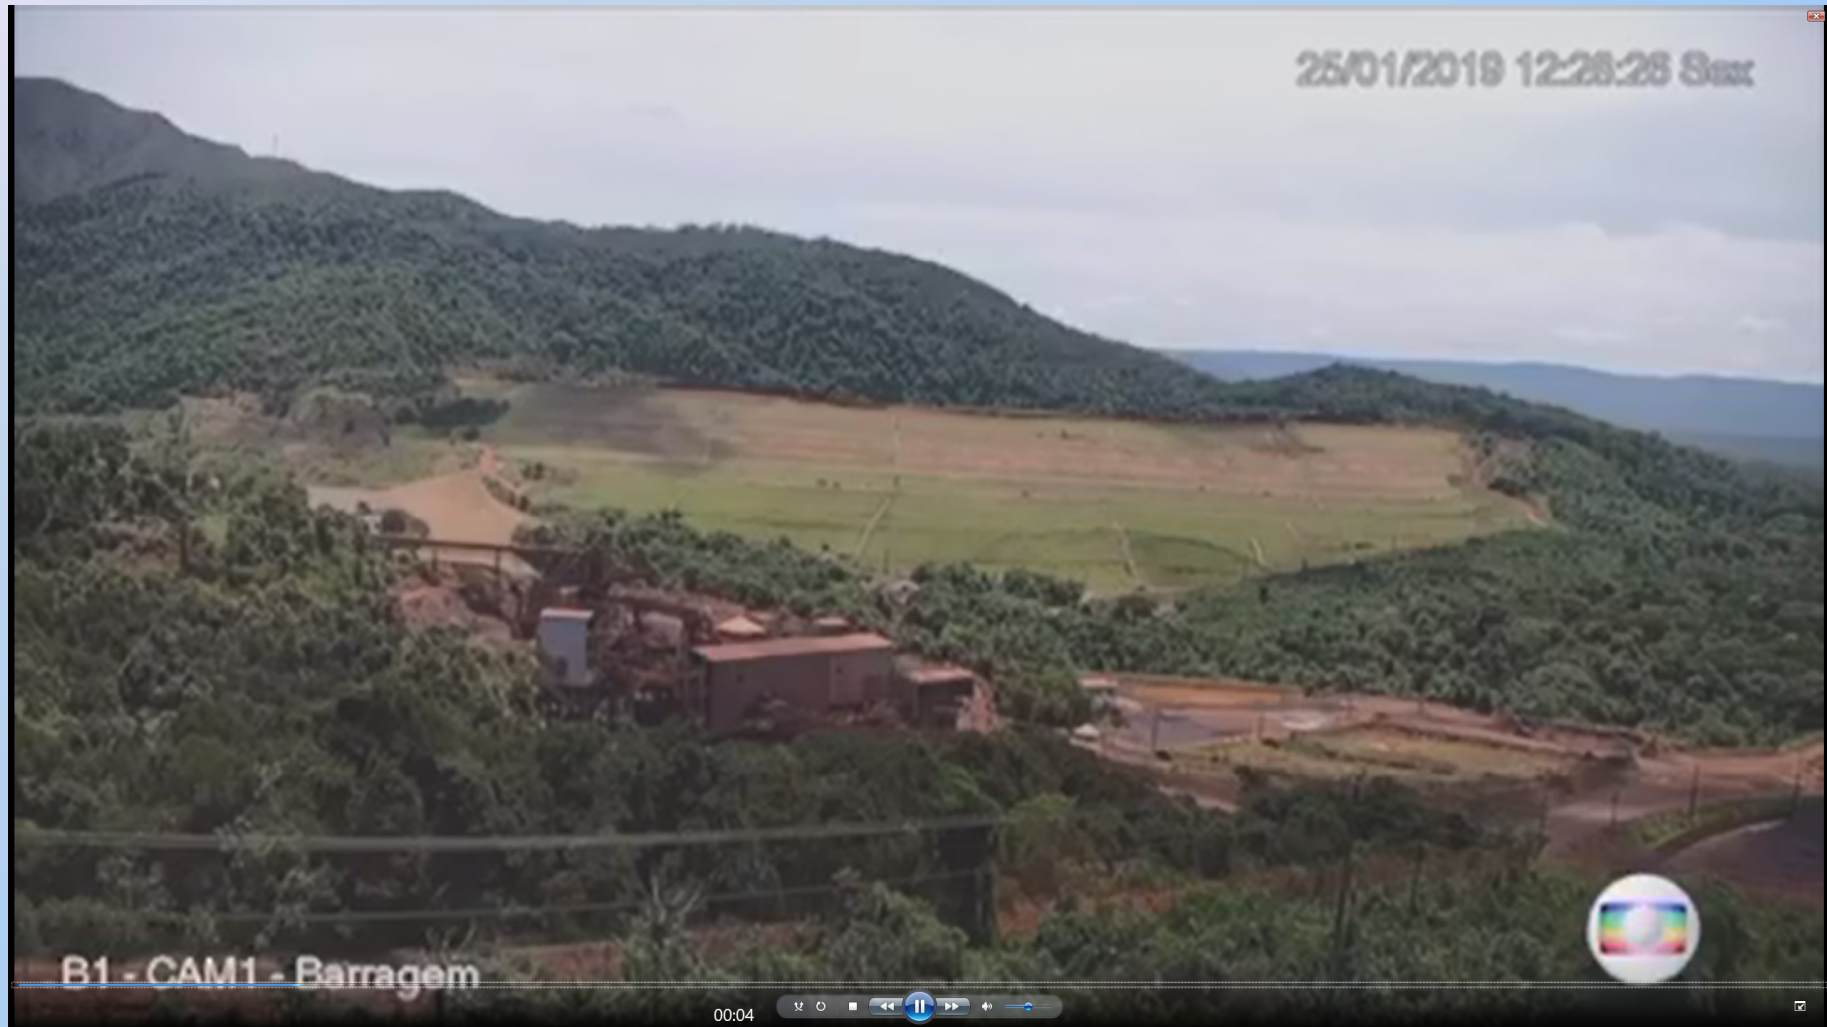
12.28.28

The failure of Brumadinho Barragem No.1 on 25th January 2019

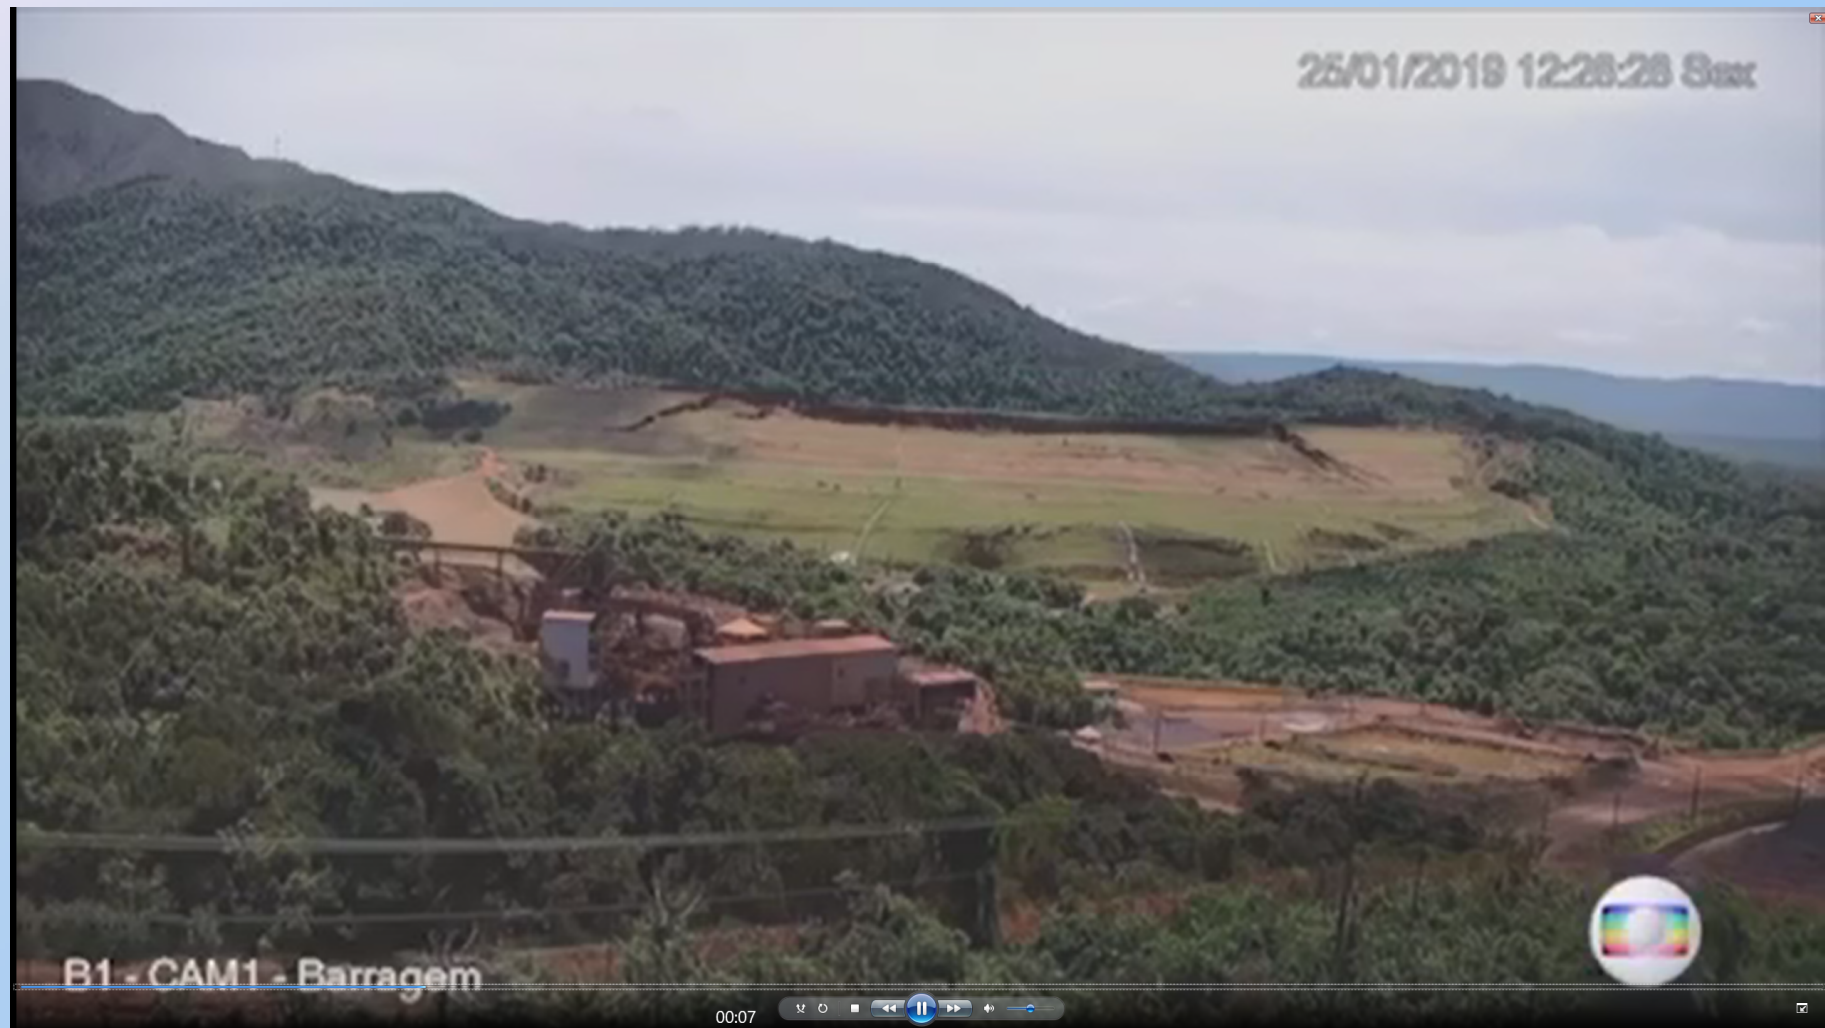
12.28.29

The failure of Brumadinho Barragem No.1 on 25th January 2019

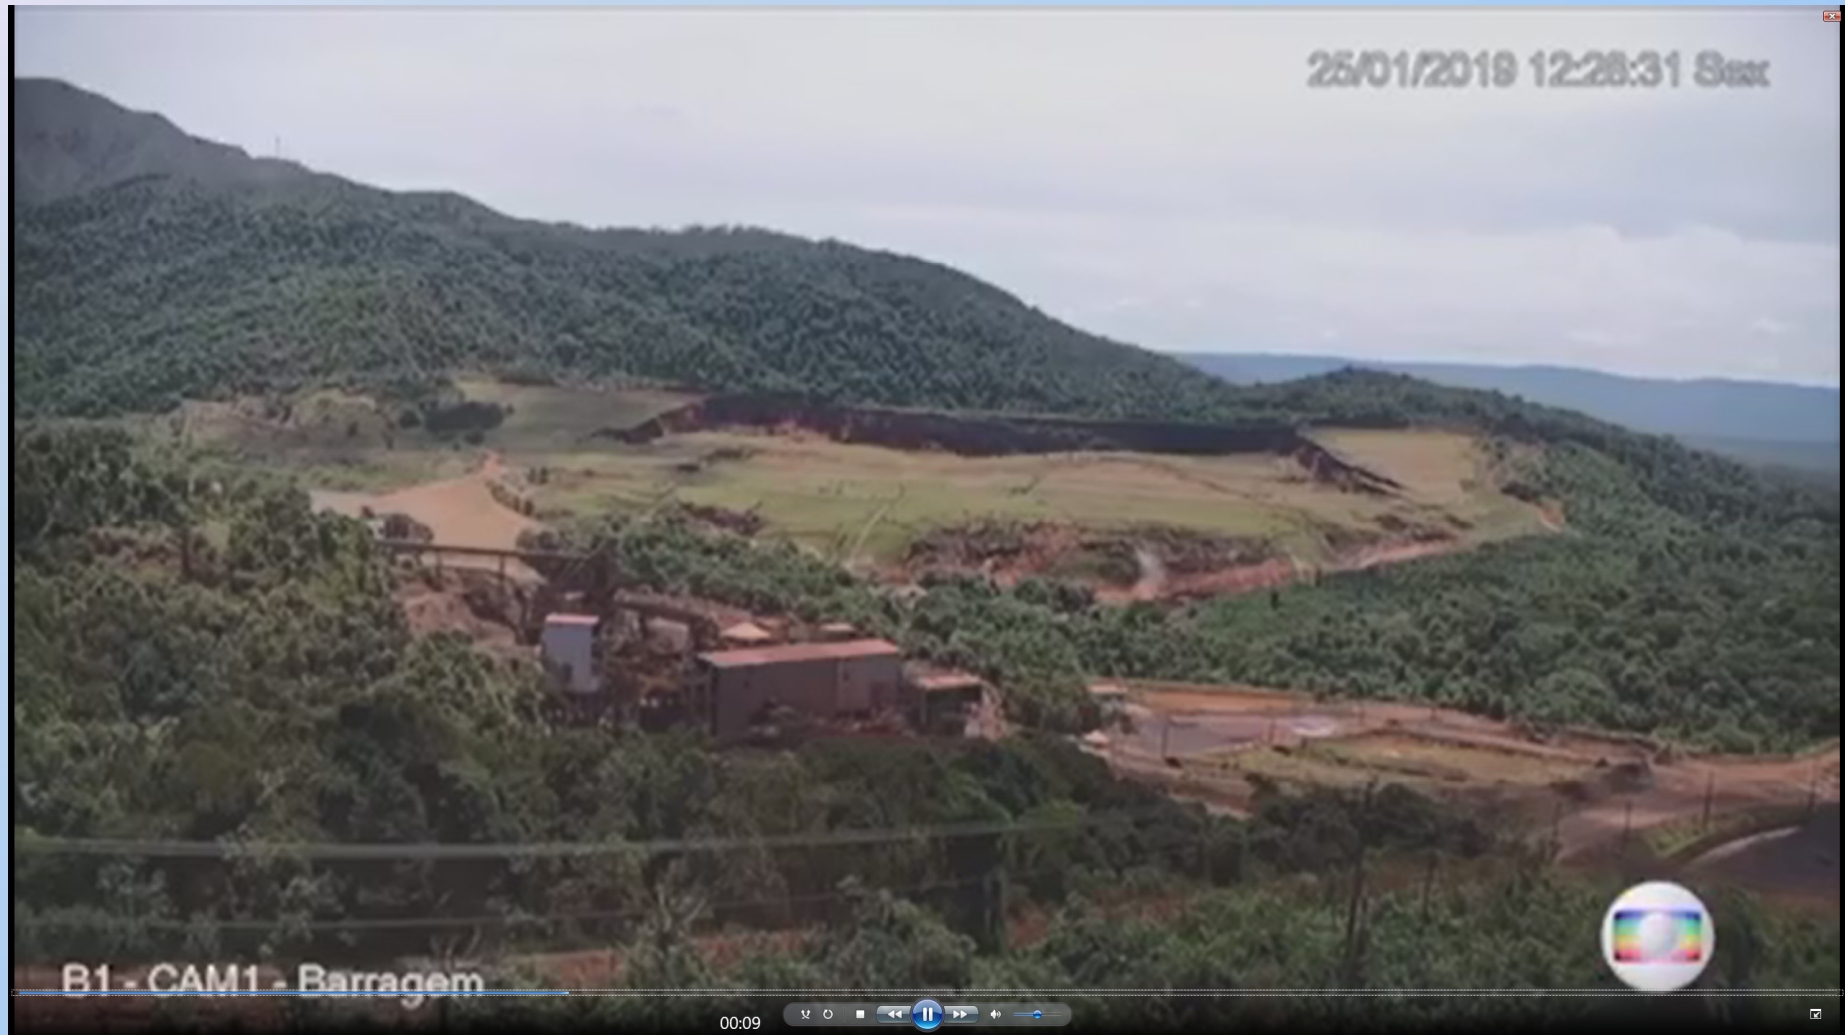
12.28.31

The failure of Brumadinho Barragem No.1 on 25th January 2019

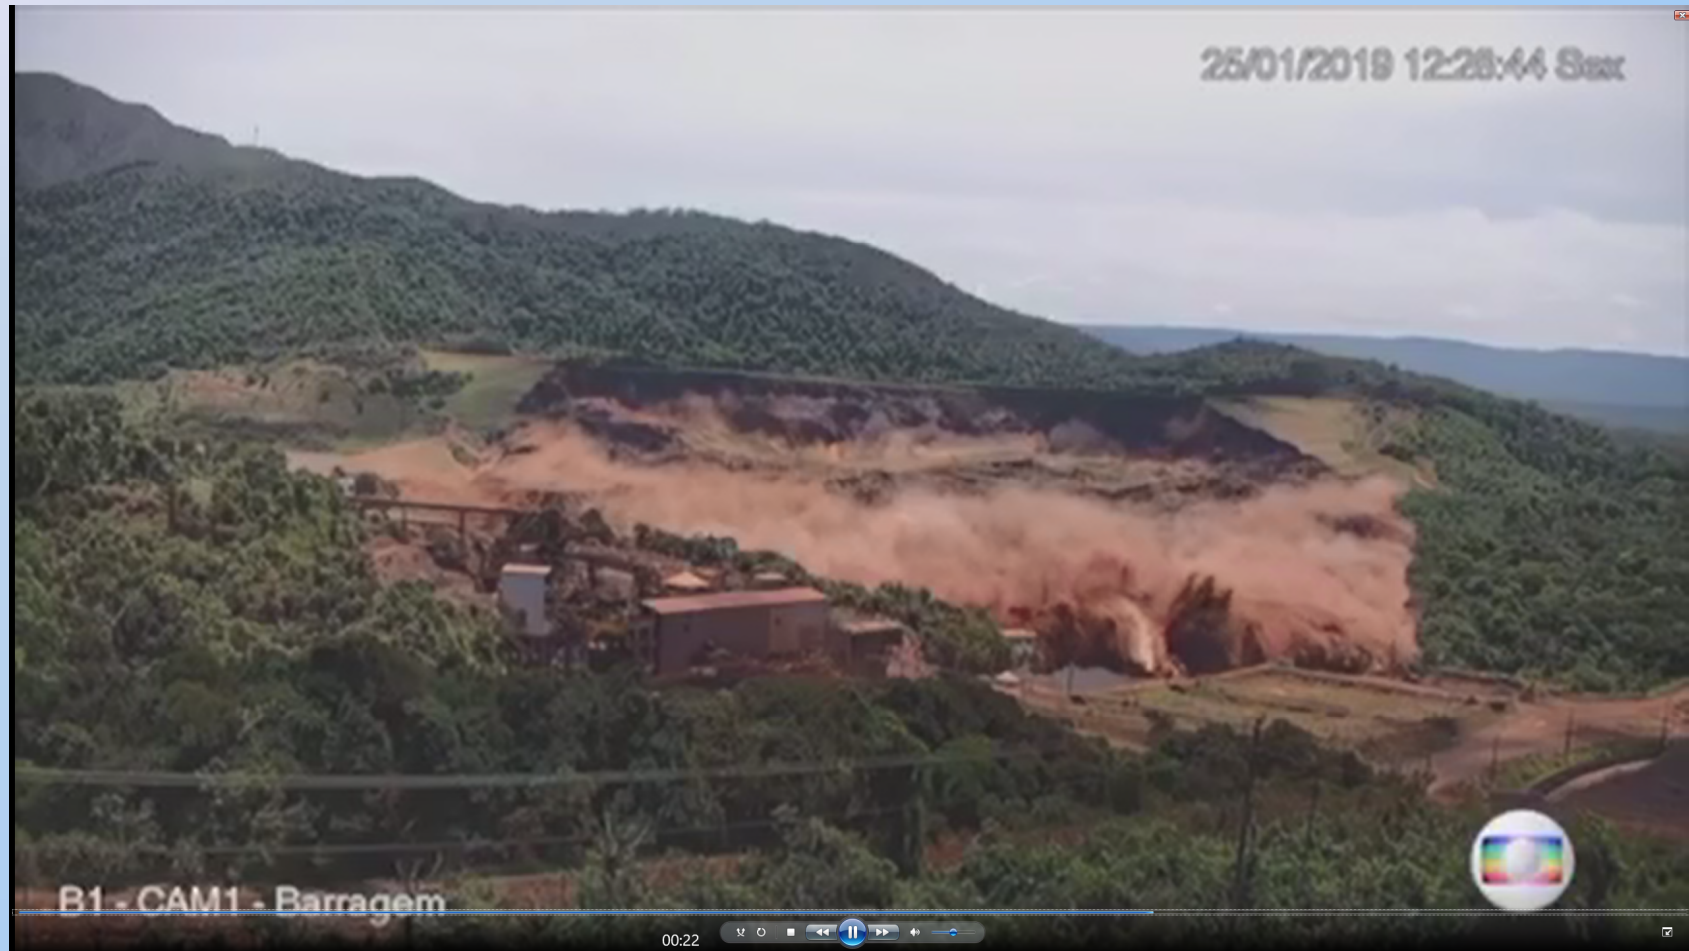
12.28.44

The failure of Brumadinho Barragem No.1 on 25th January 2019

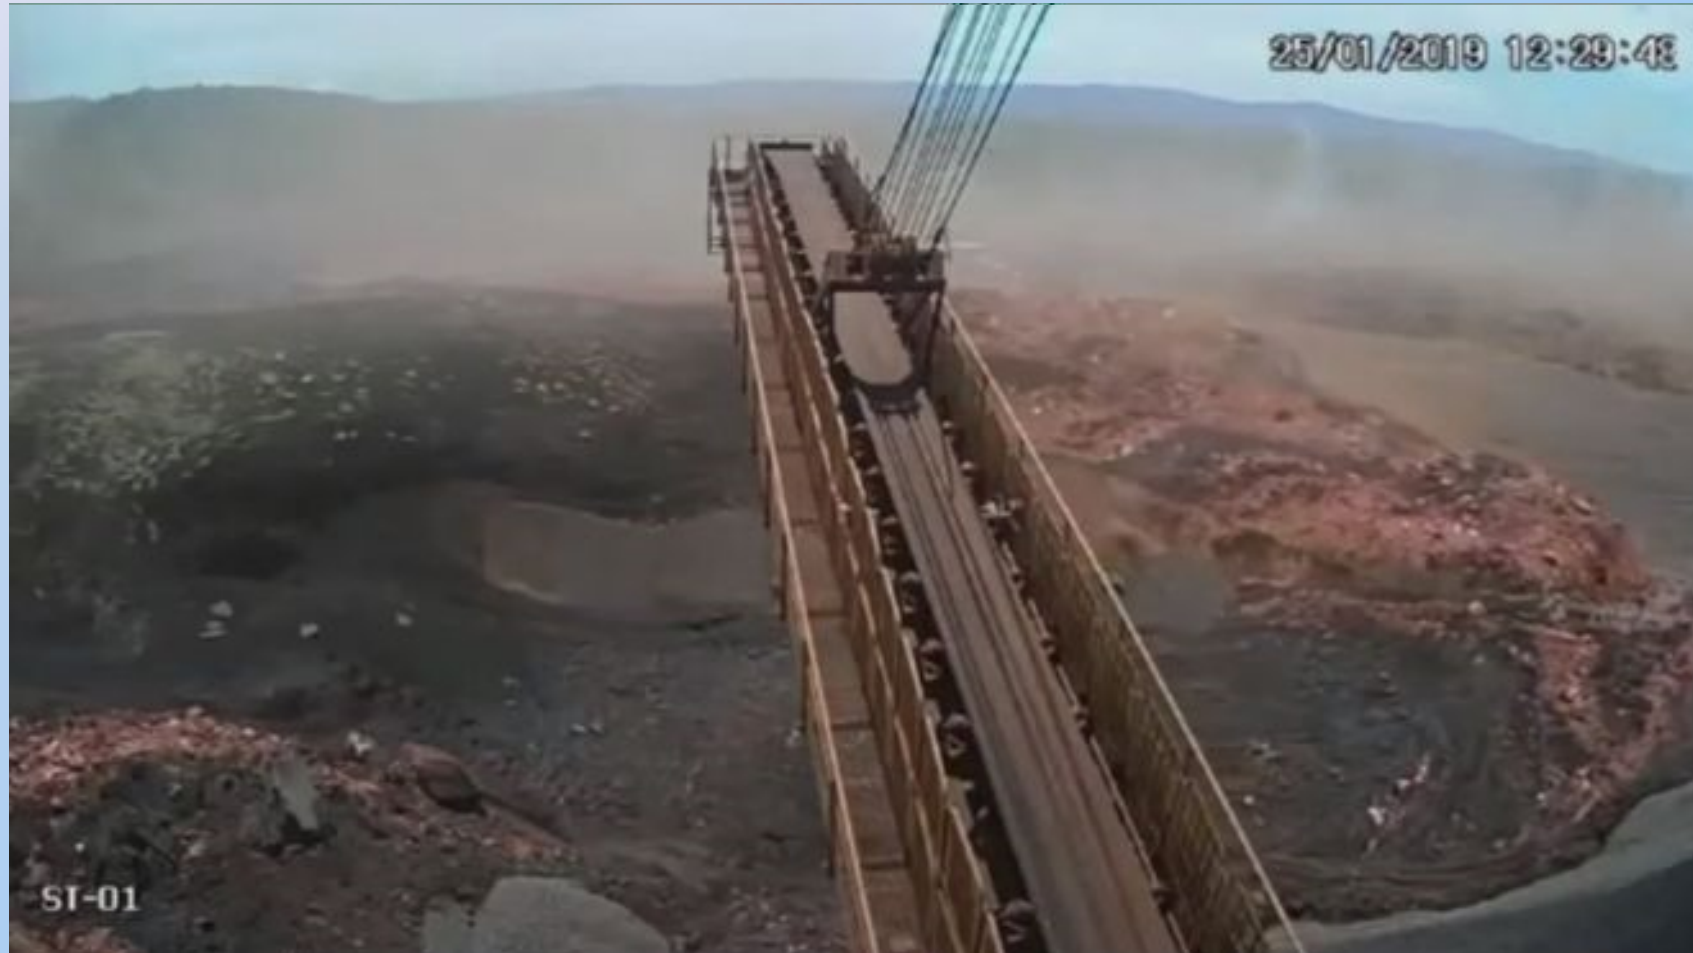
12.29.01

The failure of Brumadinho Barragem No.1 on 25th January 2019

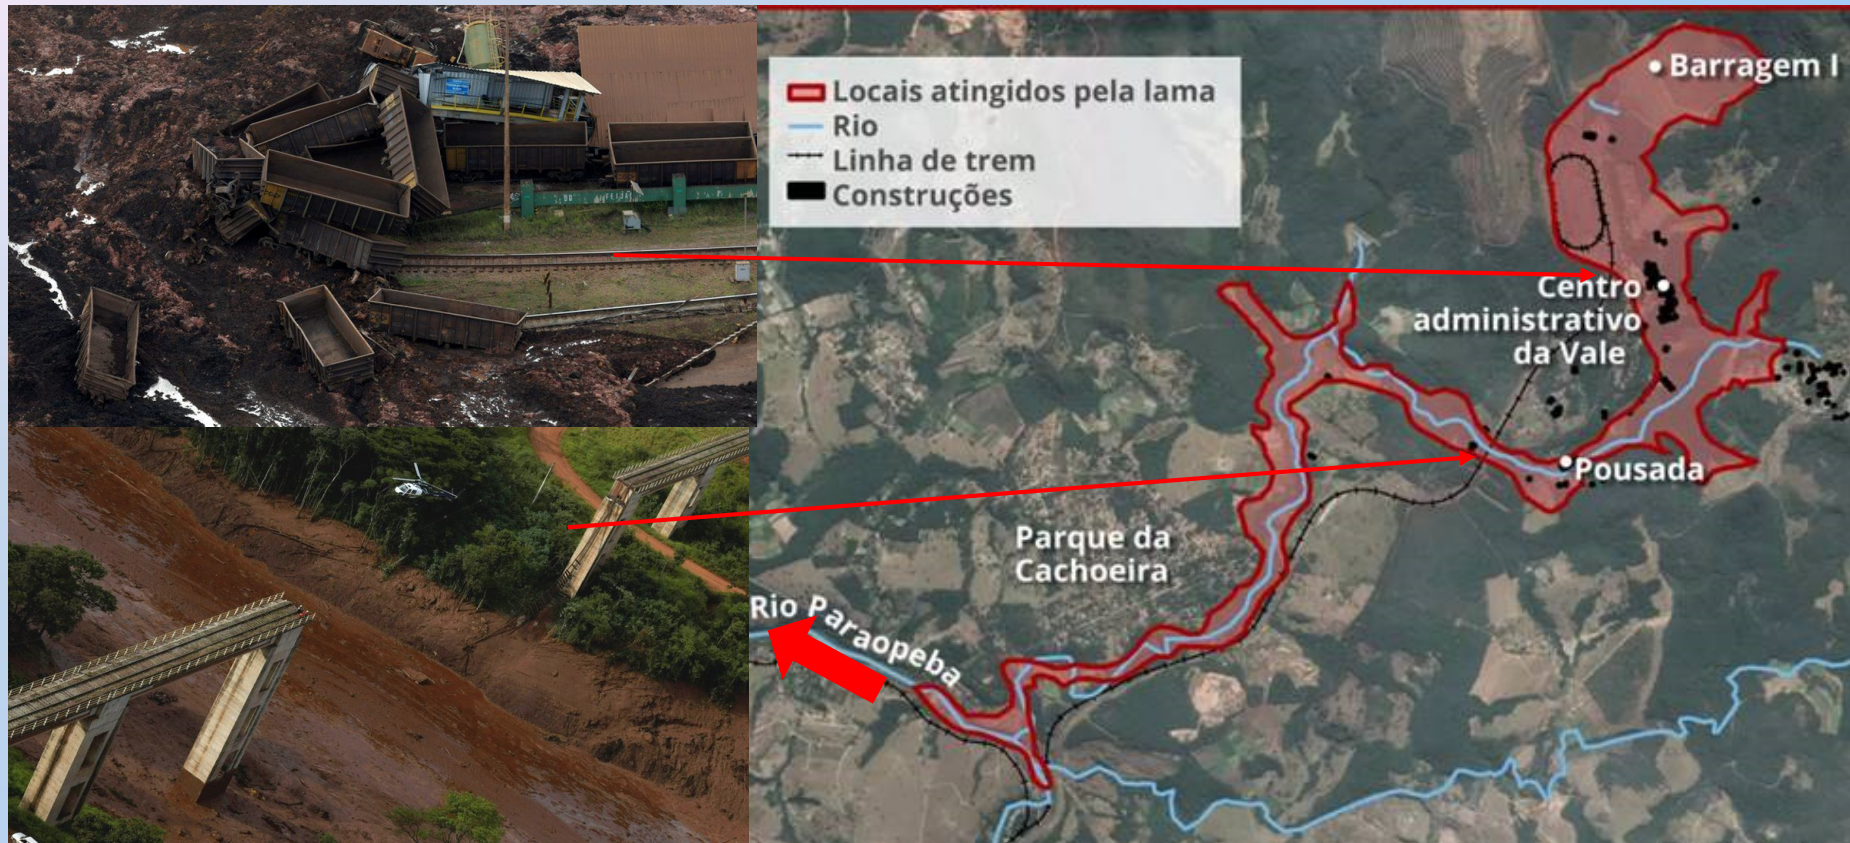
The failure of Brumadinho Barragem No.1 on 25th January 2019

- The liquefied tailings flowed through the mine site, engulfing mine infrastructure and downstream settlements and reaching the confluence with the Rio Paraopeba with significant environmental damage.
- The current confirmed death toll is 242, though a significant number remain unaccounted for.
- In terms of the death toll this incident probably represents the worst tailings dam disaster *for 40/50 years.*

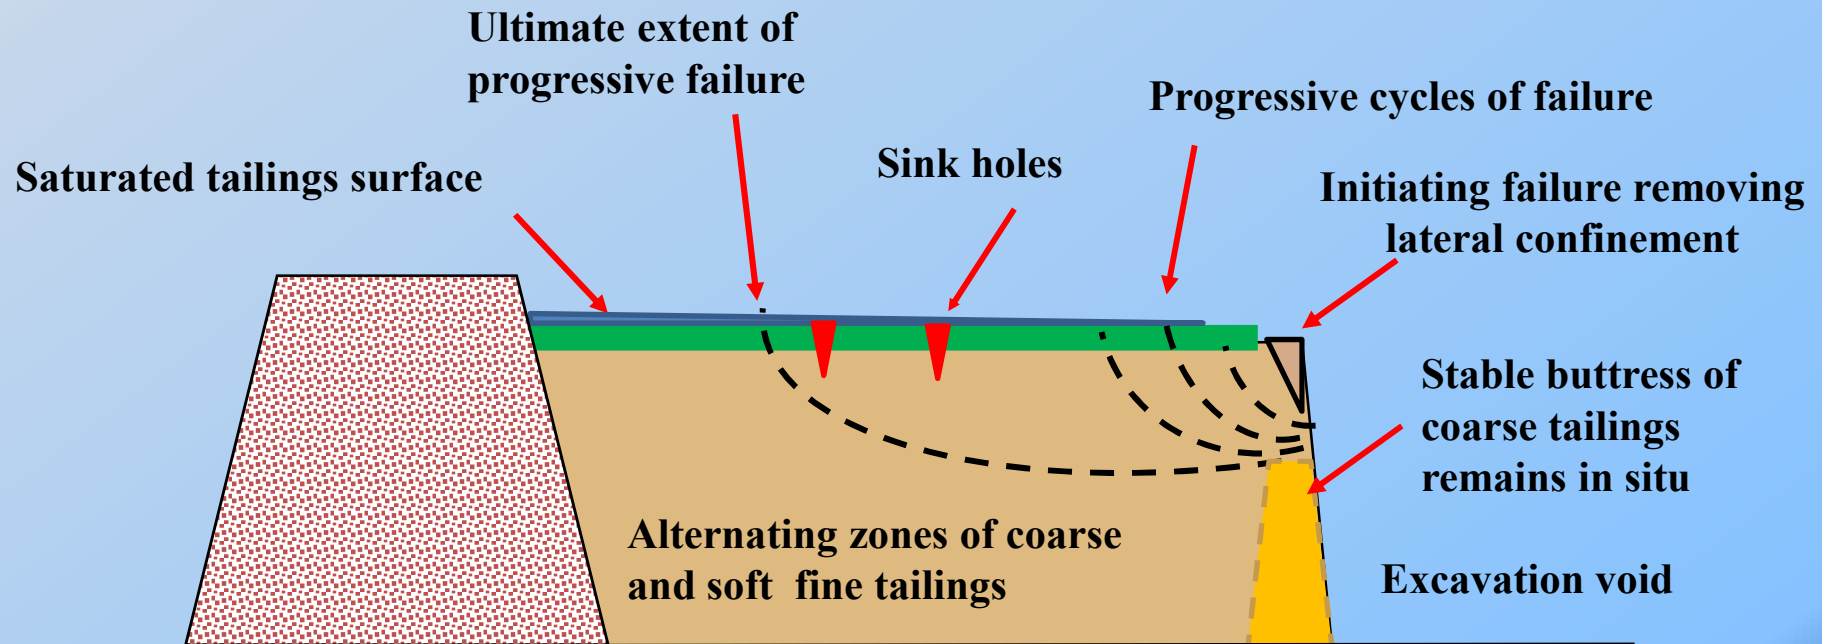
- The removal of lateral confinement via a small localised slope failure precipitated a series of liquefaction/flow slide events.
- Each failure induced further liquefaction events as the flow slide developed.
- 25,000m³ were mobilised through the 3m wide initiating slope failure.

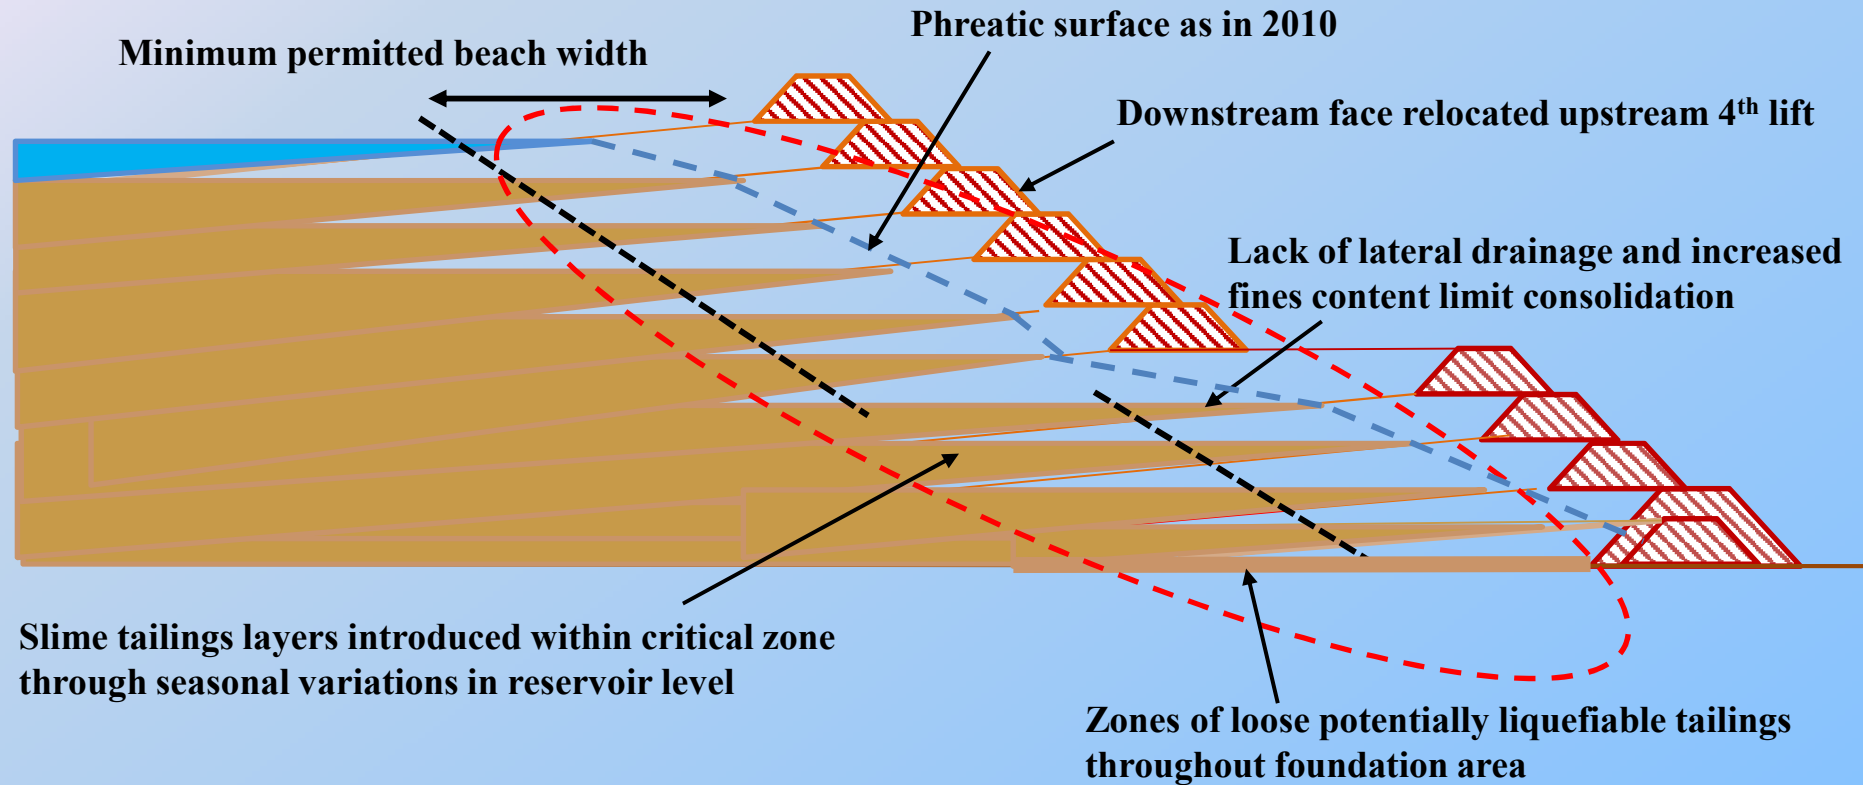
Brumadinho Barragem No.1 - modified deposition system

- **The grading of the tailings within the embankment foundation zone and the high sensitivity of this material to moisture changes would have exacerbated the potential for rapid strength loss and for liquefaction.**

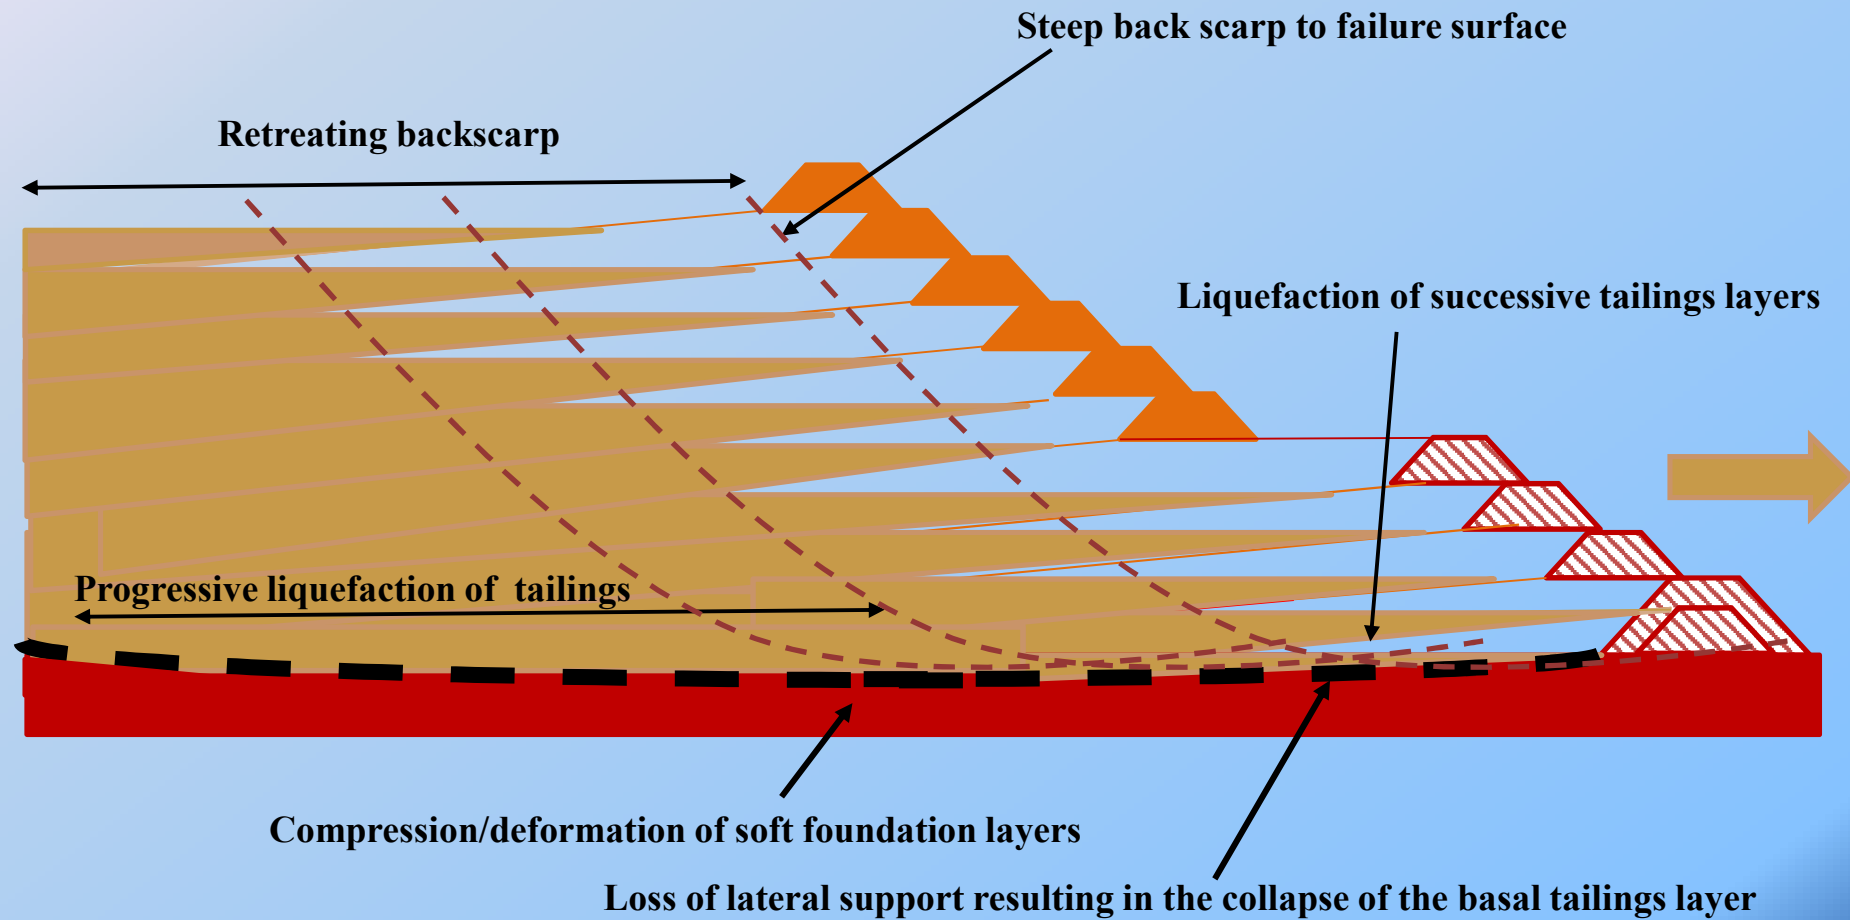
Preliminary assessment of the progressive failure of Brumadinho Barragem No.1

- **No seismic trigger mechanism has been reported for this site.**
- **The increased load on the foundation zone appears to have led to the collapse of the low density tailings underlying the confining wall, leading to liquefaction.**

- **Liquefaction of the embankment toe was followed by the rapid development of a series of complex arcuate failures from crest level.**
- **The liquefaction flow slide moved rapidly downstream, overwhelming both mine and other infrastructure, killing more than 242 people and severely degrading the environment for several hundreds of kilometres.**
