Post-incident reporting for UK Reservoirs - annual report 2013

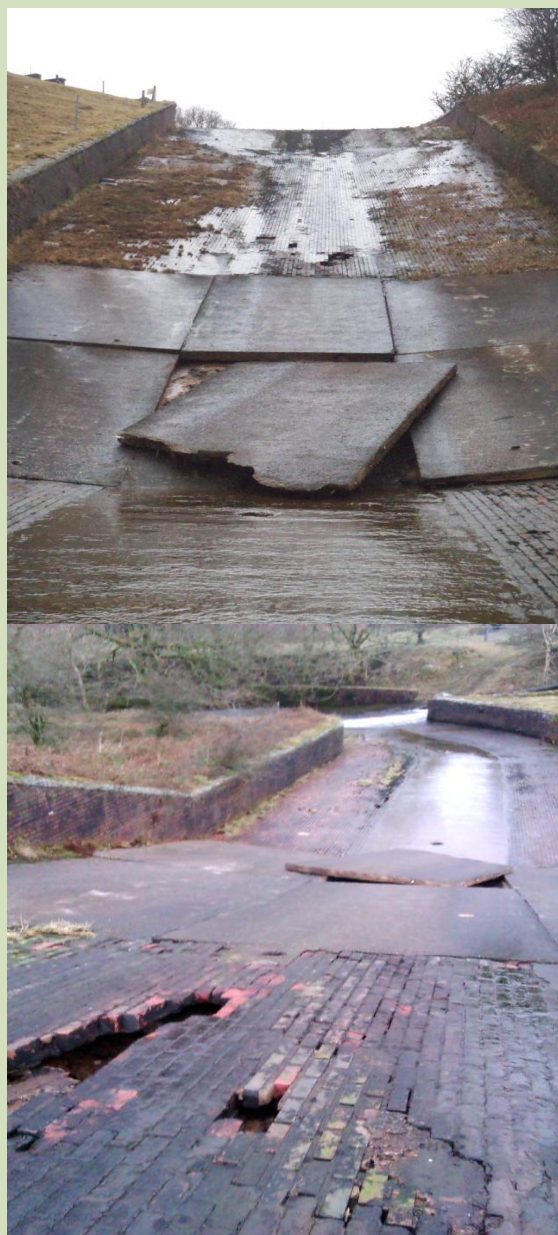
Incident 381	
Dam type	Earthfill embankment
Reservoir legal status	Statutory impounding reservoir
Dam height (m)	18
Incident type	Inflow flood, spillway deterioration
Incident severity	3

The reservoir was subjected to unusually high water levels in the previous year which led to leakage through the embankment that had to be repaired by grouting. Following another period of sustained high water level, the spillway structure was found to have deteriorated with brickwork plucked from the base of the spillway channel and displacement of concrete ground slabs in the central section. Investigations found that voids had formed under some of the slabs, probably through internal erosion. This allowed floodwater to exert an increased uplift pressure on the underside of the slabs which led to the displacement. A controlled lowering of the reservoir level was carried out to allow temporary and permanent repair work to be safely carried out.

Spillway structures can be subjected to both negative and positive pressures during the passage of a flood event. Any masonry in poor condition or voids below or behind a spillway channel lining can lead to damage to the structure. If left unchecked this could lead to dam failure. In this case, the damage was identified through a routine surveillance visit which underlines the value of such visits, especially in times of flood.

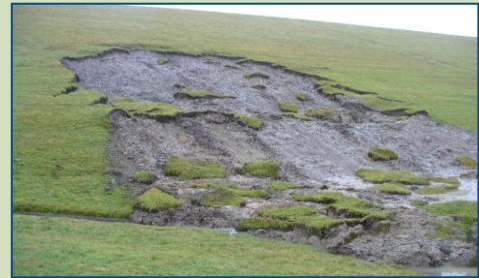
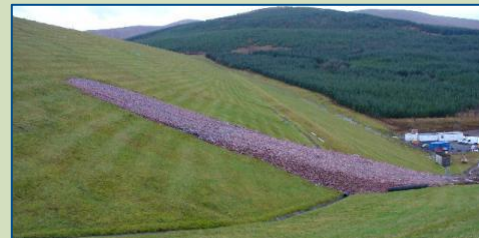
Incident 389	
Dam type	Earthfill embankment
Reservoir legal status	Statutory impounding reservoir
Dam height (m)	41
Incident type	Embankment instability
Incident severity	2

A routine inspection of a large embankment dam identified a shallow slip on the downstream face of the dam over a large area close to the right mitre. The slip covered an area of approximately 27m by 25m and extended to a depth of up to 1m. The area had previously been noted in an inspection report a few months earlier as wet and in need of drainage. There was no clear indication of seepage flowing through the embankment although the slumped material was very wet from recent rain. A precautionary lowering of the reservoir level was carried out. Urgent measures were planned and implemented to stabilise the area. A rockfill buttress was placed against the face of the slip area, separated by a geosynthetic membrane.

Investigations failed to link the incident with seepage through the core of the dam. The area of the slip was known to be relatively wet, presumably due to local drainage conditions, and the depth of the topsoil was found to be relatively thick at approximately 600mm. It appears that the slip occurred due to the weak nature of the surface material during a wet period.

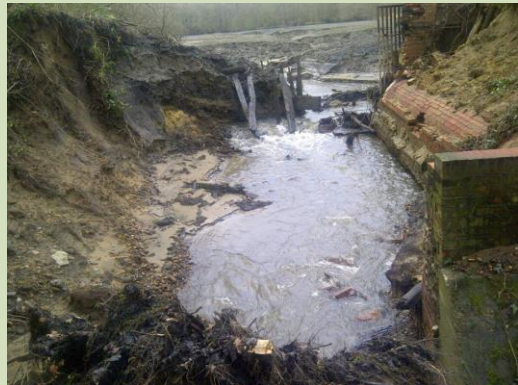
Incident 390	
Dam type	Earthfill embankment
Reservoir legal status	Non-statutory impounding reservoir
Dam height (m)	2
Incident type	Inflow flood, embankment overtopped, erosion
Incident severity	1

A small reservoir formed by an earth embankment was overtopped and breached during a flood event. The breach occurred close to an outlet culvert and was reported by the local fishing club. It appears that the released reservoir water was contained behind a bridleway embankment a short distance downstream, so fortunately there was no threat to life or properties.

The breach mechanism is not clear. Erosion due to overtopping appears more likely than internal erosion although the proximity to the culvert might indicate that internal erosion was a factor. This incident illustrates the importance of providing adequate spillway facilities to pass flood events without overtopping the dam embankment. Small embankment dams with no crest road will generally have a low tolerance to overtopping flow.
