## LONG-TERM BENEFITS AND PERFORMANCE OF DAMS

### Chapter 6. Incidents and rehabilitation case histories

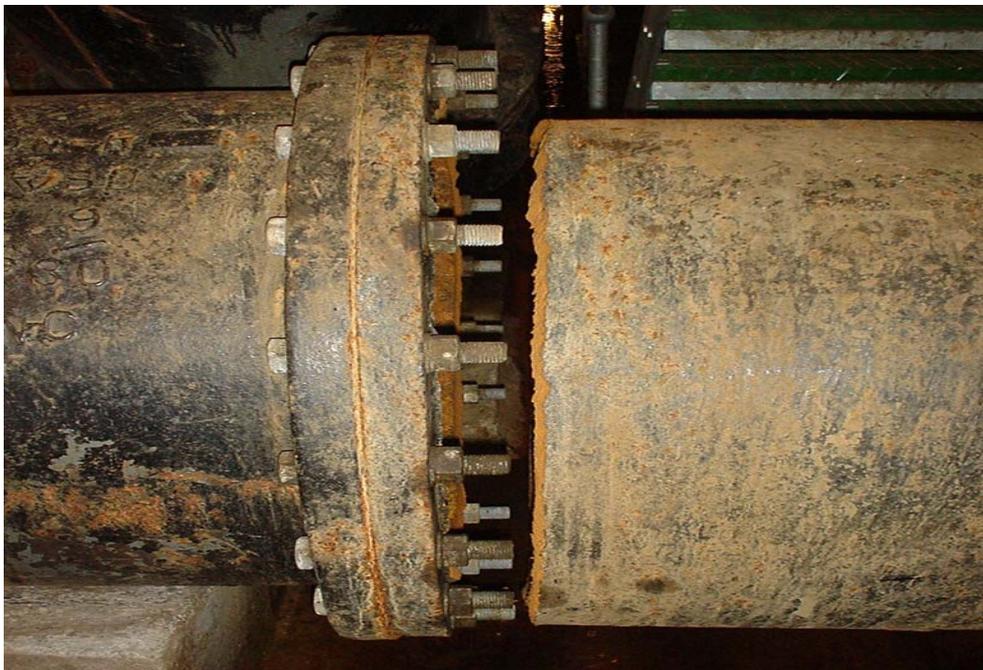
During the initial site inspections it became apparent that the draw-off tower and draw-off tunnel were not safe places to work, since catastrophic failure of the pipework had occurred in a number of places and had left the scour guard valve G4 unsupported and unrestrained in the base of the draw-off tower. Fortunately the flanges on the scour pipework either side of valve G4 appeared to have survived the surge pressures generated by the failure of butterfly valve S1. However, because of the uncertainty regarding the condition of the valve G4 and the adjacent flanged puddle pipe it was considered unsafe to operate the guard valve. Therefore there were now no means of effecting scour draw-off from the reservoir should the need arise and so 'emergency' remedial works were recommended by Dr Hughes 'in the interests of safety'.

Plate 1: Fractured 30" scour pipe

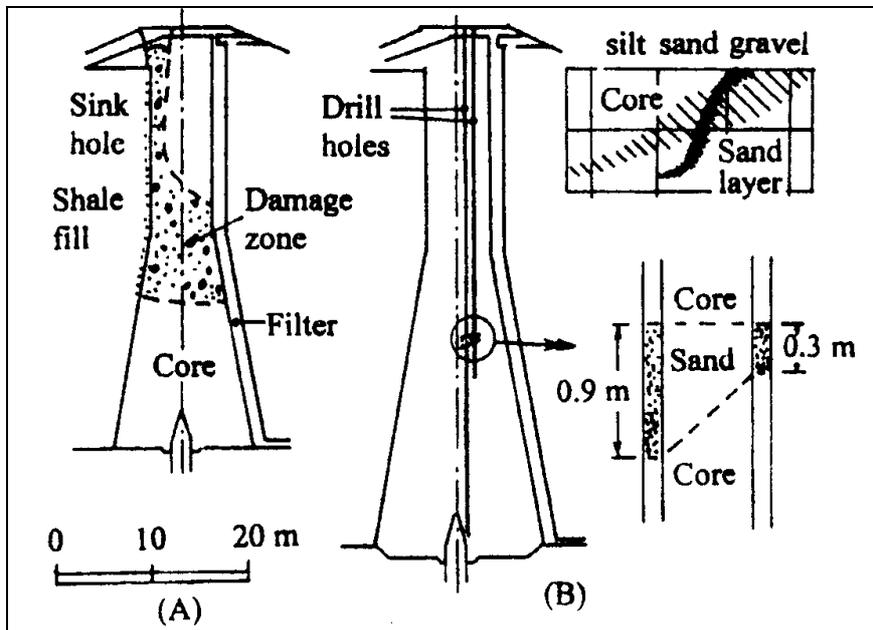
The alternative design method for filters for clay cores is the 'perfect filter' method. It was devised after sinkholes developed at Balderhead dam on first filling in 1967, as shown on Figure 2 (Vaughan et al 1970; Vaughan & Soares, 1982; Vaughan, 2000b). Segregation was identified in the erosion debris from the clay core found in the damage zone. The sand found in the eroded crack was the remains of the core fill, as the particle size distribution diagram on Figure 2 shows. The sand had been retained by the filter (designed to methods that precede both perfect and critical methods) but finer silt and clay-sized materials had passed through the filter because it was too coarse.

Figure 2 Balderhead dam, showing A - Damage zone where sink hole formed and B – Erosion hole filled with water washed sand

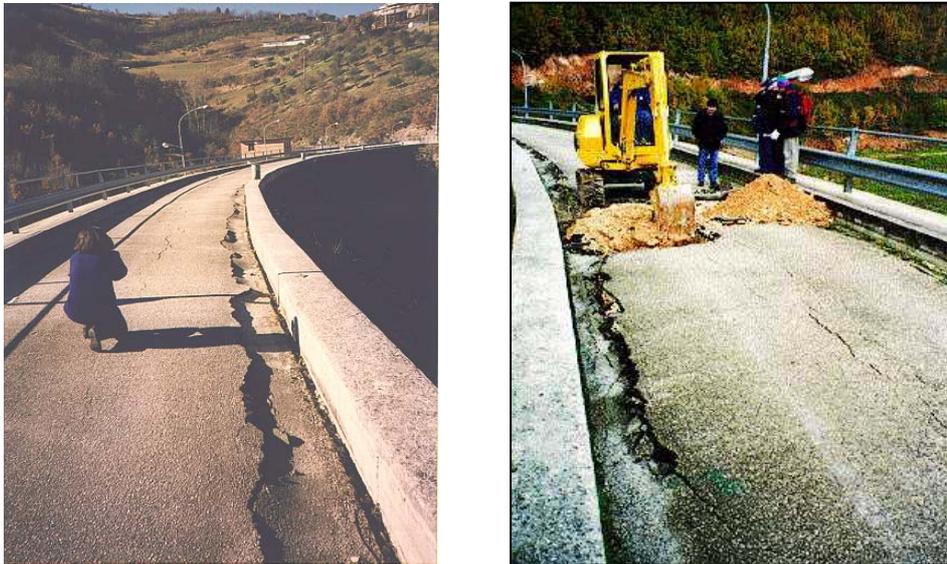
Two square exploration pits 3m wide (PE in Figure 2), dug one year later, did not show any evidence of deepening of the two transverse cracks. No extension of the observed crack path and of complementary damage has been observed.

Figure 4. The damage on the crest

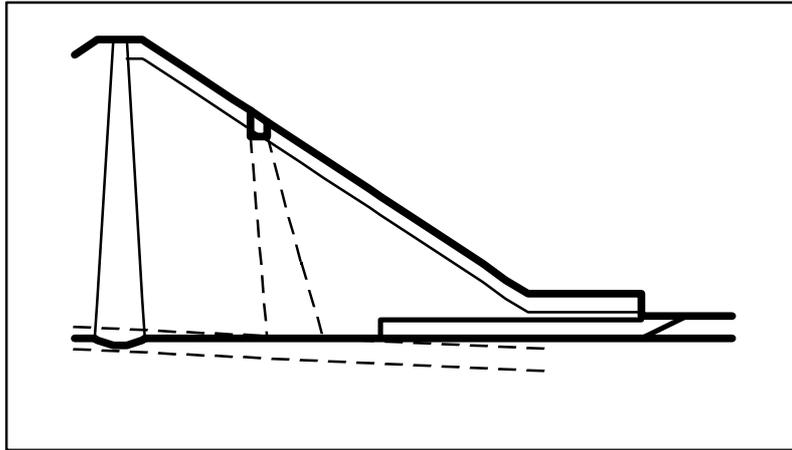
Figure 2 Erosion at interface between open-jointed foundation and fill; eroded materials carried downstream in joints in foundation rock, not visible in culvert. Subsidiary pipe leads to the hole on downstream slope.

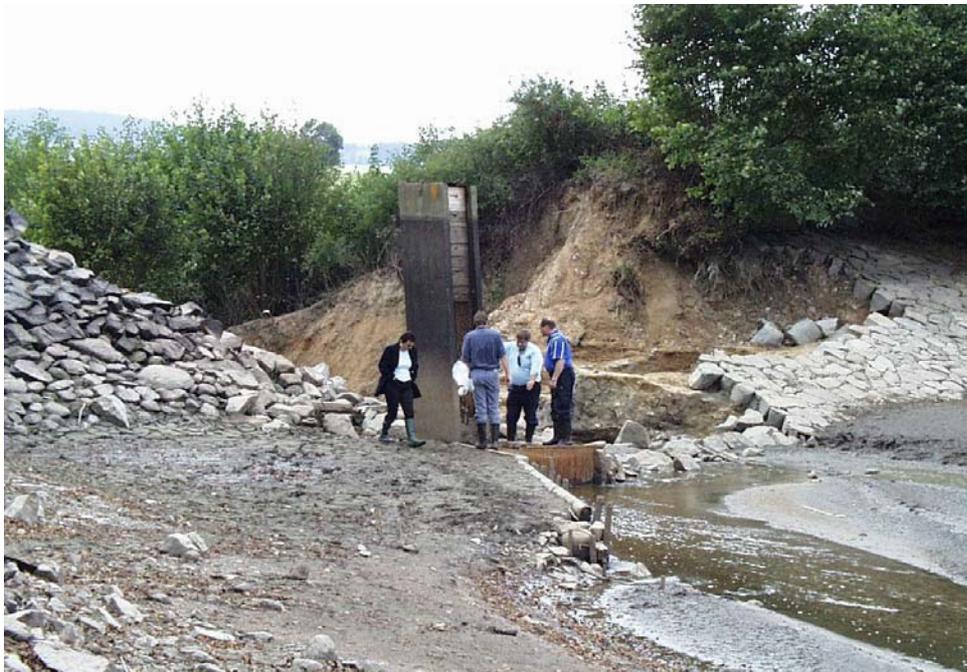
Figure 4: Melin – dam breach with remaining service shaft of the bottom outlet

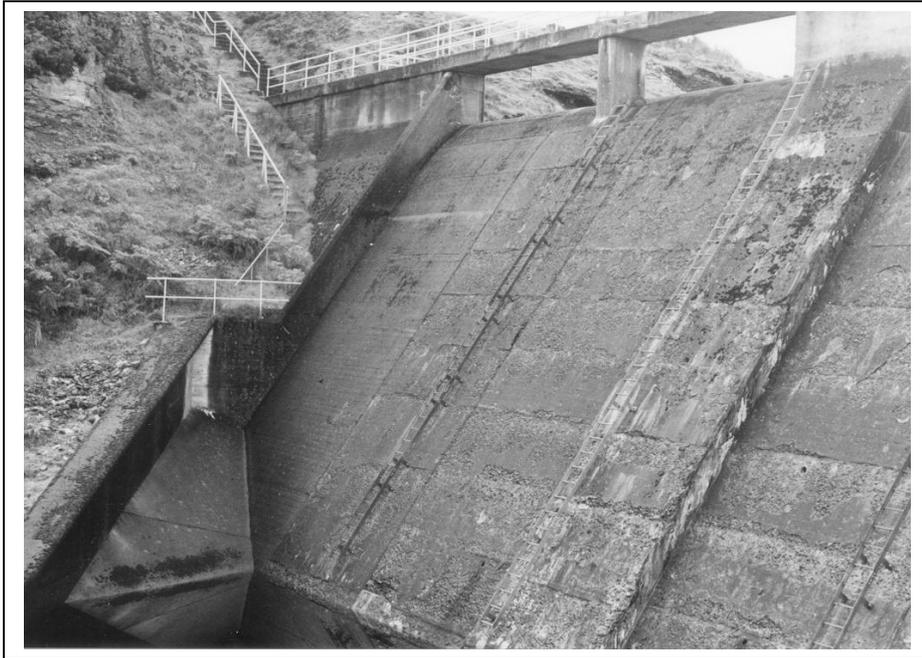
There is a reasonable photographic record of the appearance of the dam from the 1960's to the present time (1961, 64, 66, 71, 72, 75, 81, 84, 2000 and 02) and this represents one of the best indicators of change in the degradation of the structure. Figure 3 shows a picture of a typical section of degraded face.

Figure 3: Varying face degradation, blocks 3, 4 and 5

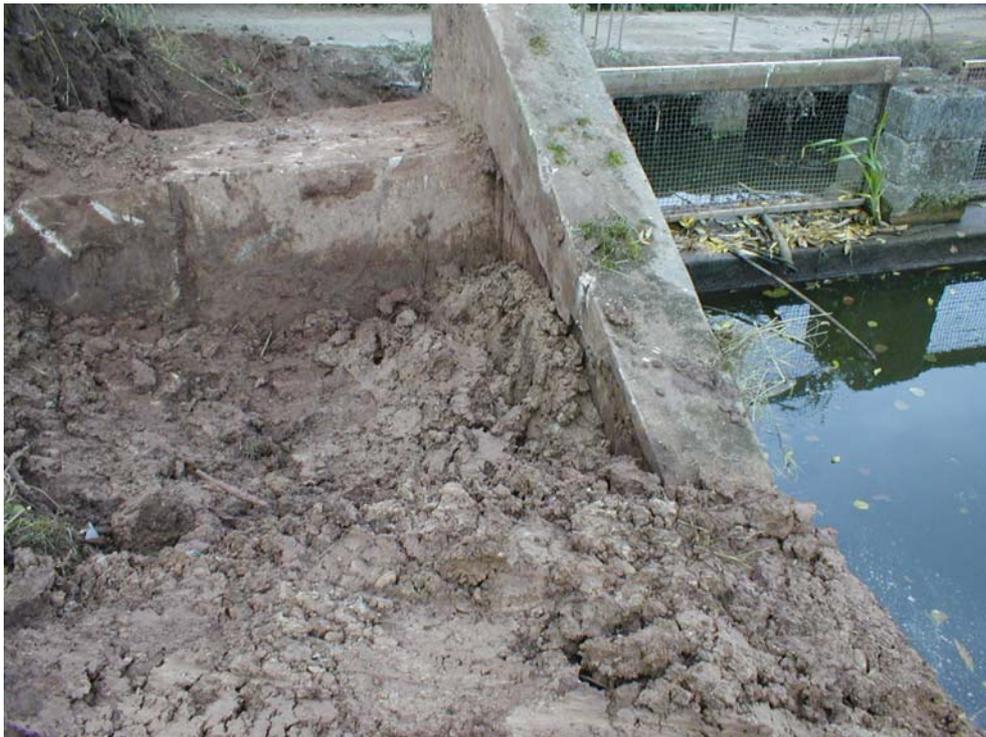
Upper Hartleton Farm reservoir has a capacity of 59,000 m<sup>3</sup> and a catchment area of 11.5 km<sup>2</sup>. It was constructed in 1972 at the same time as Lower Hartleton Farm reservoir immediately downstream. The dams were built of silty clay and performed satisfactorily except for the regular appearance of cavities and internal erosion behind the spillway walls. The cavities appeared at the Lower reservoir in 1979 and 1998 and at the Upper reservoir in 1978, 1995, 2000 and 2003. Since the dams have shown no problems along most of their length it is thought that poor compaction of material adjacent to the spillway walls was the cause of the difficulties.

Figure 1. Axial wall on left side of spillway at Upper Hartleton Farm – leakage was taking place beneath the bottom of the wall.

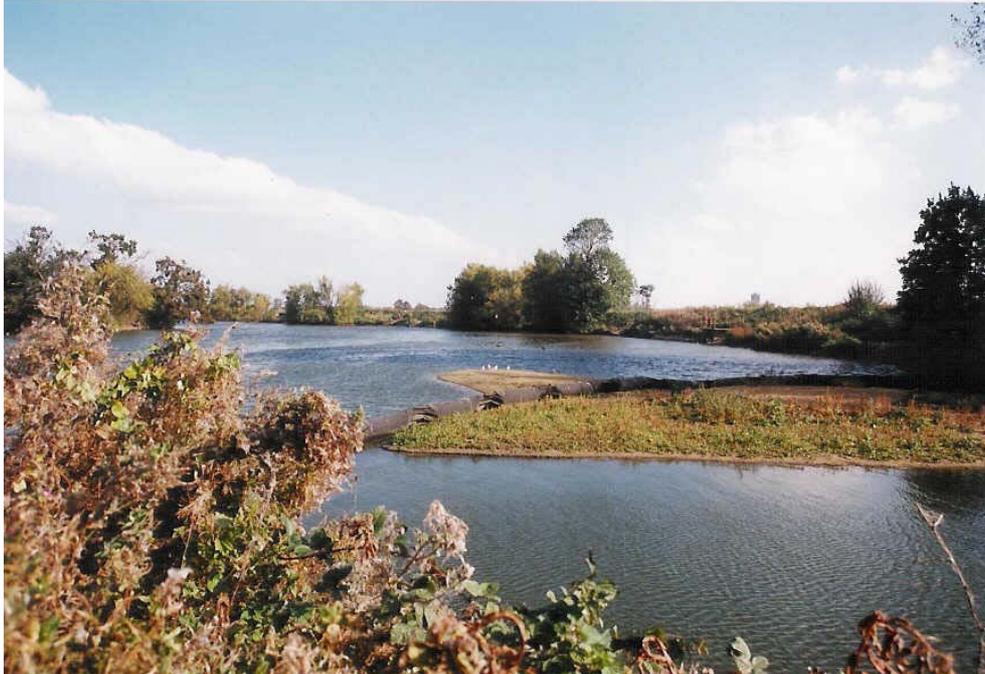
Fig. 3 Silted inlet of Reservoir (Lagoon) No. 3
