Bewl Water spillway remedial works

I DAVISON, MWH
K SHAVE, Babcie

SYNOPSIS. Bewl Water is a major impounding reservoir in South East England, UK. In the mid-1990's an external inspection confirmed that the crest of the spillway shaft was suffering from severe cracking. A paper, by one of the authors, presented at the British Dam Society Conference in Bangor in 1998 described the investigation that was carried out to determine the cause of the cracking. This paper describes the remedial works contract that was undertaken to replace the pre-cast concrete crest blocks that were suffering from Alkali Silica Reaction, and describes the extensive temporary works over the top of the spillway shaft, the methods used to remove the existing pre-cast units and the design of the new units. The new crest units have been designed to allow the crest to be raised by 350 mm without the need for further major temporary works over the top of the shaft.

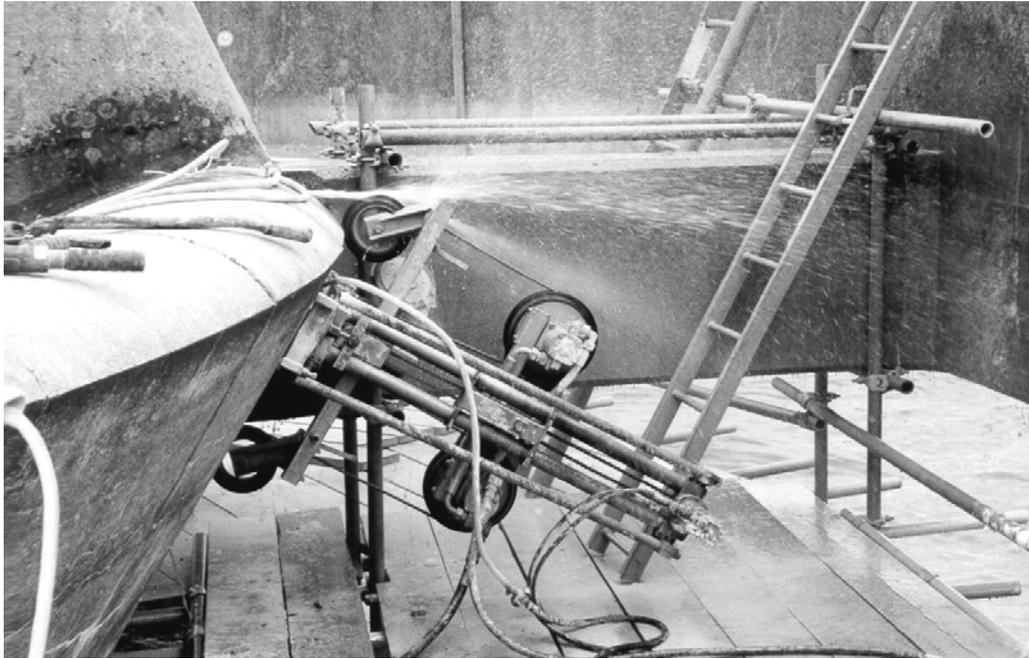
During the design stage consideration was given to the method of removal of the existing pre-cast units. Due to the restrained expansion of the pre-cast units it was considered that a sudden release of any in built stresses could cause problems. Therefore slots were required to be cut through the units prior to their removal. This was carried out by diamond drilling a hole through the base of one of the units nearest an anti-vortex pier in each quadrant. A diamond rope saw was then threaded through the hole and a slot cut upwards through the block (see Figure 2). No sudden release of stresses was noticed.

Figure 2 - Saw cutting between the existing blocks

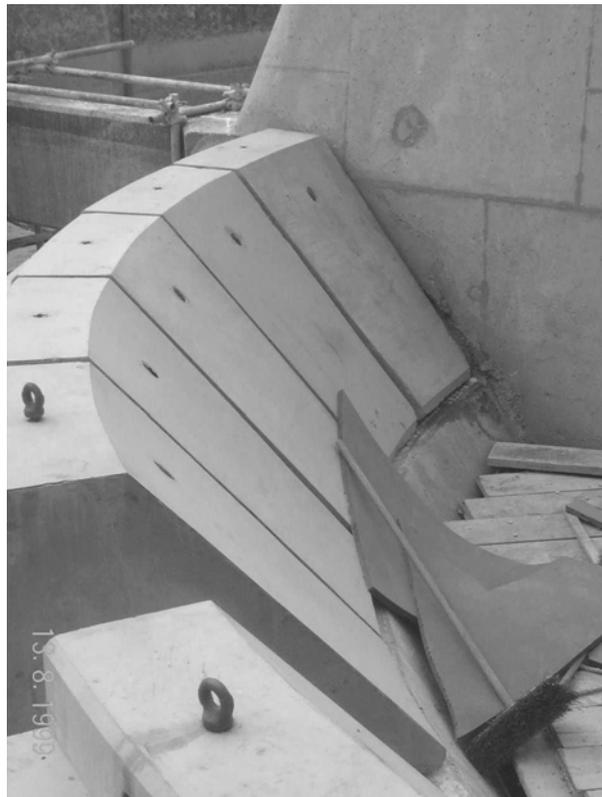
The new pre-cast units were installed using the crane on the barge. The units were placed on thin metal shims and all units were located and levelled prior to any grouting of the vertical or horizontal joints (see Figure 3). Two vertical movement joints were installed in each quadrant, consisting of a 25 mm thick compressible joint filler surrounded by a joint sealant. All other joints were filled with a non-shrink cementitious grout and then pointed with an SBR mortar.

Figure 3 - New blocks in place

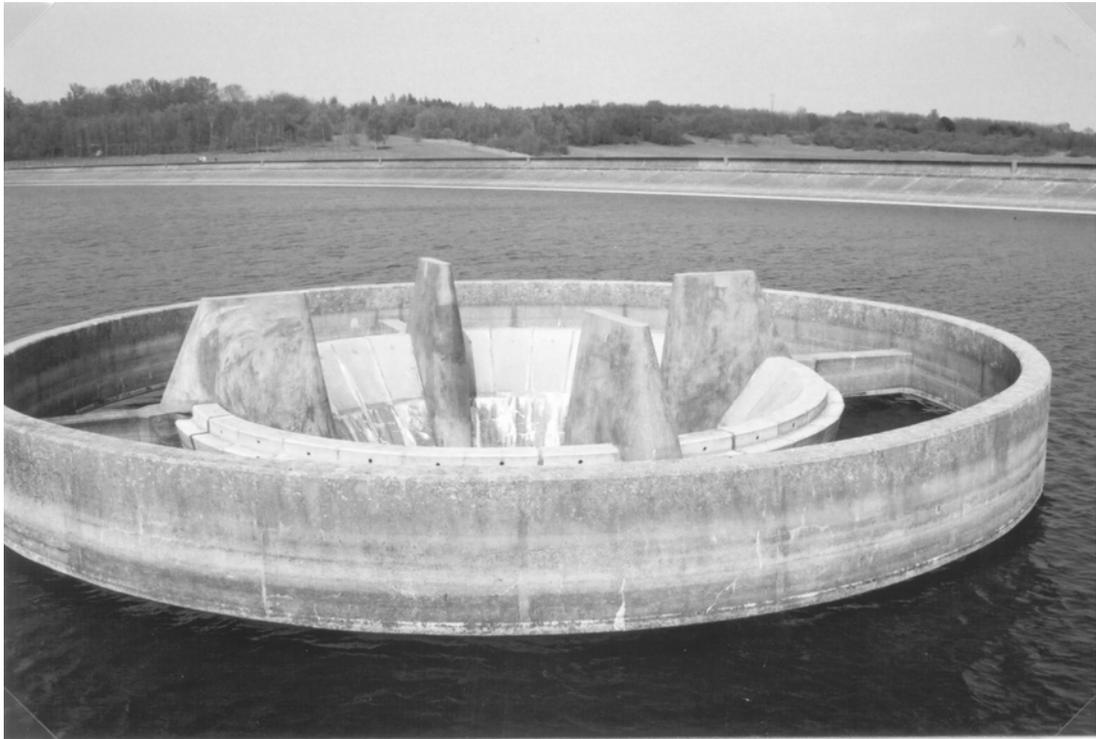
The new units have now been in place for four years (see Figure 4) and recent observations made from the balcony of the adjacent draw-off tower indicate that the surface of the replacement units are without deterioration. During this period the reservoir has spilled and this confirmed the quality of the workmanship as spilling was uniform around the perimeter.

Figure 4 - Completed spillway crest
