The long term performance and remediation of a colloidal concrete dam.

K J DEMPSTER, Scottish and Southern Energy plc, UK.
J W FINDLAY, Babbie Group, UK

SYNOPSIS. Within Scottish and Southern Energy plc's (SSE) stock of concrete dams a small but nevertheless interesting subset is colloidal dams. SSE own three dams that are part formed using this technique. A brief history of colloidal dams is given followed by detailed information on particular problems at Loch Dubh Dam. Babbie Group (BG) is currently conducting studies leading to remediation proposals.

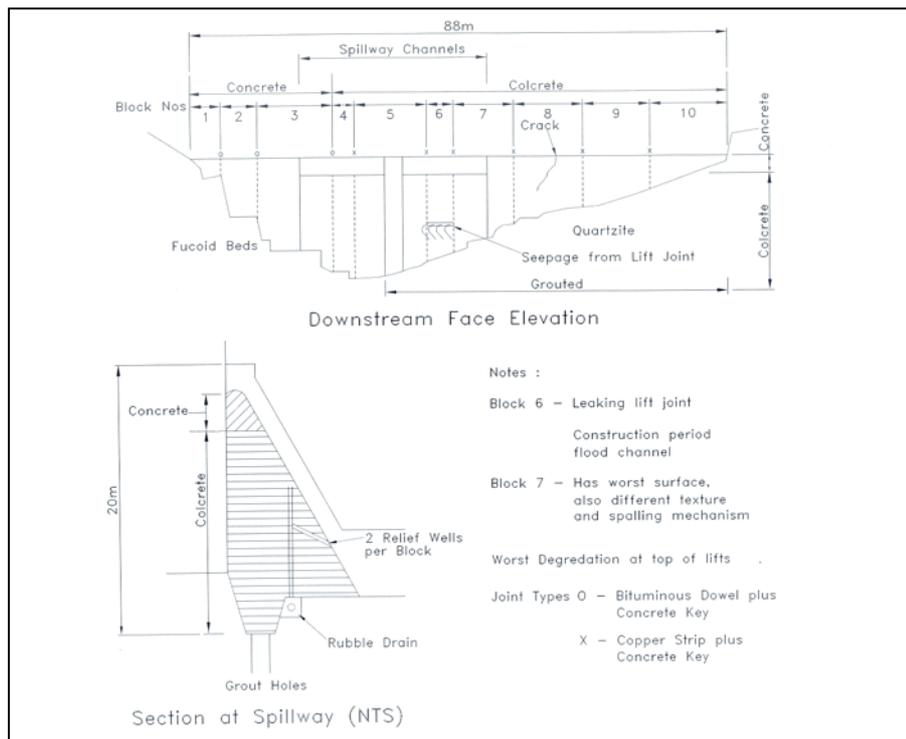
Figure 2: Principal Features

structure acts as the spillweir. The most remarkable feature of the dam is the method of construction using colloidal concrete. An associated feature that is equally unusual is the use of conventional mass concrete for a small number of monoliths on the right abutment. The reason for this decision is not clear although there is reference to a change in foundation rock type as a contributory factor (Refer Figure 2).
