An Incident at Ogston Reservoir

A.K. HUGHES, KBR, UK

S.D.R. HARWOOD, Severn Trent Water, UK

SYNOPSIS. In the autumn of 2001 an incident occurred at Ogston Reservoir which led to the catastrophic failure of the pipework in the draw-off shaft. An uncontrolled release of water commenced which was only prevented by the quick actions of two operatives in the shaft. This paper describes the investigations carried out to establish the cause of failure, the remedial works which were carried out and the lessons learnt.

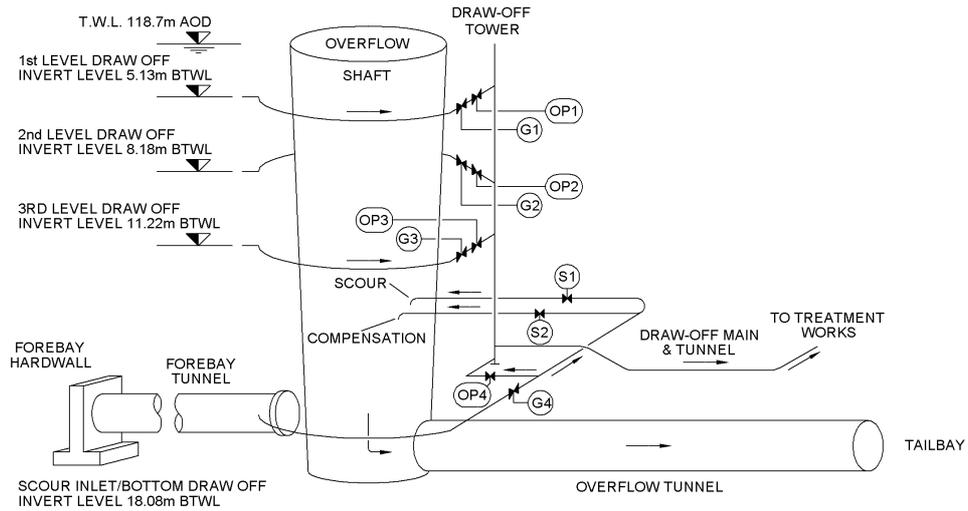
Figure 1: Schematic diagram of draw off and overflow arrangement

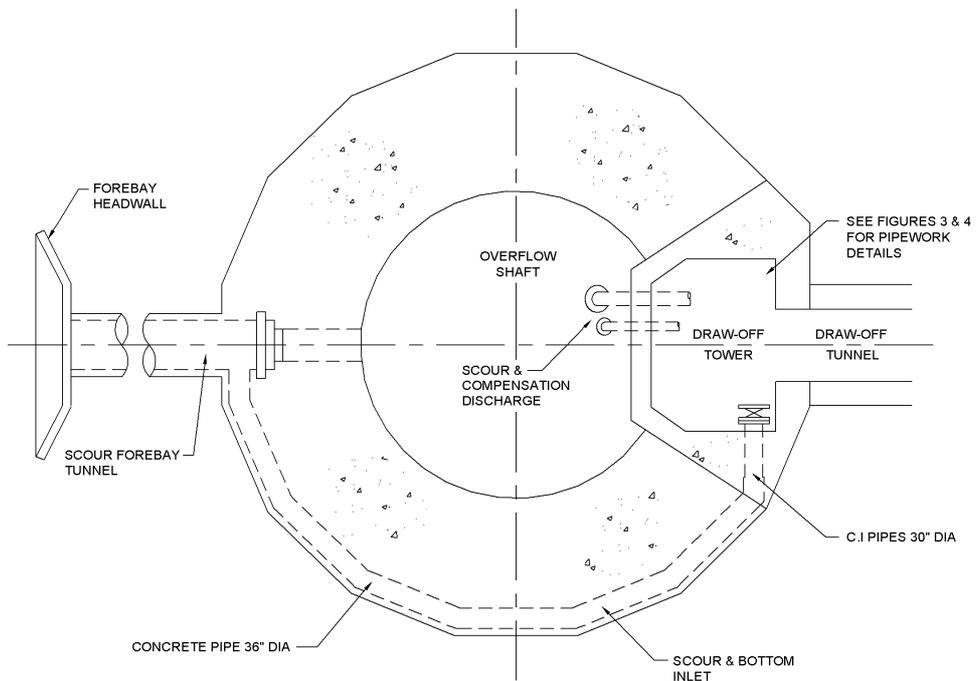
Figure 2: Plan showing scour arrangement

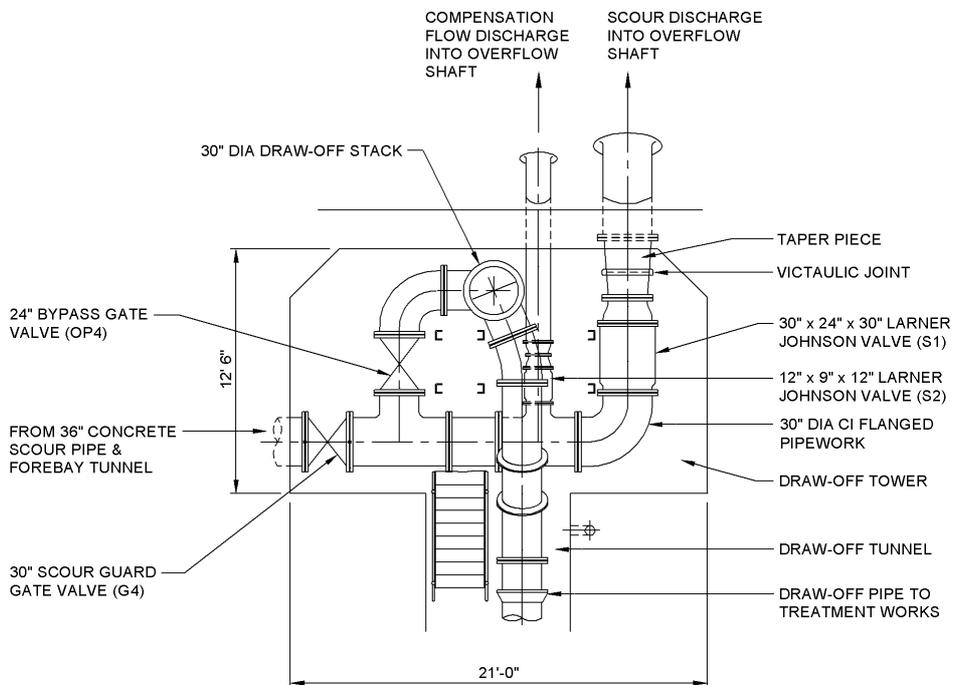
Figure 3: Original scour valve layout in draw-off tower

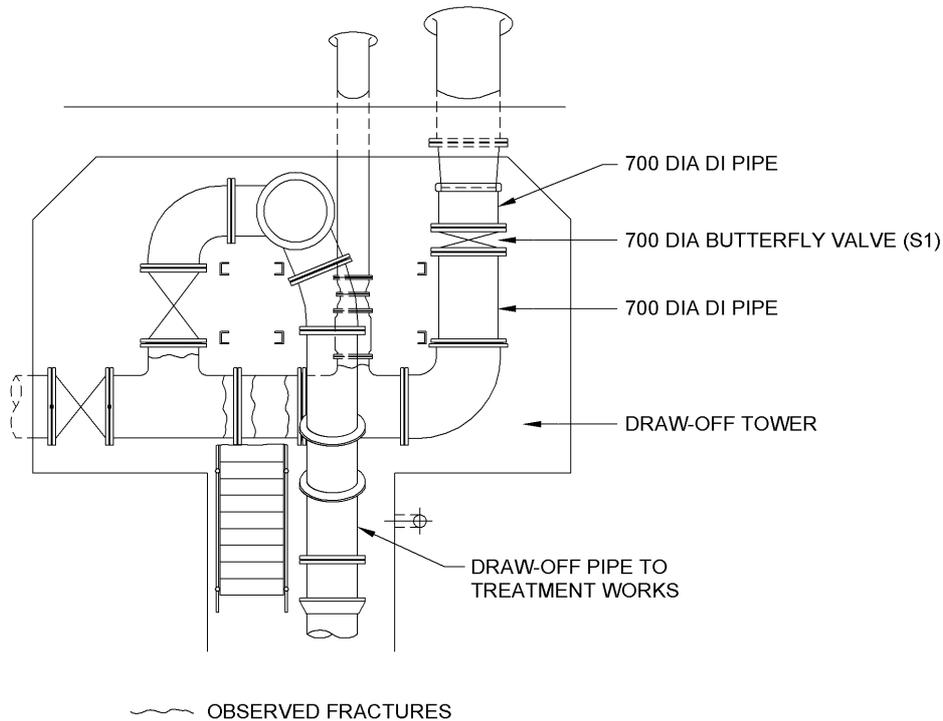
Figure 4: Modified scour valve layout in draw-off tower prior to incident

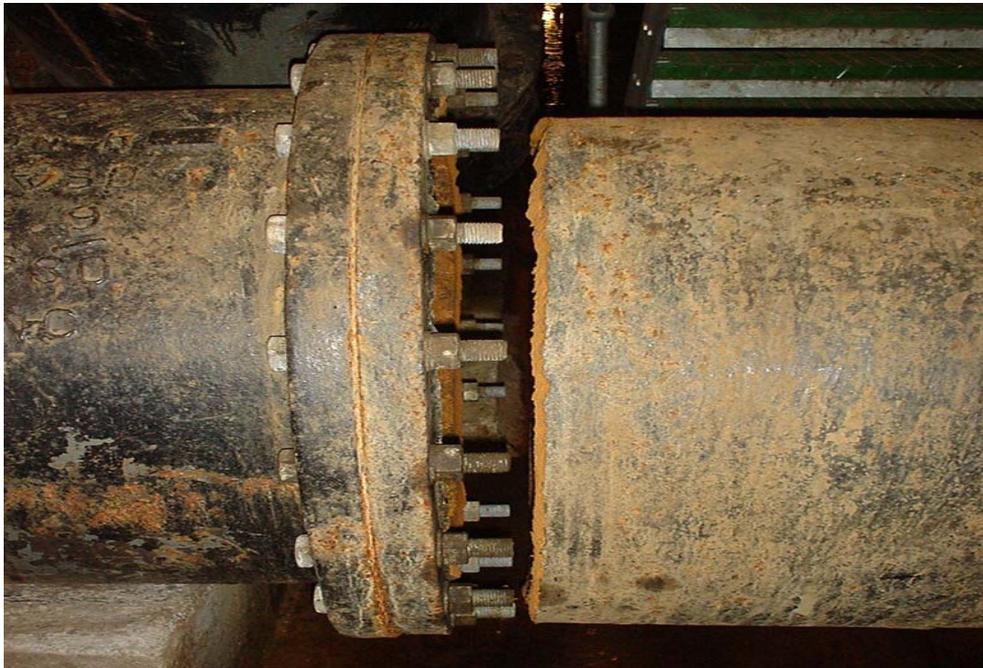
Plate 1: Fractured 30" scour pipe

It was immediately evident from the inspection following the failure of the butterfly valve S1 that the surge pressures generated by the incident caused fracture and complete failure of the scour pipework. What was not known was whether the surge pressure had caused overstressing of the valve bodies and other fittings which did not show any visible signs of failure. It was possible that the surge pressures had caused damage to:-

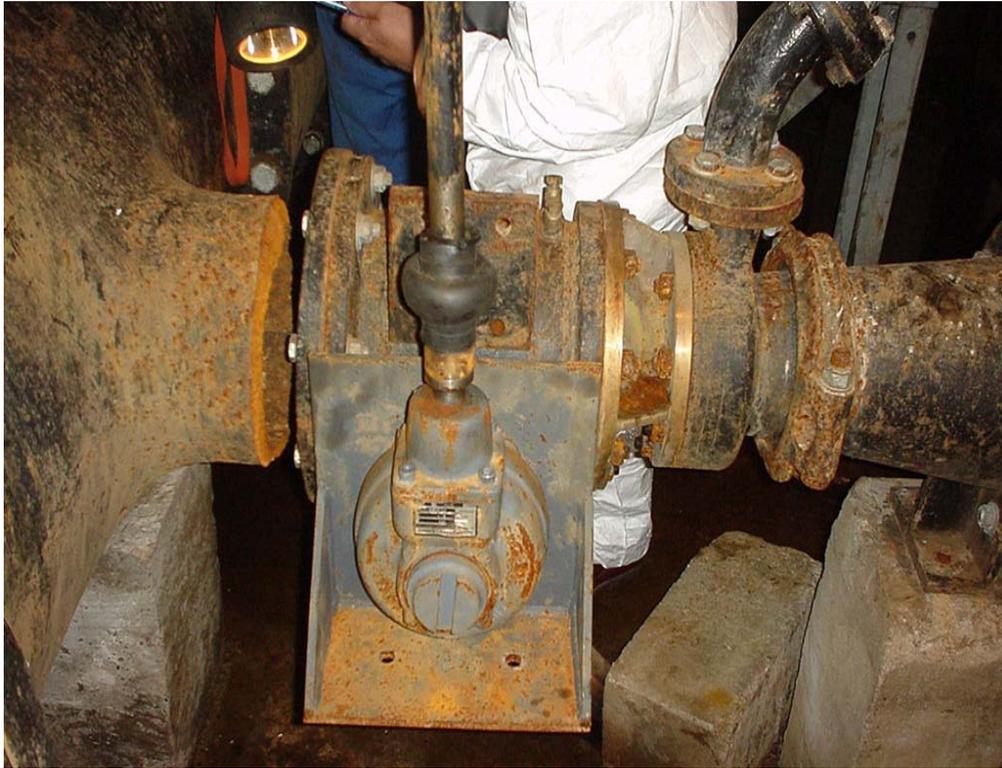
Plate 2: Fractured compensation pipework

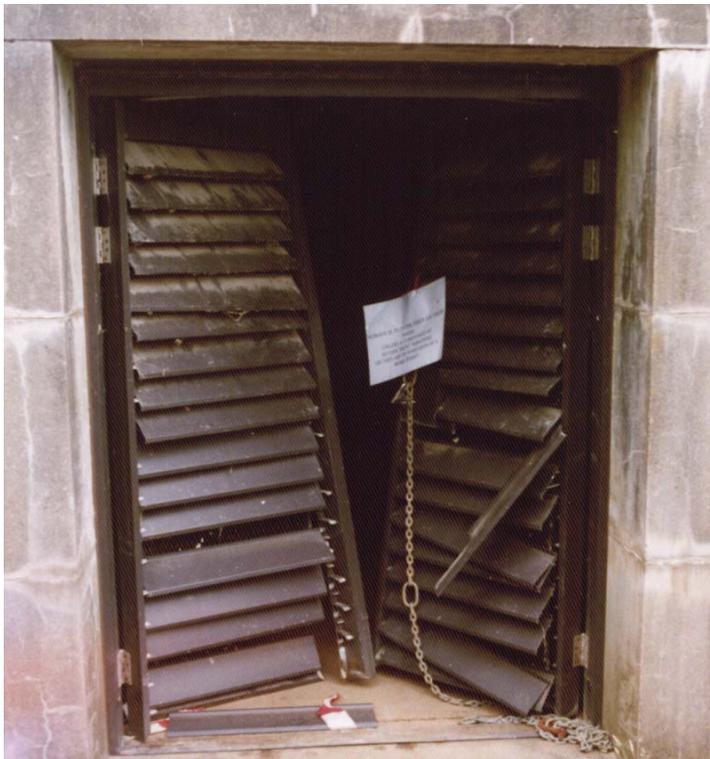
Plate 3: Damaged draw-off tunnel doors

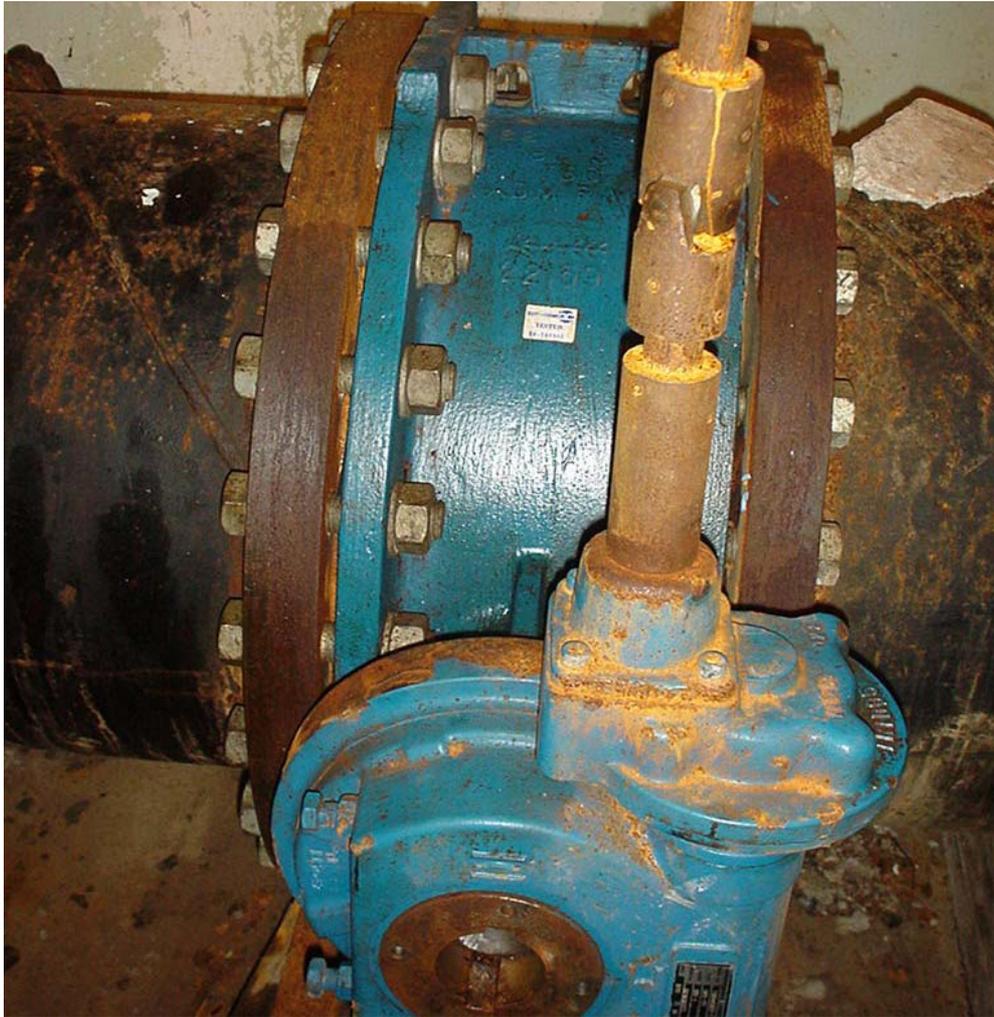
Plate 6: Failed butterfly valve in position and failed gearbox component

- The gearbox fitted to the valve was undersized for the application. The connection between the valve and the gearbox failed as a result of the excessive torque required to operate the butterfly valve beyond 50% open. This was due to the calculated presence of full cavitation and uneven flow profile, caused by the close proximity of the bend and the positioning of the valve.

- The capability of the gearbox was considerably reduced by one of four screws used for coupling the gearbox to the valve drive sleeve being missing.
- When the connection between the valve and gearbox failed there was nothing to prevent the valve slamming shut.
- There was little external corrosion of the pipes; however internal corrosion within the structure of the metal had reduced its tensile strength to some degree.
- The estimated surge pressures generated by the instantaneous closure of the butterfly valve would have resulted in the failure of new pipe to the same specification as that installed.

In summary, the failure of the pipework was due to the torque required to operate the butterfly valve being underestimated by its manufacturer and the gearbox being too small for purpose. This problem was exacerbated as one of the screws was not fitted into the gearbox drive sleeve and the remaining screws were not able to take the applied load. They subsequently failed allowing the valve disc to be rotated by the water flow, slamming closed and bringing the water flow to a sudden halt. The resulting change in momentum caused a pressure surge estimated to be in excess of 55 bars. This surge caused several sections of the pipework to fracture releasing a considerable quantity of water.

Following an assessment of the options for replacing the scour valves, KBR recommended that the butterfly valve should be replaced by a Larner Johnson valve. Fortunately it was possible to track down the original Larner Johnson valve which had been removed and have it refurbished for subsequent installation by the appointed contractor.
