Detailed investigation of an old masonry dam

Dr.-Ing. ACHIM JAUP, Lahmeyer International GmbH, Bad Vilbel,
Germany

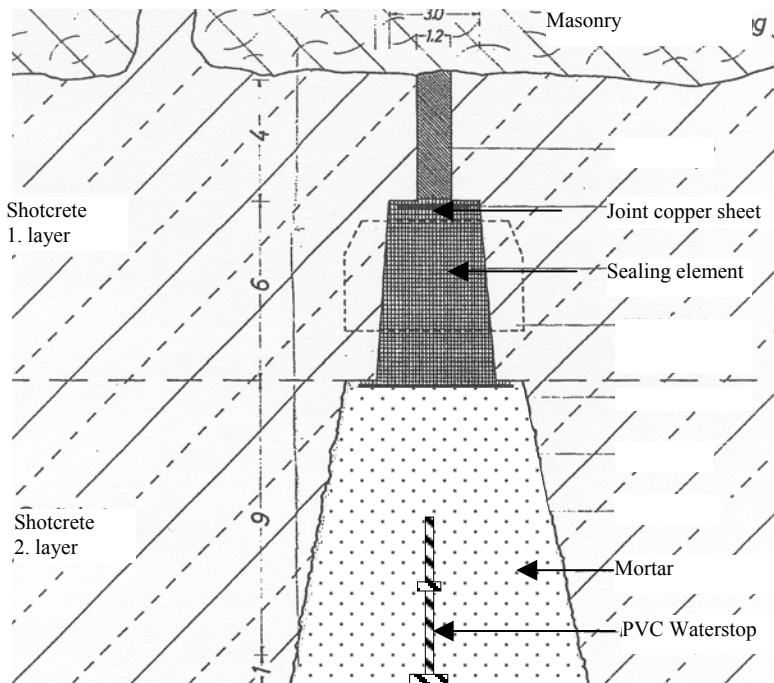
Figure 1. Cross section through joints of shotcrete layer

The main aspect of this rehabilitation was to seal the upstream face of the dam. The rehabilitation consisted of a reinforced shotcrete lining in panels of 5.0 x 5.0 m. Figure 1 and 2 show the shotcrete lining and the joints as a plan and as a photograph.

Each panel was anchored into the dam by 16 anchors with a diameter of 20 mm and a length of 2.50 m. The shotcrete was applied directly onto the masonry in two layers, each 10 cm deep. The joints between these shotcrete panels were formed with a sealing element and mortar, see figure 1.

Despite these complex rehabilitations the sintering process deterioration was only slowed down slightly. As the joints were not really flexible joints the joints were disturbed due to thermal movement in the dam. Hence the water could leak through these joints into the dam.

In contrast to the shotcrete layer the panel joints were in a worse condition. This was because the joints were not flexible joints, see figure 1. Thermal movements of the dam caused high compressive stress in the joint material, which often resulted in cracks. More than two thirds of the joint material had to be replaced. The geomembrane needs a smooth subsurface with no protrusions, so these joints had to be reconstructed.

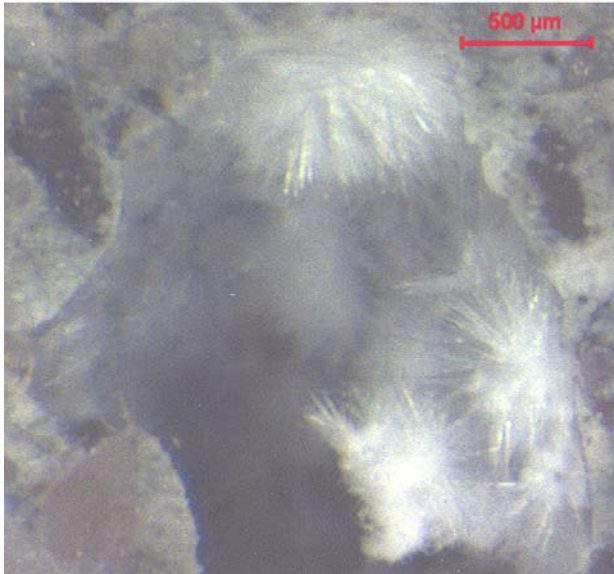
Figure 4: Microscopic view of shotcrete

- The concrete was classified as a concrete C20/25.
- All cores showed a steady microstructure. Also the transition zones between masonry and shotcrete and in between the shotcrete layers showed no voids.

- The geometry of the shotcrete layer could be confirmed: thickness 20 cm and two layers of reinforcement.
- In both the shotcrete and the joint material ettringite was found. Where ettringite fills the pores completely, an internal pressure arises and the microstructure is disturbed. As described above, the shotcrete is in good condition (no hollows, good microstructure), so the shotcrete will not be damaged by the ettringite. Figure 4 shows a microscopic view of the shotcrete. A pore with slight ettringite can be seen. Generally these very small pores are found in the shadow of the reinforcement. Further information on ettringite can be found in Jungermann (2000). In the joint material the pores were filled with the ettringite and the microstructure was destroyed. All the factors which lead to damage of the microstructure can also promote the formation off ettringite. The existence of ettringite crystals in concrete cracks is, as a rule, only a consequence and rarely the cause of the cracks, Stark/Bollmann (2000). This matches with the visual investigation, that the joint material was in a bad condition.

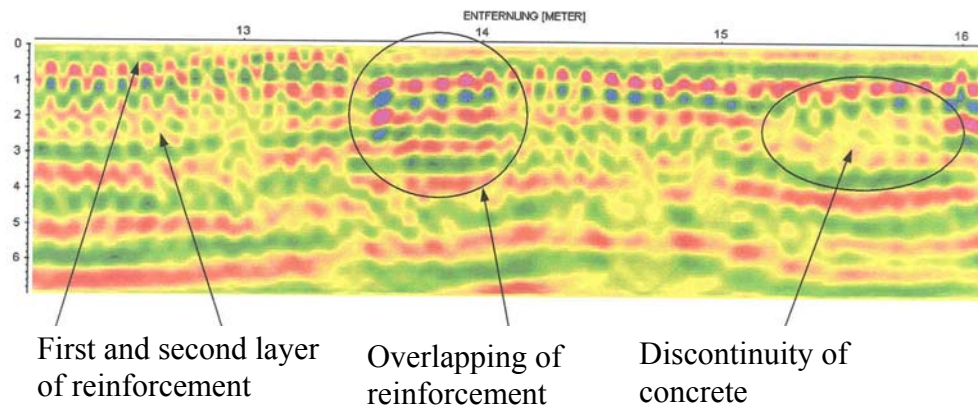
Figure 5: Example of evaluation of Georadar investigation

With the georadar survey the good condition of the shotcrete lining could be confirmed. There is a high consistency with the core drilling results, e.g. the thickness of 20 cm of the lining and the existing 2 layers of reinforcement. Discontinuities, e.g. the right side of figure 5, were in all cases minor.
