Papan dam studies and remedies.

C.MAKINSON, JacobsGIBB Ltd, Reading, UK.

SYNOPSIS. As part of a major irrigation refurbishment programme in Kyrgystan, seven major dams built in the Soviet era have been examined and rehabilitation measures designed and costed. Perhaps the most complex of these was Papan Dam near the city of Osh on the Silk Road. The dam is a 100m high gravel embankment with a grouted core, set in a very narrow limestone gorge. High regional seismicity and local fault alignments all increase the risk of failure of the works, and the provincial capital downstream is only part of the consequent hazard. This paper describes the inspection and investigation process, and the difficulties of identifying the seepage pattern in a three dimensional context. The justification of remedial measures currently in progress, and comprising a 70m deep diaphragm wall through the upper half of the dam core, is discussed. A short description of the bottom outlet and spillway and their current condition is given, together with comments on the parallel issue of reservoir operation and flood freeboard.

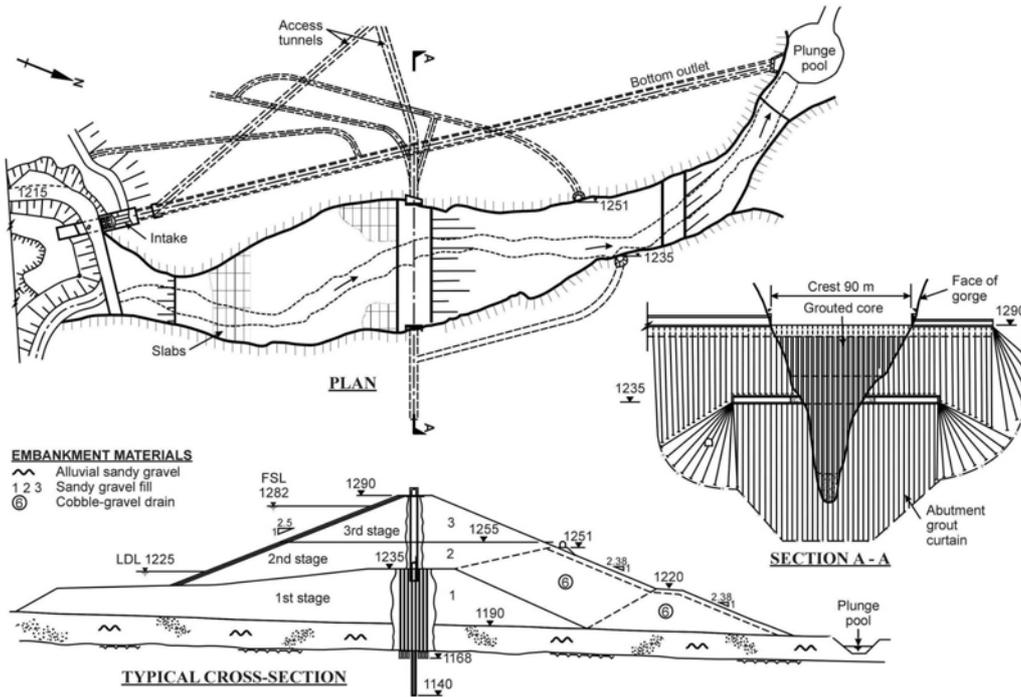
Figure 1. Papan Dam Plan and Sections

The layout and key sections for Papan Dam are shown in Figure 1, and construction took place from 1975 to 1985. The construction stages are indicated and the unusual downstream shell zoning that resulted. The few remaining piezometers had indicated a high phreatic surface across the downstream shell, suggesting a defect in the water tightness of the centrally located core/curtain and an internal hydraulic control under the downstream berm. The lower core was known to consist of a nine-line grouted zone constructed within a selected clean gravel fill, supported by sandy gravel shells. Details of the geometry of later stages relied on an obviously super-

superceded planning drawing, but it was known that the upper core and shells were placed across the full dam width as a single sandy gravel zone followed by three lines of grouting near the dam centerline. The right abutment grout curtain at the upper level had been re-grouted in 1990 to reduce leakage into the gallery from 120 to 52 l/s.

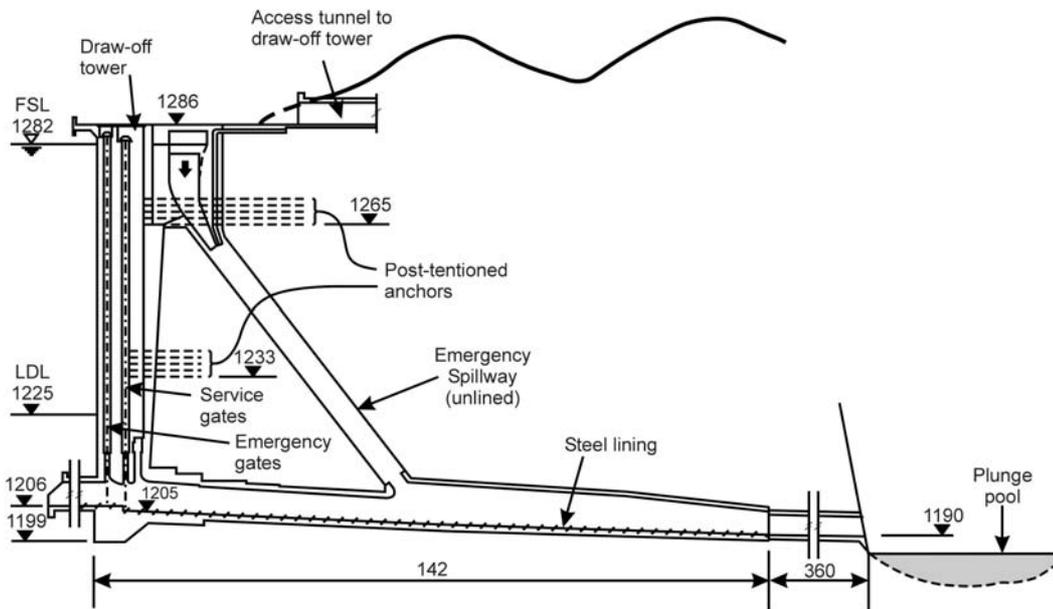
Figure 2. Combined Intake of Bottom Outlet and Spillway of Papan Dam

The combined spillway and bottom outlet system were described in Reference 1 and are shown here on Figure 2. TemelsuGIBB calculations for flood routing in the DER 1999 were based on western concepts such as passing the full PMF over a spillway, ignoring the bottom outlet. Dambreak would not only destroy the provincial capital Osh but also pass through the main agricultural zone of the Ferganah Valley, and cross several national borders as a flood wave on the Syrdarya River (Reference 2). There are numerous local precedents for designing dam projects with massive freeboard so as to absorb flood peaks as reservoir storage. In the unusual case of Orto Tokoi dam the spillway capacity had to be severely restricted to increase the live storage and water yield. In most other Kyrgyz dams additional spillway provision was recommended, and in the case of Papan this implied an expensive separate tunnel spillway with the possible addition of a mini-hydro station to augment the two 9m long weirs at the intake tower (Figures 2 and 5).

previously been repaired, the gates have vibration and aeration problems, and the tunnel outlet and plunge pool are sub-standard.

The reasons for this situation being tolerated only gradually became clear. First the maximum gate discharge is only 160 m³/s as permitted by the gate manufacturer not 260 m³/s as calculated for two fully opened gates. There is a continuous minimum discharge of 20 m³/s compensation water for Osh city potable water. Fundamentally there is no benefit in filling the reservoir and even after rehabilitation a 1275 masl normal top water level will be applied. Flood routing then becomes much simplified with 45Mm³ extra flood storage, doubling that for the 1282-88 masl flood range. The gate vibrations occur at small openings and have now been measured and found to be within acceptable limits of the Soviet code (SNIP). The obstruction to the aeration shaft has been lifted and an aeration slot will be created, and minor welded insitu reinforcement of gates and linings added, rather than proposed major off-site gate modification. The tunnel outlet rock-support wall and plunge pool amplification at the inaccessible dam toe will be carried out, after diverting the compensation flow by a temporary adit linked to the tunnel.

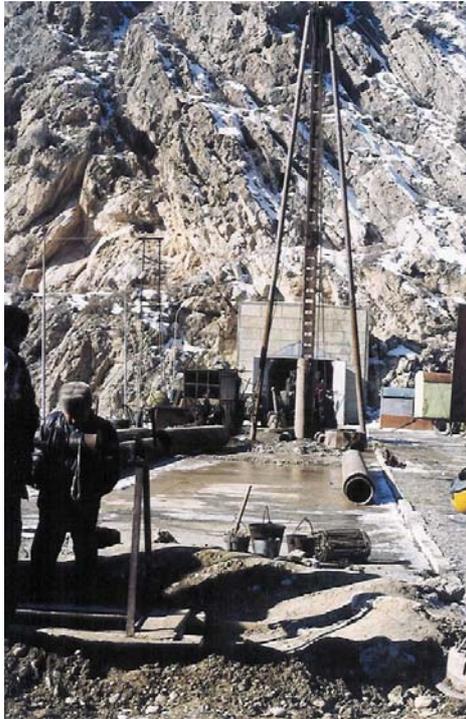
Fig.3. Investigation on Dam Crest

The exploration in the dam core was particularly useful in indicating that the grouting had been only partially successful. The deep borehole appeared to indicate a large-scale window of high permeability in the lower core. Together with the 20m deep by one metre square, wood-braced, shafts a good impression of the upper core was also obtained. Eye witness accounts of construction had been useful in establishing that the gravel here was placed in 60 cm layers with non-vibrating roller compaction. The dumping and dozing placing sequence resulted in significant segregation, and only the top of each layer was compacted, resulting in effective horizontal stratification with permeable sub-layers and thin aquicludes. Only occasional boulders, wedges or sills of cemented gravel or plain cement grout takes were found in the upper core constructed by grouting this segregated, sandy gravel material. This scenario is consistent with the seepages observed at high levels on the downstream slope whenever the reservoir rises above about 1270 masl.

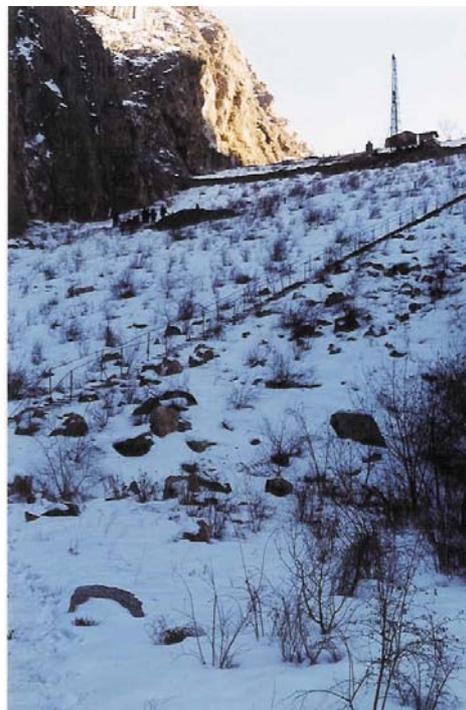
Fig.4. Downstream Slope from Berm

The downstream berm feature is not some temporary cofferdam feature obstructing flow, but a drainage zone. A simple calculation of the flow through the narrow inner river channel alluvium, using measured insitu permeability at the measured low hydraulic gradient, indicates that the discharge is insufficient to maintain equilibrium so the rock walls of the inner gorge are also carrying seepage flows. Looking at the upstream gorge section the water levels in the inner downstream shell zone (first stage construction) are close to 1228 masl and conceivably fed from higher levels on the abutments. The left abutment plots are all based on dry readings, and this whole abutment is considered to be a groundwater sink. On the right abutment the readings are near the bottom of the inclined piezometers from the upper gallery down to 1250 masl (possibly in mud or trapped end sections), and water overflows from the lower gallery piezometers at 1235 masl level. The upstream piezometers faithfully reflect the reservoir level and appear to indicate a head drop of 3 to 8m across the grout curtain.
