Raising of the Ajaure embankment dam by extending the moraine core with a geomembrane

Å. NILSSON, SwedPower AB, Stockholm, Sweden

I. EKSTRÖM, SwedPower AB, Stockholm, Sweden

SYNOPSIS. The Swedish Ajaure embankment dam is a high consequence dam which is 46 m high and was constructed between 1964 and 1966 with commissioning in 1967.

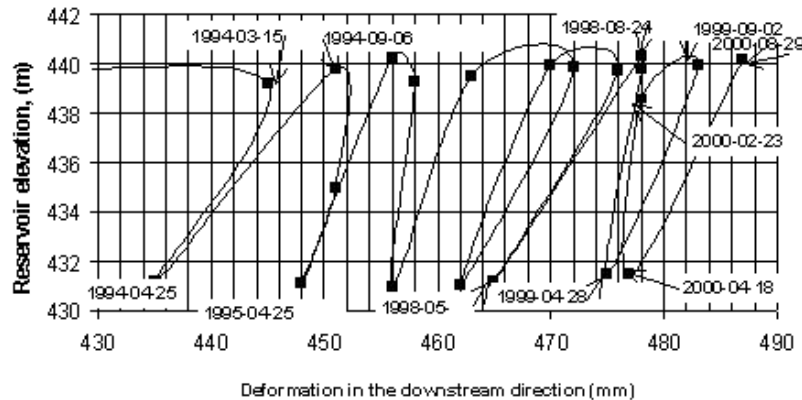
Figure 2. Record of horizontal displacements at the crest

During the 1980s it was noted that the horizontal downstream displacements in the main embankment dam didn't show any sign of diminishing over a time period. The horizontal deformations are significantly influenced by the reservoir as shown in Figure 2.

Compared to measurements of deformation in other Swedish dams of similar design, the horizontal deformations were notably large. The present horizontal displacement of approximately 8 mm/year was almost linear and showed no tendency to diminish.

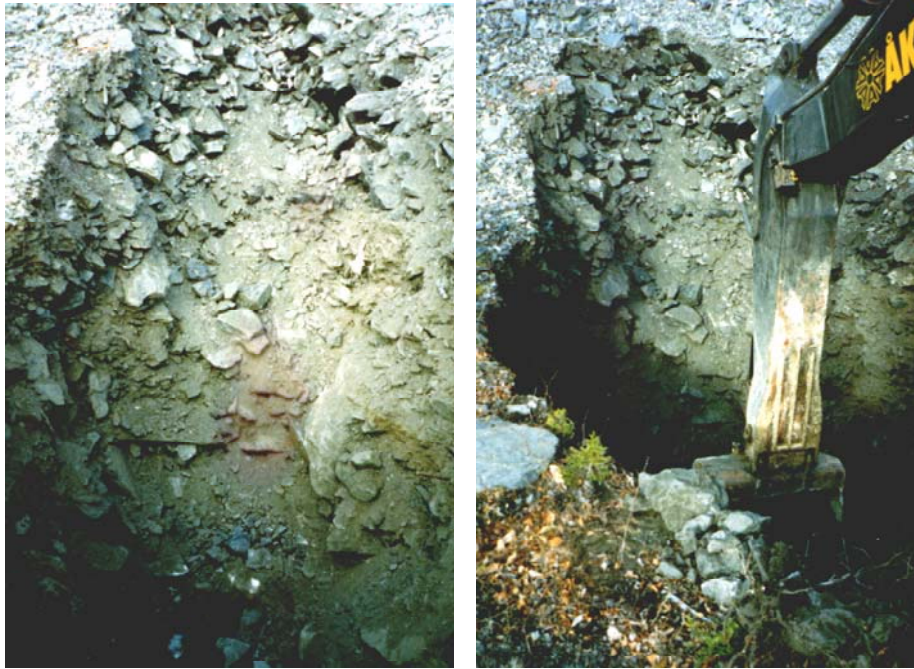
Figure 3. Test pits in the downstream toe of the original supporting fill

In 1989 test pits were excavated along the downstream toe of the left embankment dam. The rock fill consists of schists and gneiss with a high content of mica. The rock fill had a high content of fines, see Figure 3. It is judged the fines at the lower parts of the fill are partly washed down from higher elevations by the precipitation.

Laboratory shear tests showed that crushing of the material occurred to a large extent. The result of these tests established the weakness of the material at high shear stress, as well as exceptionally low shear strength of the material in the supporting fill. The low safety factor indicated that the shear stresses in situ were close to possible mobilized shear stresses at failure. It was concluded that the high shear stress, in combination with the cyclic loading from the reservoir, results in the progressive crushing of the rock fill and that crushing could be causing the continued horizontal deformations.

Stability analyses also indicated low stability and a stabilising berm of blasted rock was placed against the lower half of the downstream side of the left embankment dam to increase the stability margin in 1990. The berm was 18 m wide and 20 m high, with a total volume of approximately 50,000 m³. The fill material was placed with the slope inclination 1 vertical to 2 horizontal. The berm was also intended to increase the erosion resistance at the downstream toe in the dam. No decrease in deformation was however noted after the lower berm had been placed.

A second upper berm with a total volume of approximately 100,000 m³ was placed in 1993. At this time the berm that was placed in 1990 was raised using in the same inclination 1 vertical to 2 horizontal up to a level approximately 1.5 m under the original crest of the supporting fill. The main purpose of the second berm was to further increase the stability margin. Furthermore the second berm was designed to make it possible to raise the crest in the future.

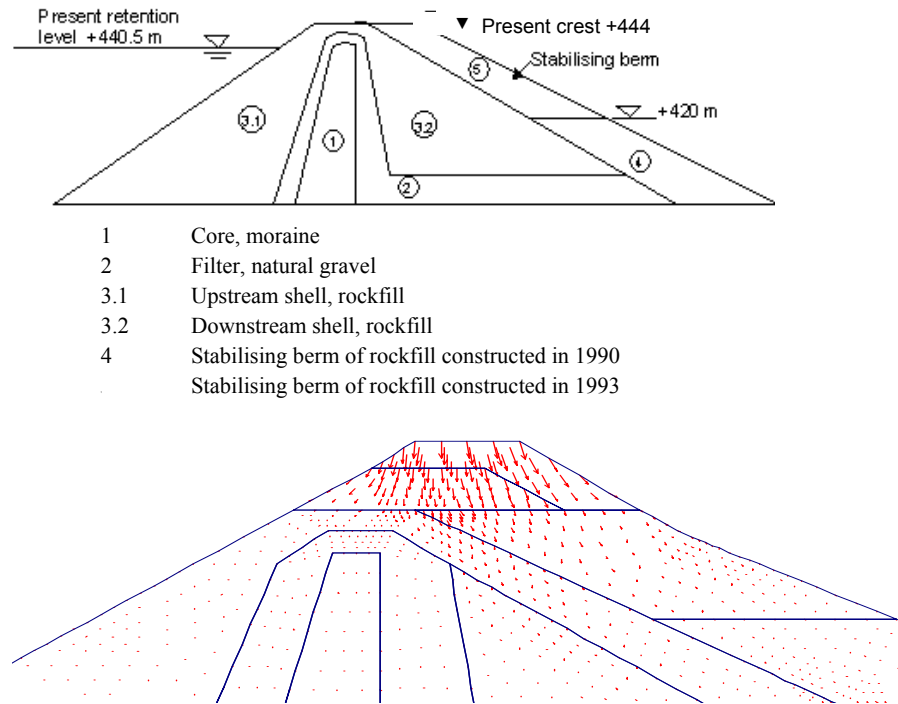
Figure 4. Calculated displacements using the PLAXIS program [ref.1].

It has been possible to calibrate reasonably well the deformations that have been recorded while the two supporting berms were placed in 1990 and 1993 with the deformation calculation program PLAXIS. Thereafter the displacement for the raising of the crest from +444 m to +446 together with a 4.8 m higher water level during a design flood was calculated as shown in Figure 4. The sealing element in the crest is not modelled and thus not shown in the figure.

The horizontal deformation in the top of the existing left embankment dam core is expected to be minor, in the order of 5 mm, while the vertical displacement in the dam crest is expected to be in the order of 100 – 120 mm. The largest vertical displacements are however expected to occur in the downstream supporting fill. In case of the design flood occurring an additional horizontal displacement of some 130 mm is expected, taking a new suggested crest elevation of +447 into account. The notable displacement will according to the calculations take place outside the moraine core, see Figure 4, which is important since the ongoing horizontal displacement could otherwise cause transversal cracks in the moraine core.

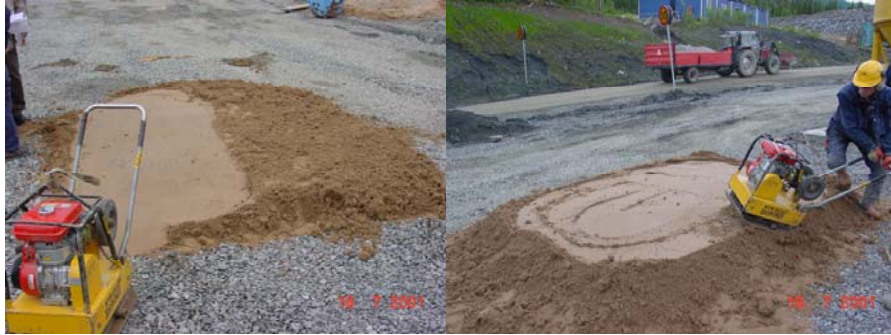
Figure 6. Field trials with BES. At left the trial surface is compacted in layers of 0.1 m and to the right the material is compacted in two layers of each 0.3 m at water content of 15 %.

The BES was tested to determine the optimum density, moisture content and bentonite content in order to achieve the required permeability. Pre-testing of the BES was performed using the following methods: wet screening; sedimentation analysis of material < 0,075 mm; and determination of the hydraulic conductivity at 95 % of Standard Proctor density. The mix was then tested in field trials seen in Figure 6.

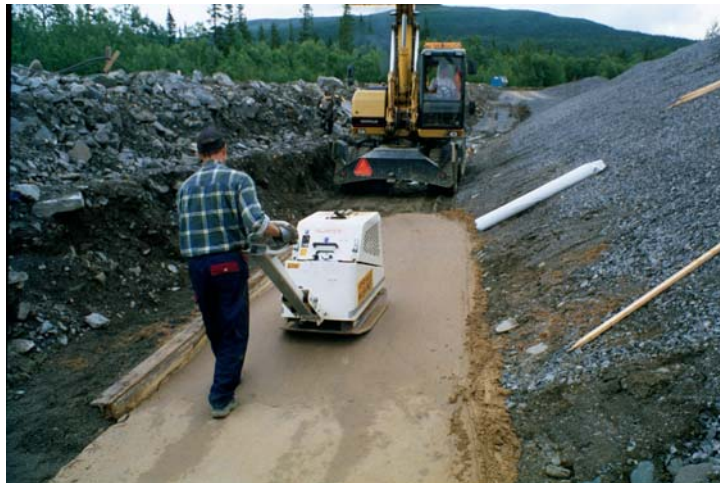
Figure 7. Compaction of the BES bedding layer for the membrane on the existing moraine core. To the right is the compacted coarse filter bedding for the geotextile.

The stripped existing core was compacted and then lightly scarified and sprayed with water immediately before placing the BES. A layer of BES was then placed as bedding for the membrane on the excavated core surface, Figure 7. The BES surface was protected against rain and drying using plastic covers while the geotextile was placed on the coarse filter, see Figure 8.

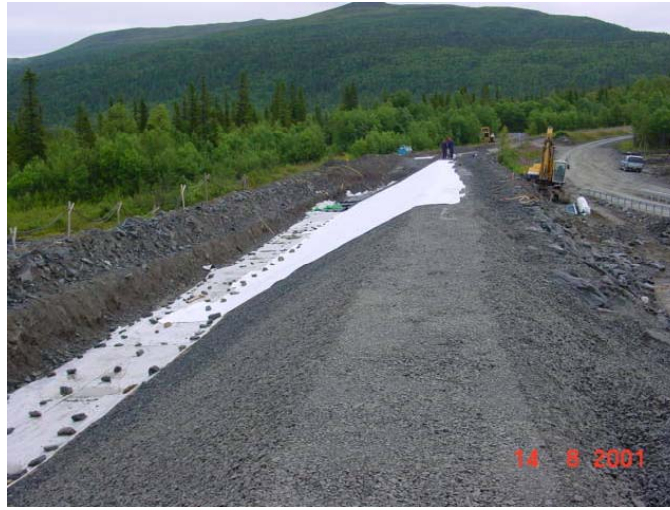
Figure 8. Placing of geotextile on the compacted coarse filter bedding. The textile is temporarily held in place by rocks.

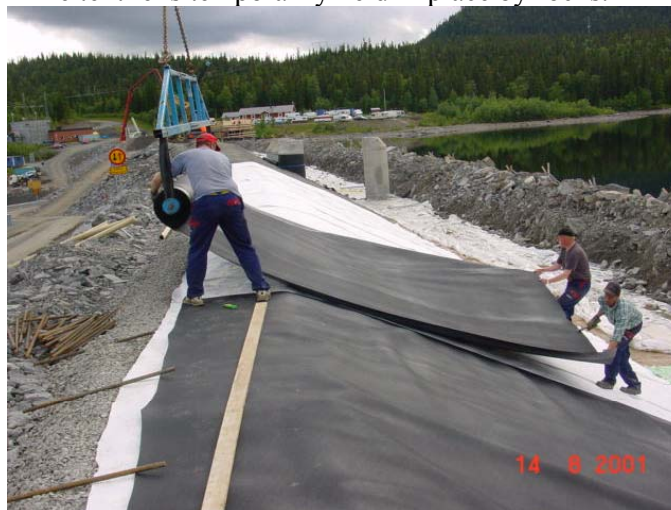
Figure 9. Placing of membrane on the geotextile. The BES (to the right in the picture) is temporarily covered by plastic to protect the core against the heavy rainfalls that occurred during construction.

The next step in the construction sequence was to place and weld the membrane on the slope directly on the geotextile, see Figure 9. As the membrane was placed at an inclination of 1V:2H a temporary anchoring was required at the top of the membrane. This was carried out by nailing the membrane in its upper end with 1 m long, \varnothing 20 mm, reinforcement bars. The load of the fill material on the top part of the membrane as described above achieved the permanent anchoring.

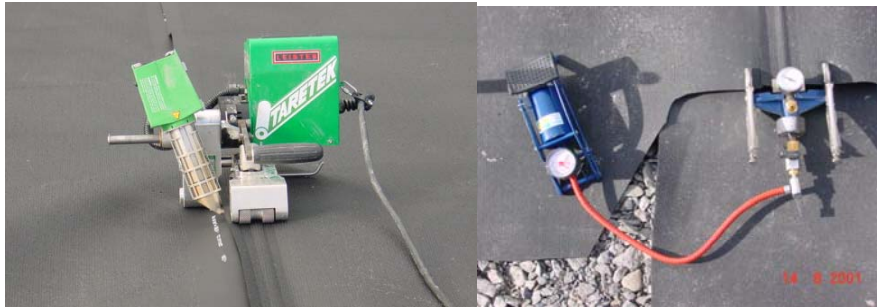
Figure 10. Membrane welding machine for double seams (left) and air pressure pump for air pressure tests of the membrane seams (right)

Welding was done with double seams in order to be able to test each seam for water tightness, see Figure 10. The seams are required to have at least 75 % of the geomembrane strength at stress at break yield point. In addition to this destructive testing was carried out on a selected part of each gore of the membrane. These parts were tested for peeling and shear resistance.

A non-destructive air pressure test at a minimum pressure of 200 kPa (2 kg/cm^2) was carried out along the entire lengths of all field seams including patches and repairs, see Figure 10. The requirement was that following initial pressure stabilization the pressure should not drop by more than 10 % in 5 minutes.

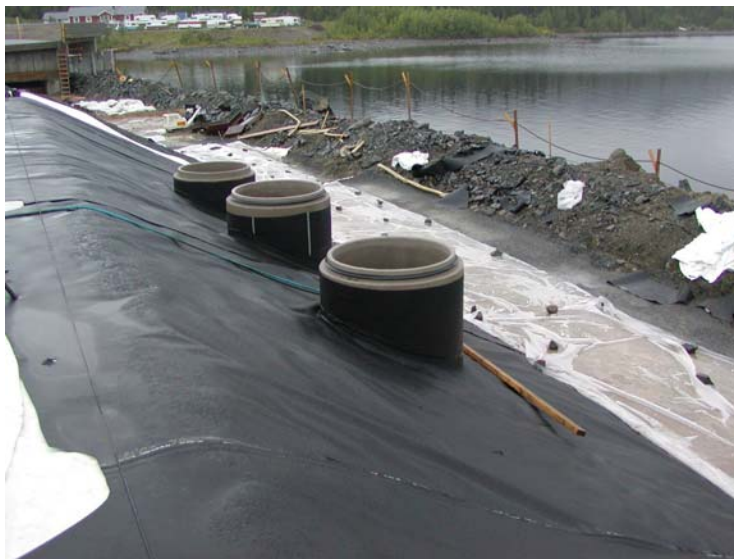
Figure 11. Protected connections through the membrane for instrumentation in the downstream filter.
