Remedial drainage to Laggan and Blackwater gravity dams

SYNOPSIS. Alcan's 48m high Laggan Dam and 26m high Blackwater Dam have both been reassessed for extreme floods and seismic loading, and stability at both was found to fall short of modern guidelines. In the case of Laggan Dam the critical load case was the PMF, which would overtop the substantial masonry walls of the spillway bridge. Blackwater Dam stability was found to be marginal under normal conditions and unsatisfactory under both extreme load cases because of its slender section and serious doubts that it could carry tensile stresses, particularly at the foundation contact. An assessment of alternatives found that remedial drainage provided the cheapest satisfactory solution at both dams. At Laggan Dam this involved drilling from the dam crest to intersect the gallery and from the gallery into the foundation. At Blackwater Dam, which has no gallery, the solution involves inclined holes from the downstream face to intersect the dam/foundation interface.

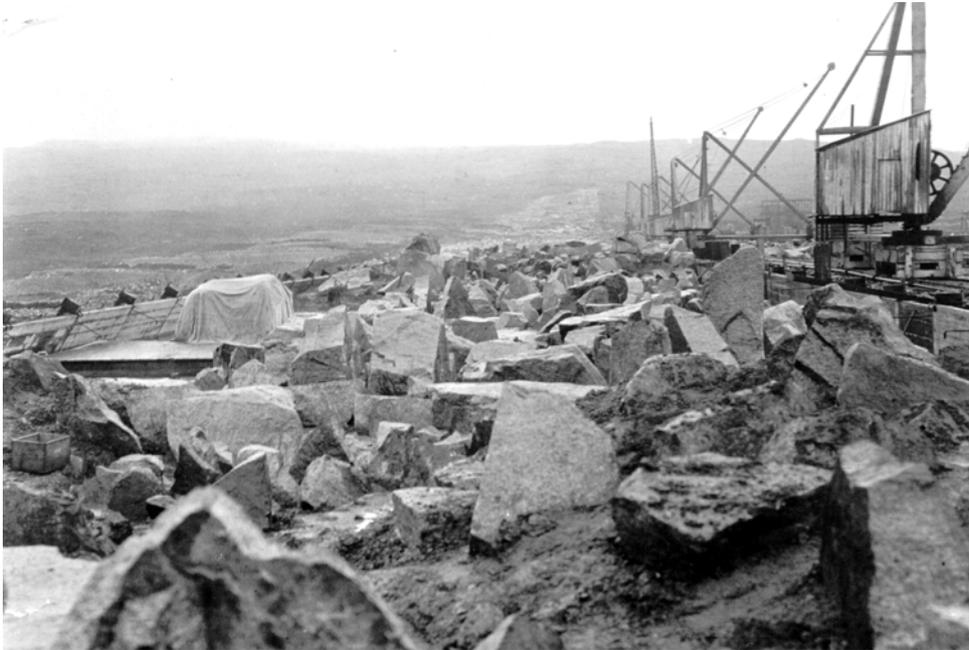
Figure 2 Displacer blocks on lift joints at Blackwater Dam

The hearting of the dam was constructed incorporating large granite displacer blocks, weighing up to 10 tons. The extent of these is clear from the construction photographs [Figure 2]. Particular care was taken to include these across lift joints, and they have a significant influence on the tensile strength at the dam body. Inspection of the joints at the upstream and downstream faces, however, suggested that the concrete material in the joints is significantly weaker than the rest of the dam concrete [Figure 3].

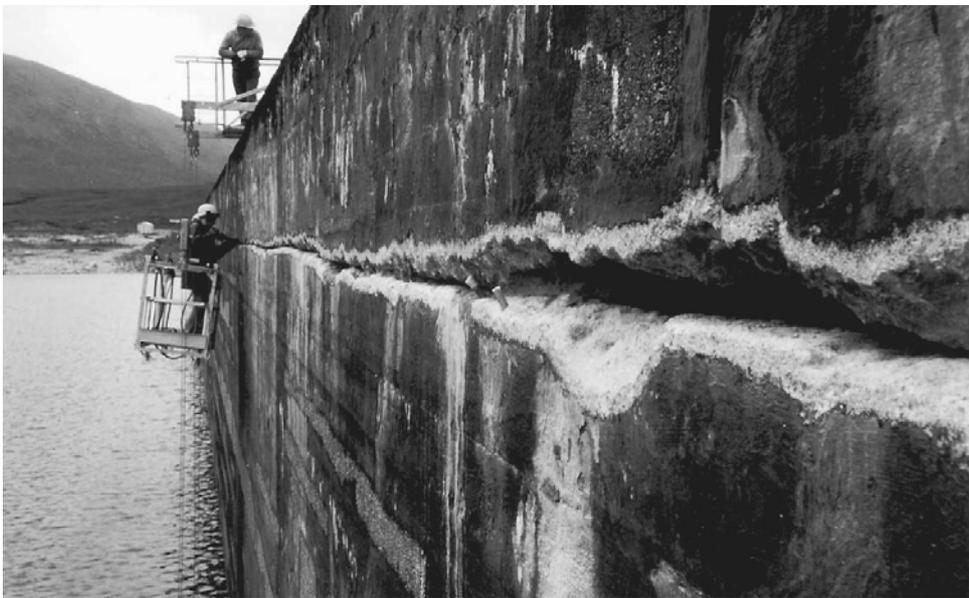
Figure 3 Raked-out joint in upstream face at Blackwater Dam

1998 and was completed in October 1998. The factual report covering the drilling and testing was submitted in December 1998 [12]. Few of the lift joints were recovered intact and significant areas of honeycombing and poor joint bonding were found in the cores.

A further Stability Review [13] taking the collected data into account, concluded that, while concrete tensile strength could not be expected at lift joints, the rock displacers provided an acceptable degree of tensile strength across lift joints in the dam body. However unacceptable cracking could still occur at the dam foundation/rock interface. The cheapest option to remedy this was found to involve drilling inclined holes from the downstream face to intersect the foundation contact and so relieve uplift pressures.

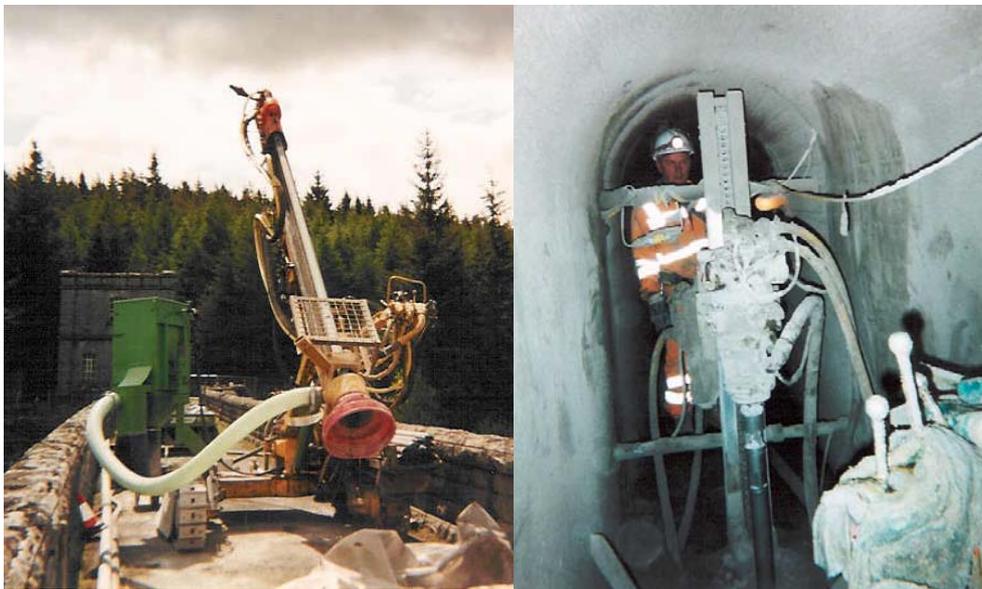
Figure 4 Drilling equipment at Laggan Dam crest and gallery

All holes were drilled using down the hole percussive hammer techniques. A crawler mounted rig was used for vertical and inclined holes on the dam crest roadway. The contractor elected to drill at 95mm diameter in order to reduce drill string deflection with the top 3metres of each hole being cored and cased to aid directional control through the rubble filled piers and the “air gap” between the underside of the roadway bridge and the curved spillway below. The drilling system drilled well through light reinforcement and rock displacers in the concrete. At the final count only three out of 30 holes drilled from the dam crest just missed the gallery, this was likely caused by the drill head “glancing off” embedded steelwork. However all three were later located using a vibrating tool and intersected from the gallery. A special drill rig was fabricated to work in the confines of the gallery and used successfully to drill 50mm diameter holes inclined and vertically upwards and downwards. However progress was slow and a rock drill with an air leg was used to increase production rates on some of the shorter inclined holes.
