Masjed-e-Soleiman Dam instrumentation

PAUL J WILLIAMS, Halcrow Group Limited

SYNOPSIS. The 187m high Masjed-e-Soleiman clay core rockfill dam forms part of a 1,000MW hydropower scheme. The dam was constructed between 1996 and 2001 and impounding commenced in late 2000. The instrumentation installed at the dam was designed to meet international guidelines for the primary purposes of monitoring construction, impounding and long term performance. The instrumentation comprises earth pressure cells, extensimeters, piezometers, groundwater observation holes, survey monuments and seismic monitors. In the event a significant proportion of the buried instrumentation failed during construction. A study was undertaken to review the performance of the instrumentation, evaluate available monitoring data and develop the criteria for control of the impounding.

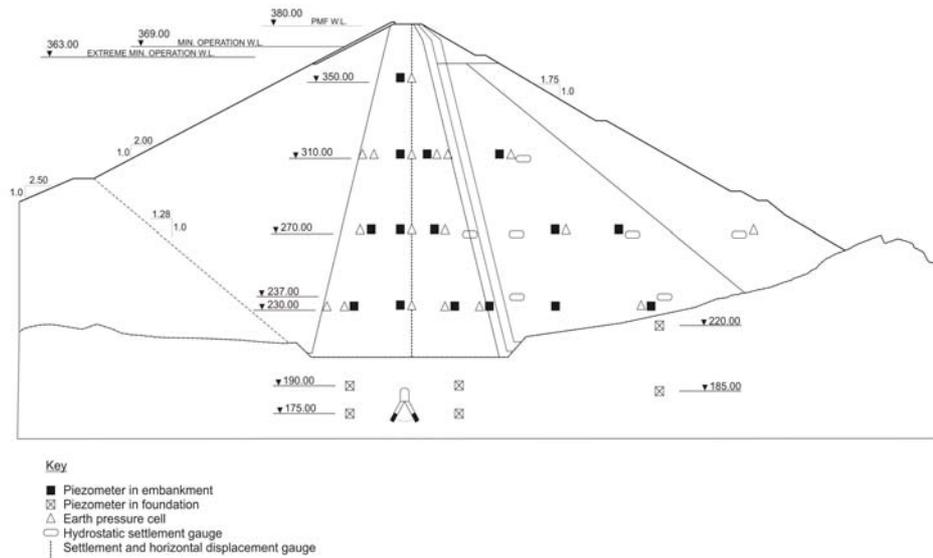
Figure 2: Typical Instrumentation Arrangement at Masjed-e-Soleiman

The dam comprises a rockfill embankment with clay core and upstream and downstream filters. The upstream slope of the dam is at 1^V to 2^H and incorporates a rockfill cofferdam with upstream clay membrane at its toe. The overall downstream slope is at 1^V to 1.8^H and incorporates an access roadway for construction. The clay core of the dam has a minimum width at the crest of 10m increasing in width by 0.4m for every 1m below crest elevation. Each of the filters has a nominal width of 5m. A typical section through the dam is shown in Figure 2.

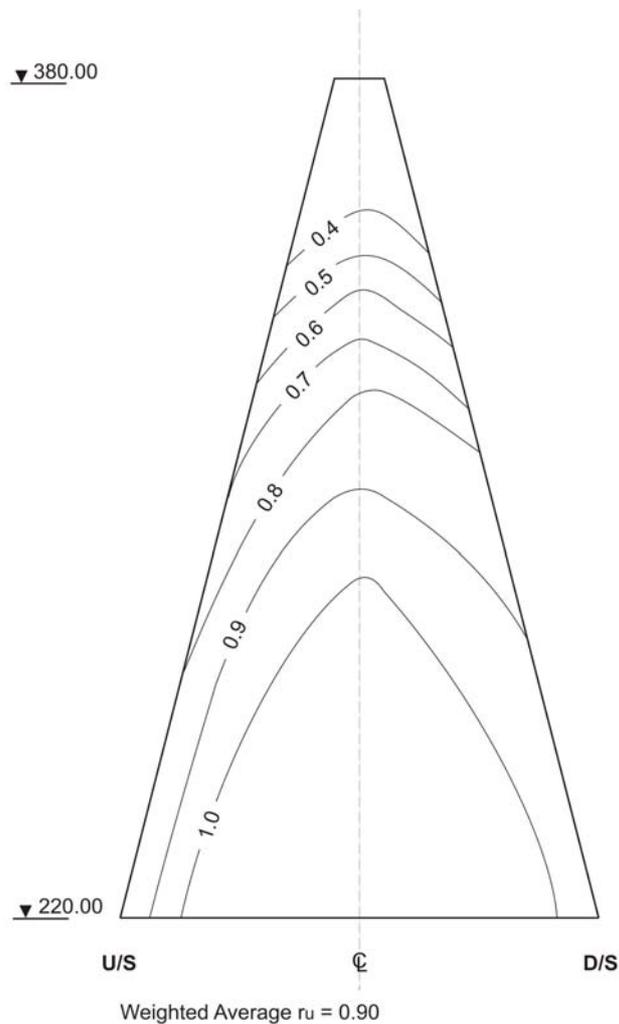
Figure 3: r_u values for the dam core at completion of construction

Before impounding could proceed it was necessary to demonstrate that the embankment section was stable and that there would be no safety problems associated with the excess pore water pressures that were being experienced. On completion of the embankment construction it was found that pore water pressures in the core were particularly high and that even at the lower elevations there had been very little dissipation of pressure. This meant that with low effective stresses the shear strength of the clay core was also reduced. Figure 3 shows the recorded pore pressure ratio r_u values on the highest section of the dam at the end of construction in 2000, despite the fact that construction at the foundation level had commenced in 1997. It was

estimated that it would take a further 1-2 years for the pore pressures to dissipate significantly.

Of particular concern was the stability of the upstream face of the embankment for the condition of embankment at full height and also for initial impoundment. The slope stability issue was exacerbated by a layer of alluvium under the cofferdam forming the upstream toe, which had a potentially lower angle of shearing resistance. This layer had a thickness of

up to 8m and had not been stripped from the foundation when the cofferdam was constructed. The uncompacted toe layer when coupled with the high r_u values in the core meant that it was possible to generate a non-circular slip failure surface through the core and upstream toe foundation, which was barely above unity for the condition of unregulated impounding. A separate study showed that provided the impounding rate was controlled to allow pore pressure dissipation in the core then the short-term factor of safety for impounding could be maintained above 1.3.

The need to make a controlled impounding became more pronounced shortly after embankment construction was completed as the single operable diversion tunnel suffered major damage to the concrete lining when the other diversion tunnel was taken out of service for conversion to a bottom outlet. The situation that developed meant that unless the remaining diversion tunnel could be closed to allow repairs the tunnel would erode further and lead to collapse. It was against this scenario that a balanced impounding procedure was developed. The impounding procedure allowed for initial impounding to EL 303m whilst the bottom outlet was brought into service and then for the water level to be held at this level using the bottom outlet, with its inlet sill at EL 300m, for a period of 3 months to allow the embankment pore pressures to continue to dissipate before filling continued to spillway sill level at EL 350m at a target rate of 0.5m/day.

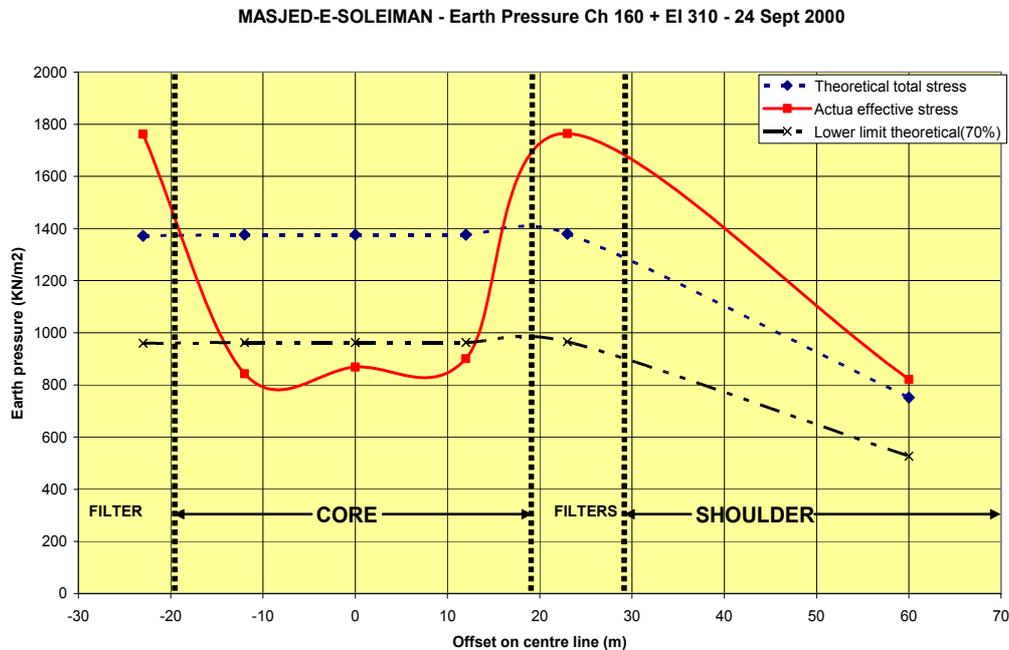
Figure 4: Distribution of effective stress across core and filters

The operational earth pressure cells show a pronounced variation in earth pressure across the core, filters and downstream fill at a number of sections. A typical effective stress distribution has been presented in Figure 4 and represents a series of six working cells. Figure 4 compares the actual minimum effective stresses against the theoretical total stress, calculated as the overburden pressure, and a lower limit of 70% theoretical, which was set as the stable limit for impounding by the designers. This represents a section towards the highest part of the dam at EL 310m some 70m below crest level and is at the time of completion of the embankment filling. Figure 4 clearly shows that the minimum effective stress in the core was considerably less than that in the filters and the shoulders. It was apparent that with effective stresses in the core of only 60% of theoretical overburden stress the core

was effectively hanging up on the shoulders which themselves were being crushed with stresses up to 130% of theoretical.

The principal concern with the clay core was that on impounding the hydrostatic pressure of the water in the upstream shoulder would exceed the effective stress in the core material leading to potential fracture. For this reason it was decided to regulate the impounding to ensure that the hydrostatic pressures from the rising water level were not allowed to exceed 80% of the actual recorded minimum effective stress at that level in the core. To achieve this it was necessary to monitor increases in water level and the actual earth pressures as consolidation and pore water pressure dissipation in the core continued. Although it was recognized that the filters may have crushed in the zone against the core it was considered that they would continue to function as an effective filter in the event of leakage through the core.

The analysis showed that the pore pressures within the core were just within acceptable limits but were dissipating far slower than had originally been envisaged. Because of the possible risk of arching and hydro-fracture of the clay core it was concluded that the impounding of the reservoir should only be made under strictly controlled conditions to prevent excess hydrostatic pressures in the upstream shoulder. The impounding was staged to allow dissipation of pore pressures in the core to ensure that at no stage would the hydrostatic pressure in the upstream shoulder exceed the minimum effective stress in the core.
