Lightweight fill in dam remediation - a case study

K. M. H. BARR, W. A. Fairhurst & Partners, Glasgow, UK

SYNOPSIS. The east dam at Millbuies Loch was reconstructed following observations of crest settlement. Investigations found the embankment was founded on a layer of peat. It was concluded that there was significant potential for further settlement of the peat foundation if additional soil were added to make up the freeboard. The embankment was reconstructed using a combination of existing fill and new expanded polystyrene lightweight block fill.

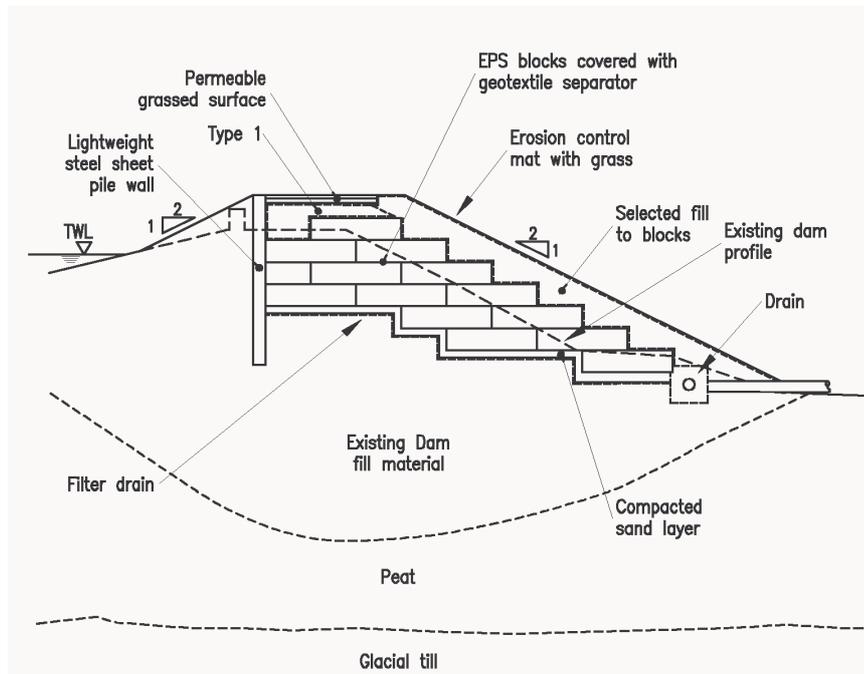
Fig. 2. Typical cross-section

It was found that the east dam is founded on a layer of peat. The boreholes in the centre section of the east dam showed over 5m of sandy gravelly clay dam fill material overlying 1.5m of soft fibrous peat. Below the peat there are glacial tills. In the wetland area downstream of the dam about 3-4m depth of peat was found.

It appears that the east dam was constructed by spreading dam fill material on top of an area similar to the wetland downstream of the dam. The peat foundation would have been compressed as the fill material was placed until an approximate equilibrium was reached when the weight of the fill material matched the bearing capacity of the peat layer. Settlement is likely to have continued over the life of the embankment. By 1989 the freeboard was inadequate and it was restored by making up the dam crest with fill material. Crest levels may have been made up on previous occasions although no record of this is available. The existence of the peat layer in the foundation was not known in 1989. Although a ground investigation was carried out, it was limited to relatively shallow trial pits because of the difficulty of access for drilling rigs and consequent cost.

Standard profiles of the block fill were derived for different dam cross-sections. These provided sufficient lightweight fill to eliminate additional loading in each part of the crest and downstream slope. EPS blocks are water resistant, but water from the reservoir could escape through the joints between the blocks so it was decided that a new low permeability element was required in the dam cross-section upstream of the blocks. The chosen design was a self-setting bentonite/cement slurry wall in a trench excavated in the existing dam crest following demolition of the existing wave wall.

To prevent uplift pressures on the base of the EPS blocks, they were constructed on a drainage layer. A filter drain and sand layer was placed before the blocks were installed. The blocks were then carefully backfilling using excavated fill material.

The downstream face of the dam was protected with an erosion control mat to prevent erosion if any occasional over-topping should occur. A perforated pipe drainage system was included to drain the filter drain under the EPS blocks.

on a midi-excavator. It was considered this alternative offered advantages over the original design so the contract was amended accordingly. Mabey M11 interlocking lightweight steel sheet piling was used. The final design cross-section was as shown on Figure 2.
