Leakage investigations at Lower Carno dam

A. ROWLAND, Black & Veatch, Redhill, UK

A. POWELL, Black & Veatch, Haywards Heath, UK

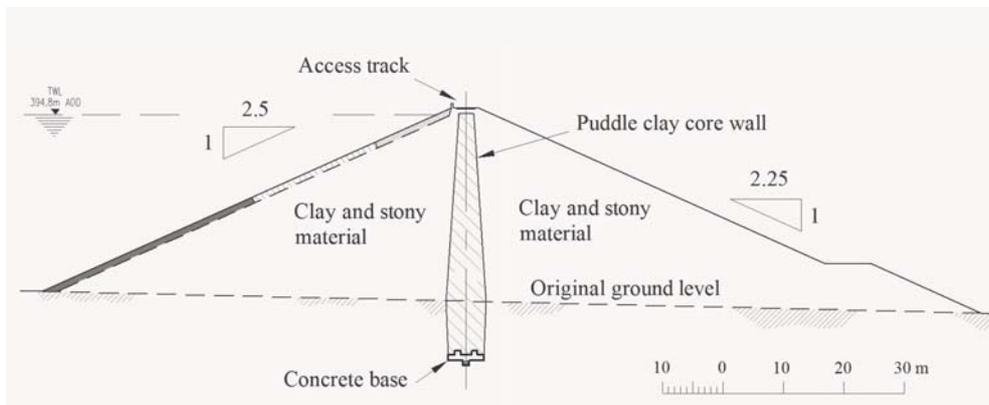
Figure 1. Typical cross section of Lower Carno Dam

The puddle clay core is supported by shoulders of clay and stony material. The shoulder fill is of variable composition. Generally it is a heterogeneous firm sandy gravelly clay and mudstone/siltstone gravel with some cobbles. Zones of stonier material adjacent to the core are thought to be present.

There are no drainage blankets or filter zones in the dam but the River Ebbw was filled with a stone product along its course under the embankment.

The clay core is extended down into the foundation as a cut-off trench which has a concrete key at the base. The trench cut-off extends 78 m into the right abutment and 43 m into the left abutment.

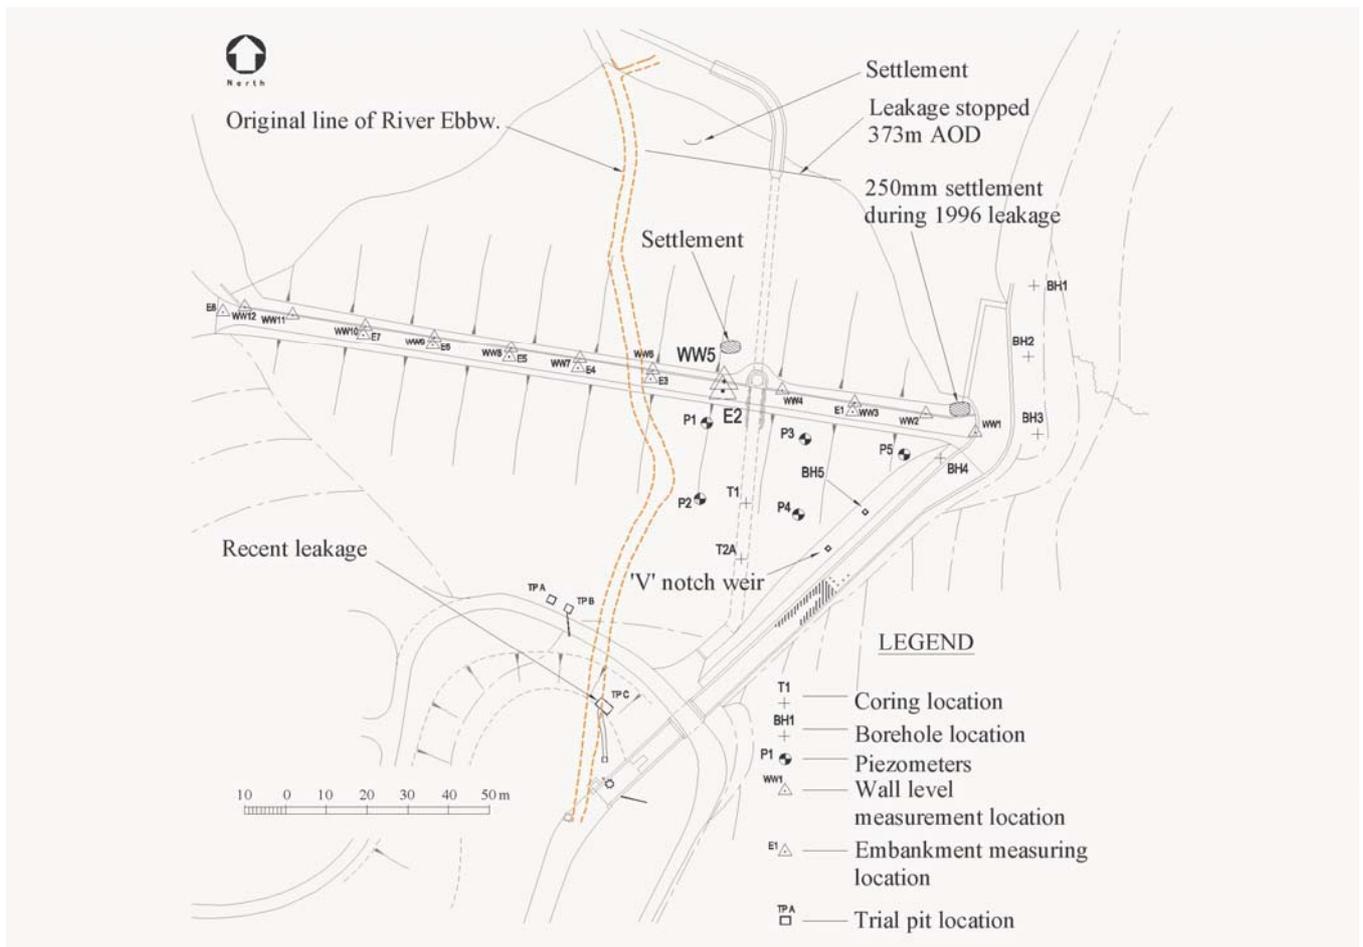
Figure 2. General arrangement of Lower Carno Dam

The locations of all instrumentation on the dam are shown on Figure 2. These installations include 24 standpipe piezometers, toe drain flow measurement, 12 wave wall settlement measurement points, 8 crest settlement points and reservoir level measurement.

During the week ending 6th February 2005, two drains (one being the discharge from the 1996 installed V-notch and the other being an unidentified drain leading towards the right abutment) had lifted to the west of the stilling basin. Flows were seen discharging from this area (marked on Figure 2) over the ground and into the stilling basin. The previous inspecting, engineer was informed and, on a site visit on 8th February, instructed that the unidentified drain should be traced back towards the reservoir.

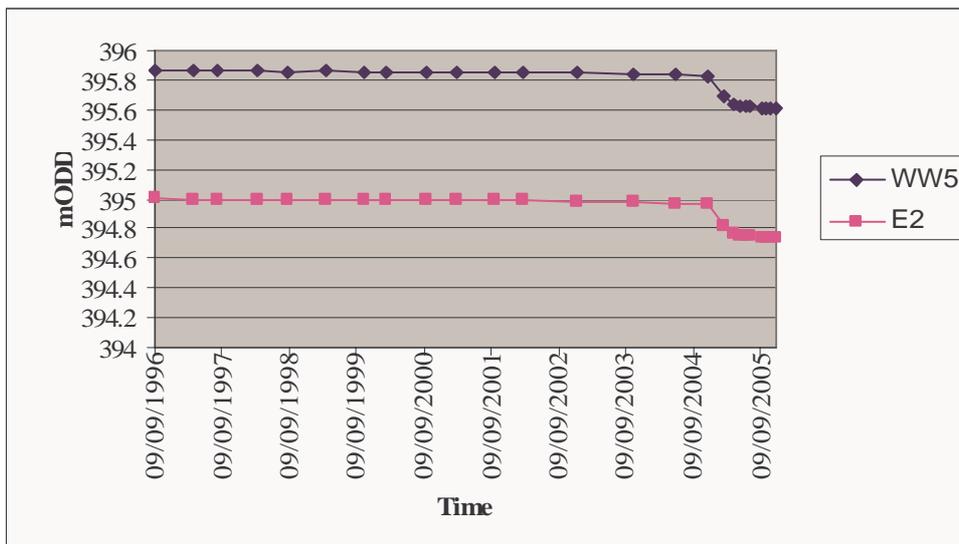
Figure 3. Settlement measuring points E2 and WW5 1996 to 2005

There was no visible crest settlement prior to drawing down the reservoir. Settlement occurred suddenly and quickly during the course of emptying the reservoir but this settlement is not associated with a rapid drawdown failure. The most recent settlement measurements indicate that the dam has settled by about 250 mm since 1990 at monitoring points E2 and WW5, as shown on Figure 3. Increased settlement is noted along nearly the whole length of the dam and is significant over a length of 70 m. The width of the settlement trough is as would be expected for ground loss at the depth of the culvert or base of the cut-off trench.

The crest pin monitoring records show that, during the period 1990 to 1996, crest pin E2 and wave wall pin WW5, both close to the line of the draw-off culvert, settled at an average rate of 5.3 mm and 5.8 mm a year respectively. Between 1996 and 2002, the average rates of settlement reduced to 3.1 mm and 2.4 mm a year. Inspection of the plots of crest level against time show that the readings taken in December 2002 suggest an increase in the rate of settlement. Subsequent readings show this trend continuing and the average rates of settlement between February 2002 and November 2004 were 6.2 mm and 8.0 mm a year for the crest and the wave wall. These represent a slight increase over the long term average. Adjacent pins show a similar pattern of settlement. The amount of annual reservoir draw down has not changed significantly and it is possible that this small change in settlement rate was an early indication of the leakage problem.
