Ulley Reservoir and high velocity spillway flows

J L HINKS, Halcrow Group Limited
PJ MASON, Montgomery Watson Harza
JR CLAYDON, Independent Consultant

SYNOPSIS. In the small hours of Tuesday 26 June, 2007 Rotherham Metropolitan Borough Council requested the evacuation of areas downstream of Ulley Dam and the closure of the M1 motorway because of fears about the safety of the dam. The danger arose because of the failure of the masonry walls of one of the original spillways at the dam during a flood with a return period of about 200 years.

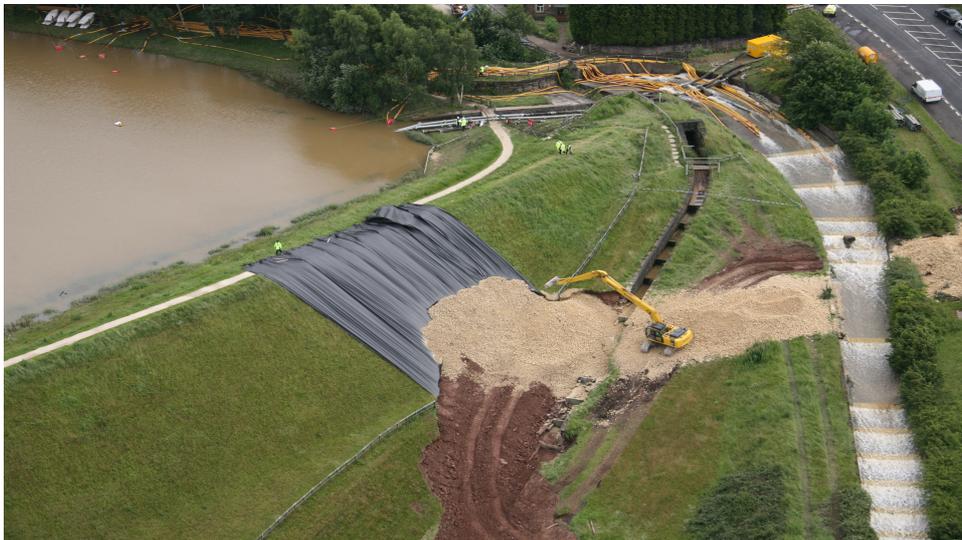
Figure 1 - Works in progress filling scour hole

Within a very short time of the incident being declared the erosion hole in the downstream shoulder of the dam was filled with stone and the old south spillway was closed off temporarily with a loaded skip. Subsequently it was permanently closed off with a concrete wall. Water level in the reservoir was lowered using temporary pumps.

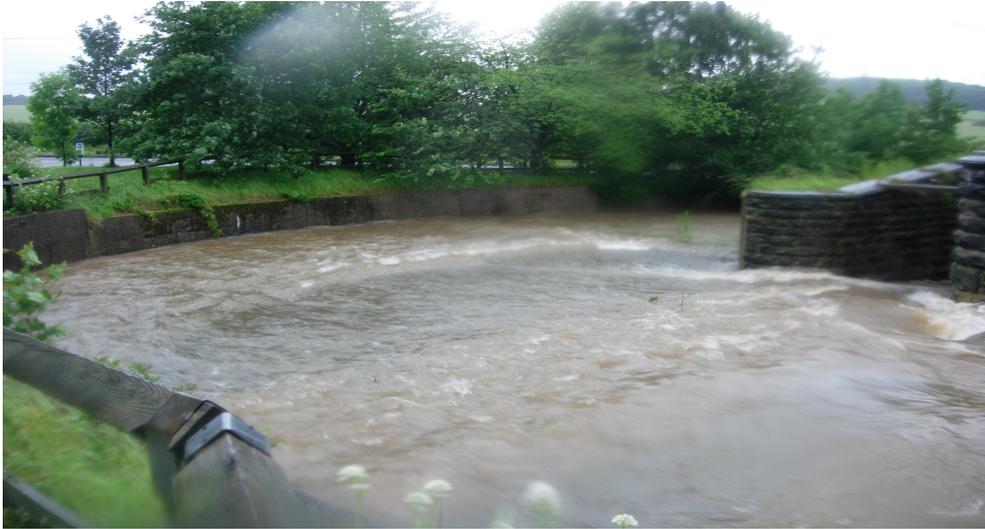
Figure 2 - Flow down 1943 spillway and original south spillway during the incident. Original south spillway is on extreme right of photograph.

The hydraulics at the south end of the dam are complicated with water entering two spillways at different levels, in one case round a sharp right-angled bend.

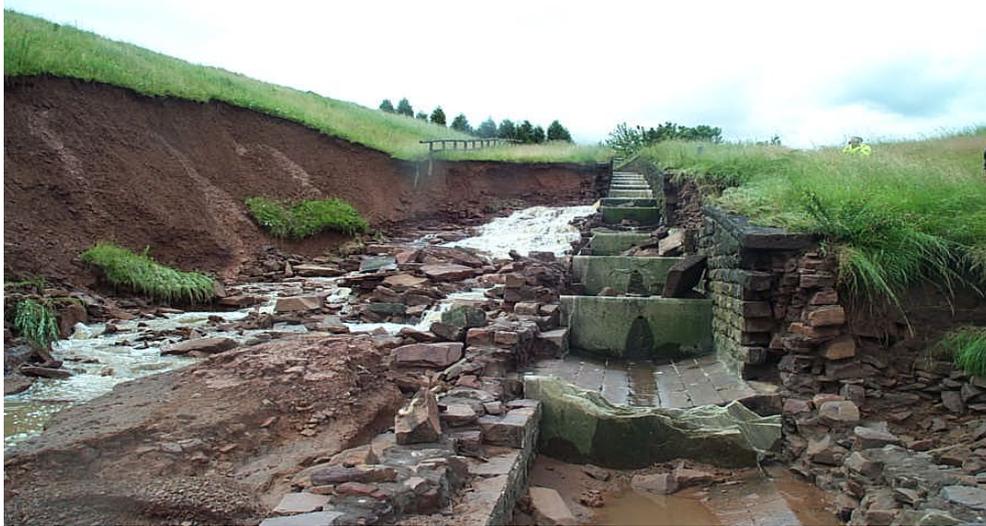
Figure 3 - Scour hole photographed on Tuesday 26 June, 2007

It would appear that the erosion of the downstream embankment shell was initiated by the collapse of the masonry chute running down the left mitre. Mechanisms proposed for this collapse have included:-

Had the chute been sited across natural ground any collapse and erosion of adjacent soil would simply have been a matter of rebuilding. The incident was compounded in this case by the chute being sited at the toe of the embankment. It is also clear from photographs taken at the time that debris from the initial collapse caused enhanced turbulence on the chute and deflected flows in such a way as to further enhance embankment erosion.

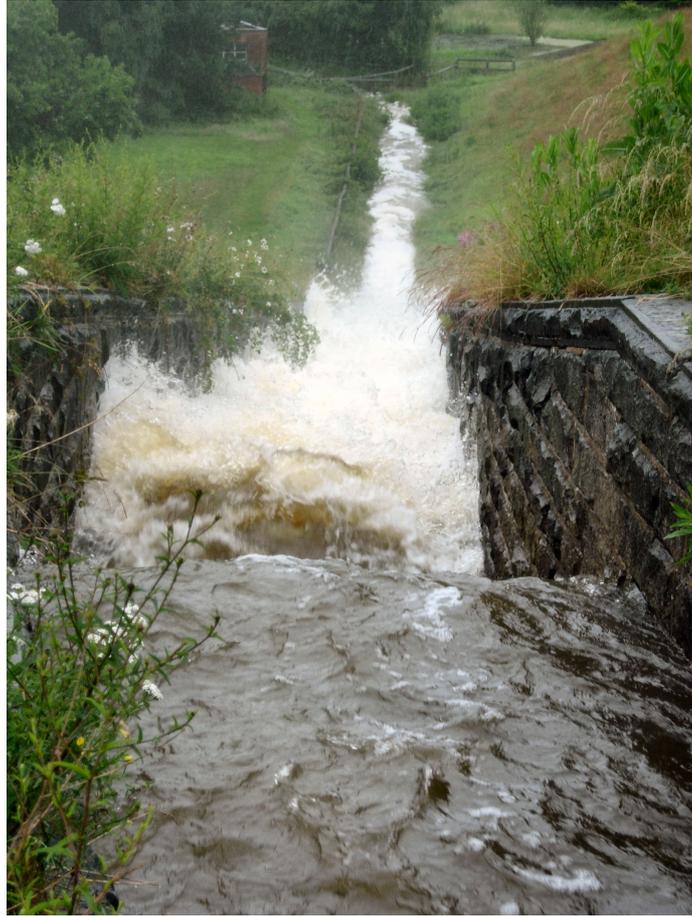
Figure 4 - Turbulent Flow in Spillway channel

The chute in question was not simply stepped but comprised a series of separate plunge basins formed by low walls across the chute at each step. Not only was the hydraulic action in these basins extremely turbulent, as evidenced by photographs, but there would have been a mix of turbulent high pressure and low pressure zones, the former caused by flow impact from the basin above.

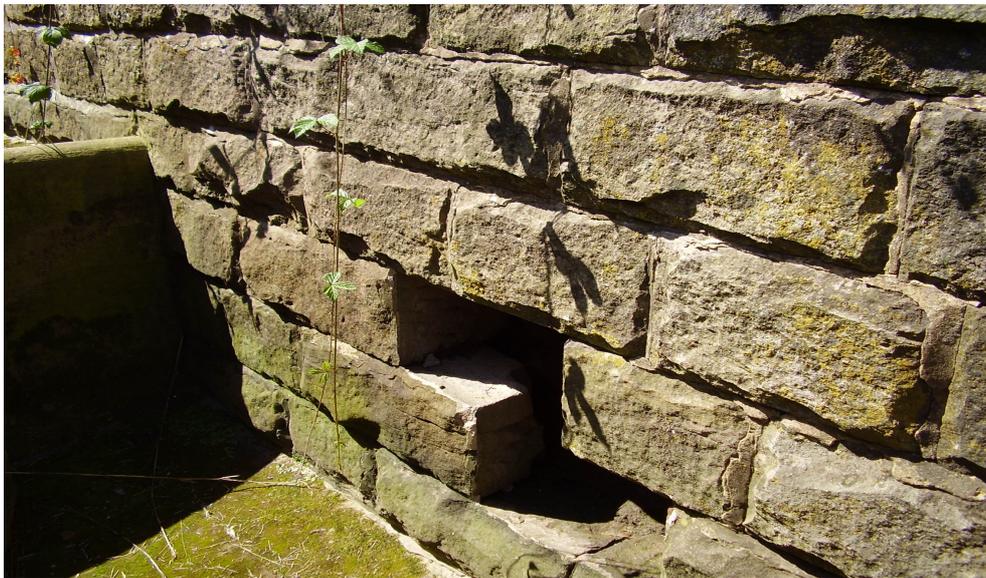
In conjunction with this the wall facing blocks were, in effect, open textured. That is to say although there were remnants of mortar pointing, the facing blocks did not seem well bedded in mortar. Furthermore these outer facing blocks were backed only by rubble mortar with no keying between the two parts. There would have been little to prevent individual

blocks being removed by pressures from high turbulent zones feeding as back-pressure behind facing blocks in lower pressure zones.

Figure 5 - Local hydrodynamic stone removal. Note also general condition of wall.

Calculations carried out since the incident suggest that ‘skimming flow’ would have set in and that the peak flow velocity probably exceeded 8 m/sec. The high velocities and turbulent nature of the flow in the channel would appear to have been quite sufficient to generate internal pressures within the masonry sufficient for stones to be extracted. Near the upper end of the chute a number of carefully shaped rectangular stones were seen to have been plucked out of the wall. This was probably by high water pressure behind the stones although suction from in front may also have played a part.

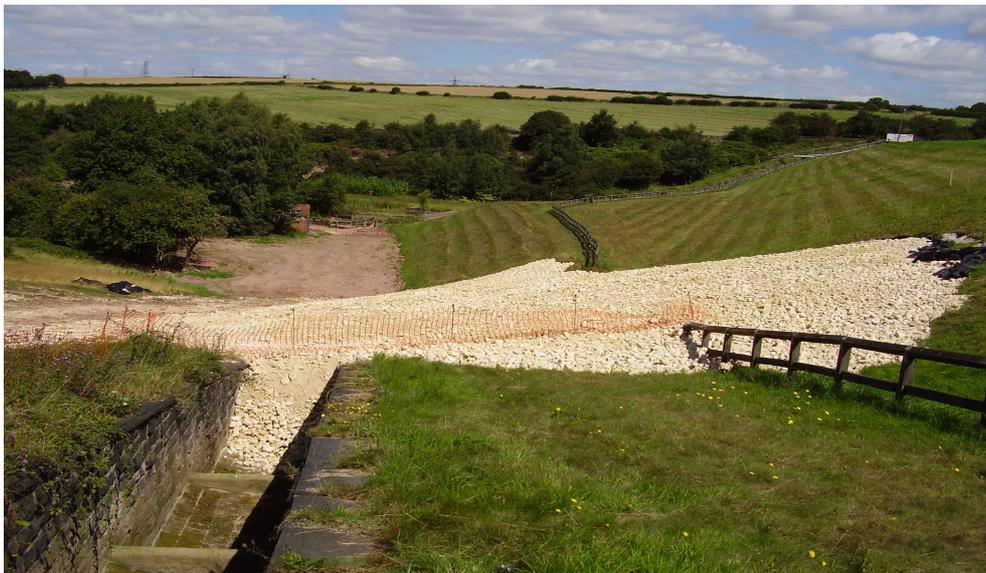
Figure 6 - Repaired scour hole after incident

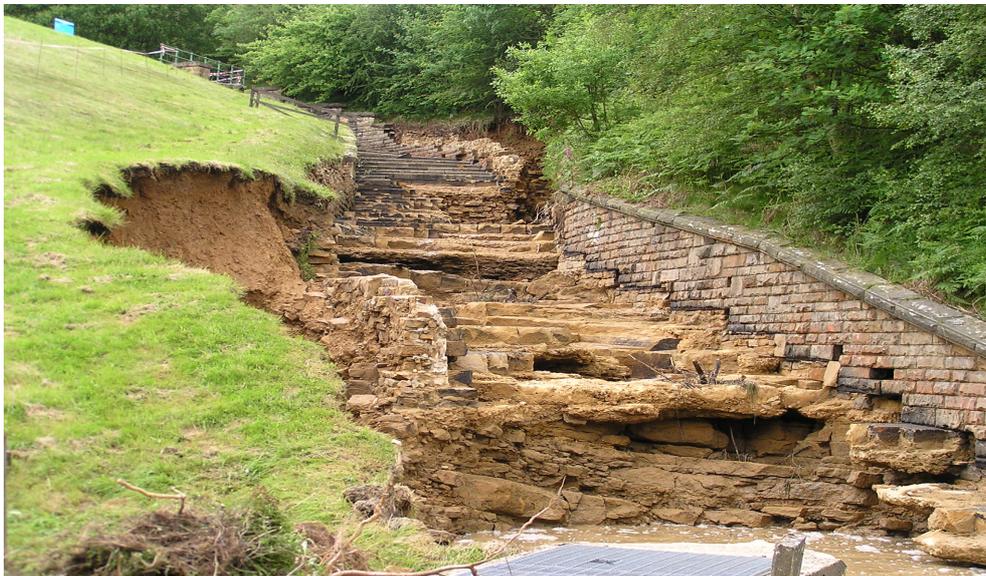
The incident at Boltby in June 2005 and the Ulley incident both point to a need for research into the hydraulic conditions that can be withstood by masonry walls of various types. Superficially the masonry walls beside the southern bywash spillway at Ulley appeared to be in reasonable condition. However, events showed that they were unable to withstand the hydraulic conditions to which they were exposed.

Figure 7 - Damaged spillway at Boltby in 2005
