## **Supervising Engineer's Account and Reflections on a Major Reservoir Safety Incident**

**SYNOPSIS.** This paper details the first response to an emergency incident that took place at Ulley Reservoir in June 2007, and provides a first hand account of the events that took place during the initial twelve hours and looks at the actions taken by the Undertaker, Rotherham Metropolitan Borough Council (RMBC), and the Supervising Engineer during that period. The paper also provides a commentary on the actions taken by the AR Panel Engineer, the emergency services and Undertaker's and contractor's staff in carrying out further emergency works to stabilise the dam during the following 48 hours. It provides a detailed account of an emergency plan being put into action and also how the emergency plan can be flexible enough to allow improvisation to deal with particular problems as they are identified. The paper concludes by providing a summary of the main lessons learnt during the emergency response and comments on general housekeeping matters such as the availability of reservoir records, communications and welfare facilities.

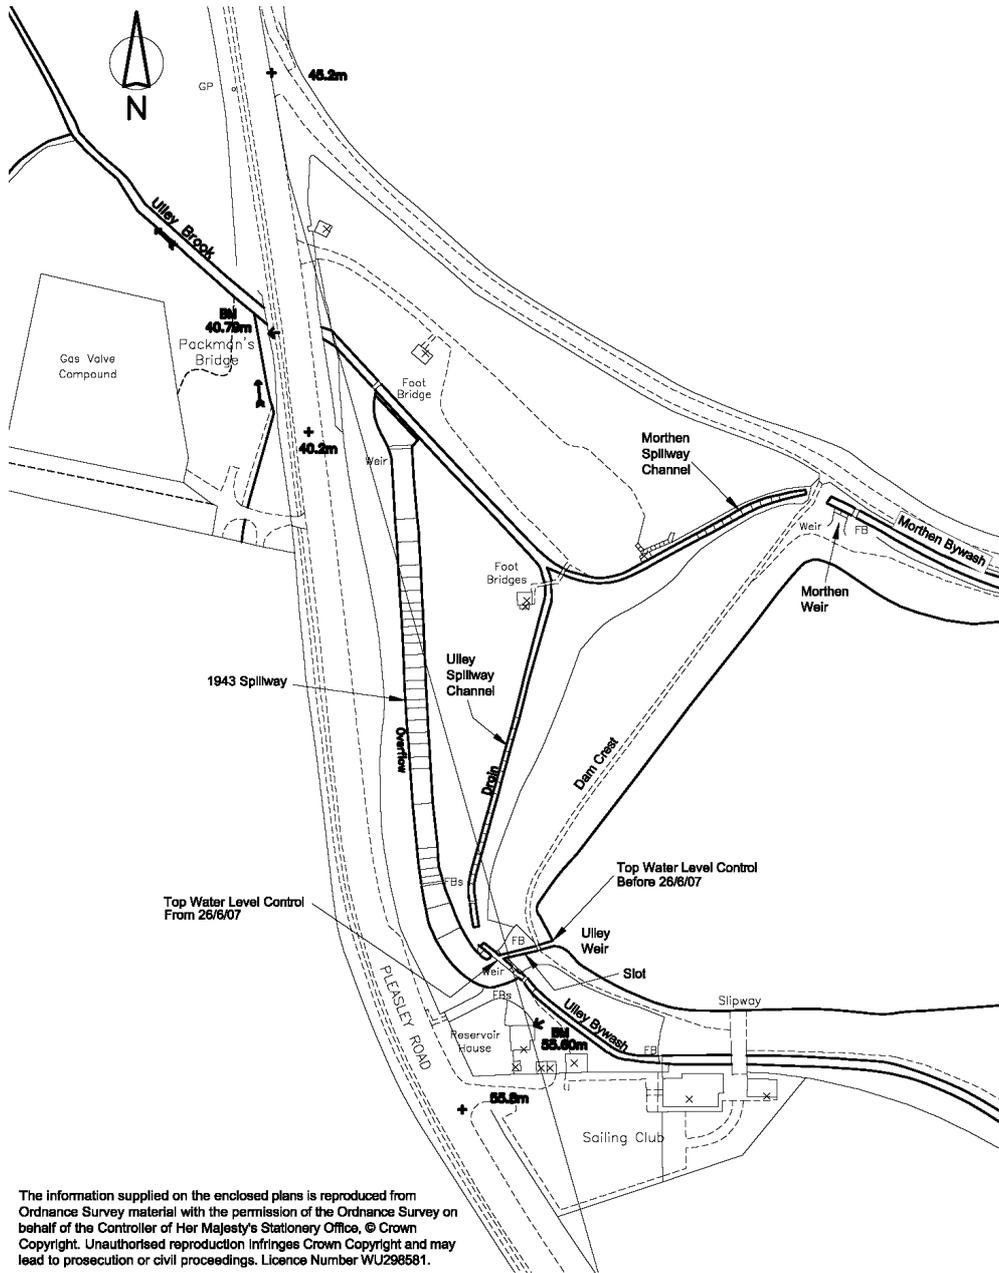
Figure 1 – Overflow Layout

The overflow arrangement is not straightforward. Each spillway at the reservoir has its own historical name and these are used in the description of the incident. The spillway names, locations and details are shown below in Figure 1 and Table 2.

Prior to the incident, the reservoir top water level was controlled by the Ulley spillway. When the reservoir level rose by 1.23m, then the 1943 spillway would come into operation. A further level rise of 0.58m would be required to bring the Morthen spillway into operation.

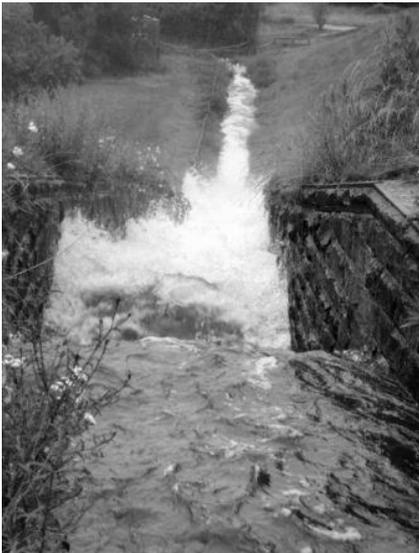
### **PHOTOGRAPH 1**

This is the last photograph of the Ulley spillway before its failure. As can be seen, there is considerable turbulence in the flow and it appears to be overtopping slightly at the bottom of the steep slope.

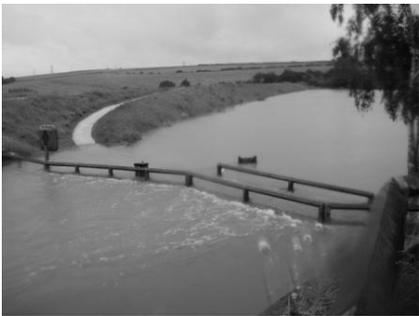
### **PHOTOGRAPH 2**

The water level has continued to rise. It is now above the lower rail on the footbridge.

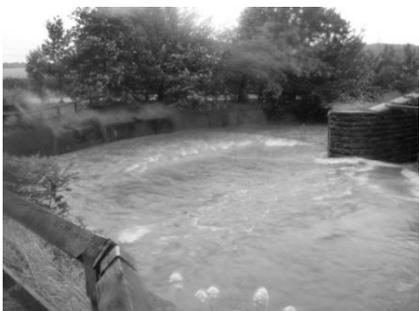
### **PHOTOGRAPH 3**

The flood is now passing down the 1943 spillway.

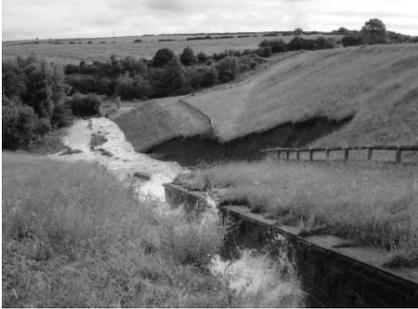
### **PHOTOGRAPH 4**

The immediate priority was to try and get a clearer idea of the amount of deterioration of the dam. RMBC were asked to obtain lights to allow a clearer view. Fairly rapidly, the Supervising Engineer realised the problem was surface erosion caused by the water flow down the Ulley spillway and a solution was to try to stop that flow. There was no mechanical means of closing the upstream end of the channel. The idea of sand bags was dismissed because they were too small and would be washed away. The next idea was to use intermediate bulk containers (IBC) filled with gravel. It was realised that to place the bags a crane would be required. RMBC, as part of the emergency plan, have arrangements to collect materials during out of hours for emergency purposes. 15 IBC's were obtained. A crane was obtained but due to the flooding in the middle of Rotherham took some time to arrive. The first attempt to place an IBC was unsuccessful; the flow of water caused it to virtually disintegrate. It was then realised that something more substantial was needed to block the channel. The answer was an 8T skip. RMBC obtained two of these as a resilience measure in case one failed, however only one was required. Once the skip was lowered into the channel, the flow was considerably reduced. The IBC's were then lowered into and packed around the skip. With this reduced flow, it became possible to look more closely at the damage to the embankment. At that time, the water was flowing over exposed rock foundation and no longer eroding the embankment material.

This shows the flow down the Ulley spillway and the water eroding the embankment.

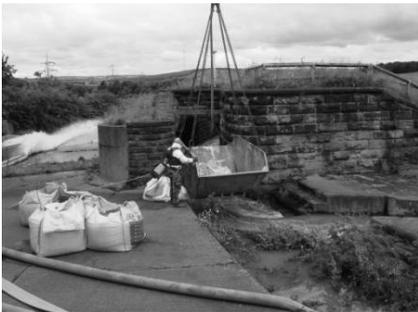
### **PHOTOGRAPH 5**

This shows the skip being placed to act as an improvised plug. The flow into the Ulley spillway can be seen below the skip.

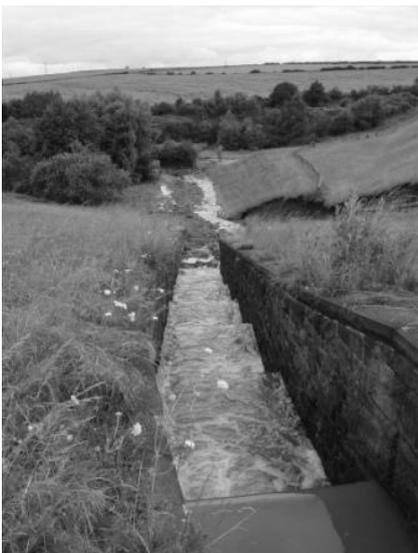
### **PHOTOGRAPH 6**

This shows how the plug had reduced the flow considerably so it was no longer eroding the embankment.

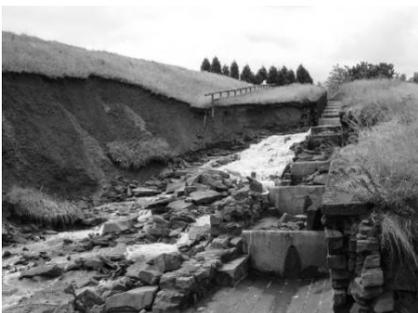
### **PHOTOGRAPH 7**

This shows the damage to the embankment and the spillway.

- Integrity of masonry spillway. The masonry appeared to be in good condition comprising ashlar masonry. In fact the units were tapered to give the appearance of ashlar and were only in contact at the exposed edges. Water was able to get behind the exposed face and there are a number of holes where individual stones have been pulled/pushed out of the wall. There is an implication for Supervising Engineers where the reservoir has another eight or so years to the next inspection whether intervention by an AR Panel Engineer is needed sooner or even a full Section 10 Inspection.

- Masonry lined channels. Where a channel is lined using masonry walls, what is the integrity of those walls if the water gets out of the channel? Will the walls collapse leading to further erosion or will they stay upright and limit any further erosion? The walls need to be able to act monolithically which means the different skins need to be tied together. Any voids need to be filled to stop water entering the masonry and pressurising the voids.

- Where there is an abrupt change in gradient from steep to slack, the spillway walls need to be high enough to contain the hydraulic jump and direct the water flow away from the embankment toe.
- The last two items in ‘things done differently’ also apply here as well.
