Bradford Area Reservoirs' Group - Flood Routing Remedial Works at Leeming, Doe Park and Hewenden Reservoirs

M.AIREY, Mott MacDonald Ltd, Cambridge, UK
G.CARRUTHERS, J N Bentley Ltd, Skipton, UK

SYNOPSIS. Following detailed flood study investigations and extensive physical model testing, it was demonstrated that the overflow works at three existing Yorkshire Water reservoirs situated to the west of Bradford were inadequate to handle the PMF design flood. A programme of design and construction of remedial works was therefore carried out to overcome the deficiencies.

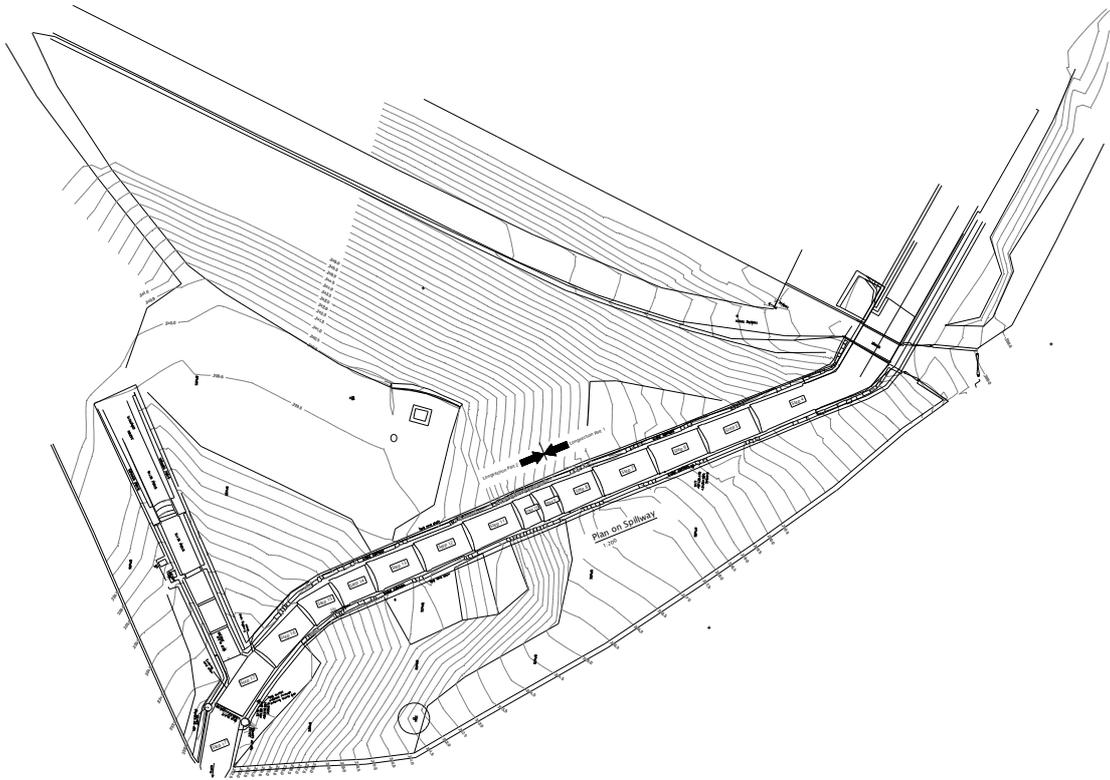
Figure 1: Leeming Reservoir Embankment and Spillway Arrangement

However, following the Boltby incident it was decided that in this case all of the flow should be contained and hence a new, larger, reinforced concrete channel was required. Given the nature of the existing spillway and its proximity to the embankment mitre, it was determined that the most practical solution was to construct a new enlarged reinforced concrete channel as a lining to the existing masonry chute.

- Deepening and widening of the tumble bay
- Enlargement of the spillway chute
- New access bridge across the spillway
- Reinforcement of the embankment wave wall

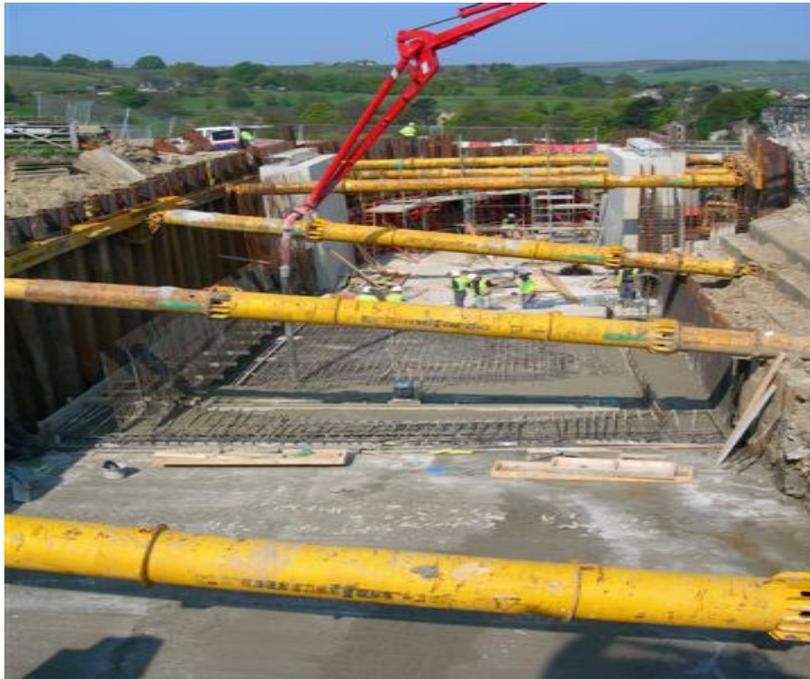
Figure 2: Tumble bay under construction

The modifications to the tumble bay were the most complex parts of the project in that the new works had to be incorporated within the existing structure. The excavation to deepen the tumble bay was about 8m deep, and Larssen LX16 piles 10m long were pre-driven and braces were installed prior to demolition and excavation of the existing arrangement. The bracing arrangement was complex as there was only one side of an excavation to push-off, so that raking props had to be used to provide the required thrust.

As part of the contingency plan all excavated surfaces were to be blinded with concrete at the end of every shift to provide some erosion protection should the reservoir have filled and overflowed. The tumble bay was constructed using reinforced concrete with a masonry clad face on exposed vertical surfaces. To increase the length of any potential leakage path a key was cast around the outside of the structure where it passed through the clay core. Upon completion of the new reinforced concrete works the majority of the sheet piles were removed. However, those which had been driven into the clay core were left in place and were cut down to crest level. The interface between the new structure and the piles was also a potential leakage path, and to overcome this problem a puddle clay plug was constructed between the key and the face of the sheet piles.

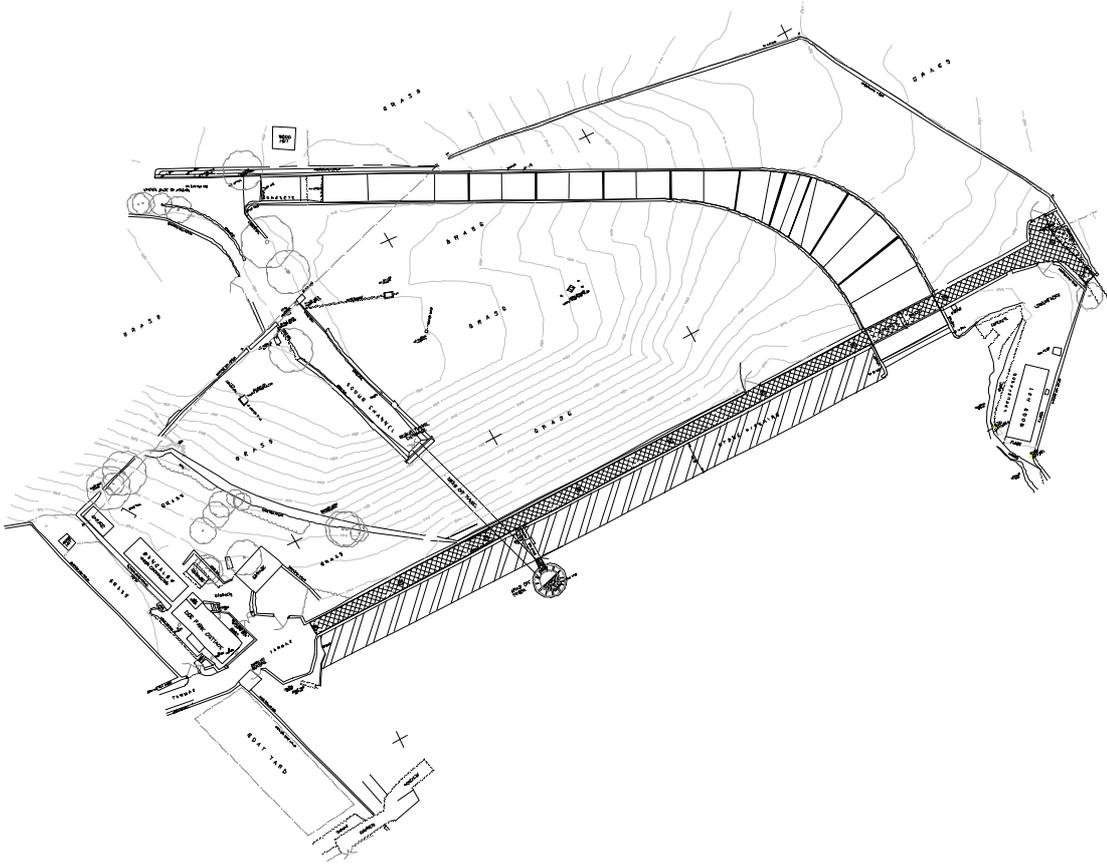
Figure 3: Doe Park Reservoir - General Arrangement

The flood study and subsequent testing of the spillway indicated that there was a significant shortfall in both embankment freeboard and spillway discharge capacity. Remedial works were essential to overcome these deficiencies and again it was determined that the outflow discharge (PMF) should be fully contained along the length of the spillway channel. In addition the existing wave wall along the crest of the embankment was in a poor state of repair and needed to be replaced.

- Increased wall heights for the spillway channel
- New wall to upstream side of crest to retain wave and flood rise
- New boundary wall to downstream side of crest
- New road bridge across the spillway
- Raising of the valve shaft to accommodate the predicted flood rise.

In the preferred solution the wave and crest retaining walls were re-built using pre-cast concrete wall units that were linked to the clay core using an in-situ cut-off trench. Essentially this widened the crest by 450mm as the reinforced concrete wall units were thinner than the existing wall units. The bridge across the spillway was built of pre-cast bridge beams with an in-situ deck. This solution dispensed with the risk of blockage beneath the bridge. The spillway was re-constructed in reinforced concrete with a formliner and stain finish to the visible external surfaces. The shaft was raised in concrete with an ashlar formliner and staining to the external surface. The concrete stain that was selected was 'ebony' which best matched the concrete and masonry of the surrounding environment.

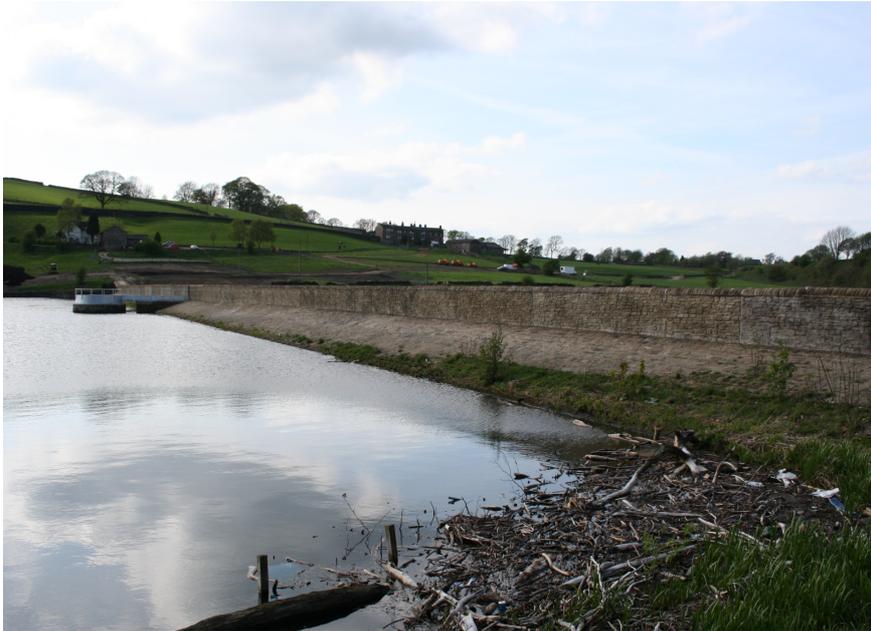
Figure 5: Hewenden Reservoir – Completed Wave Wall

The model testing of the Hewenden spillway showed that the horseshoe shaped weir operated under free discharge conditions, but even so the predicted flood rise under PMF conditions was above the embankment crest. Hence works were required to raise the core of the embankment and to provide a substantial wave wall that could withstand both the still water flood rise and the wave surcharge. It was also shown that overtopping of the spillway walls would occur over a large part of the channel and to address this deficiency, modifications were needed to enhance the channel capacity and contain the flow.

- A reinforced concrete wave wall along the embankment crest with a concrete nib beneath its base slab that extended into the clay core.

Works to the spillway were split into three phases; re-construct the 60m long upper portion of the channel in reinforced concrete, raising of the remainder of the channel walls and construction of the scour protection slab to the downstream area beyond the embankment toe. For the building of the wave wall, the use of pre-fabricated reinforcement cages greatly reduced the construction time, with the average rate of construction of 10m/day being achieved. Upon completion of the concreting works the structure was left to cure for a period of thirty days before the final stain was added. In tests on site it had become apparent that the stain reacted differently to fresh and aged concrete and that this inevitably affected the final appearance.
