The Repair of Llyn Morwinion Dam

SIMON R HICKMAN (Atkins Ltd)

SYNOPSIS. In 2000, observed settlement of the crest of Llyn Morwinion over its outlet conduit, and sediment within this conduit associated with seepage into it, led to concern that the dam was suffering from internal erosion of the core. Initially, a remedial procedure of constructing a concrete plug in the conduit under the core was proposed but, following another inspection, it was recommended that the cause of the settlement be further investigated, the dam made good and seepage minimized. This paper describes the further investigation and recommended remedial works.

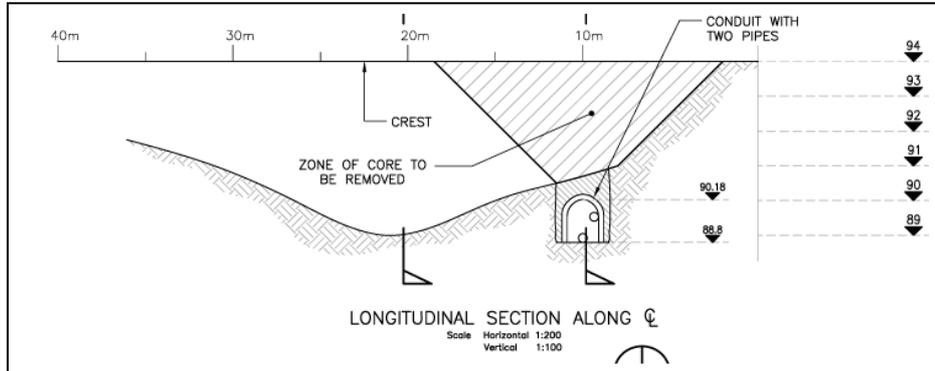
Figure 1 – Longitudinal section identifying hard horizon & conduit

The results of this investigation resulted in the identification of the hard horizon as shown on Figure 1.

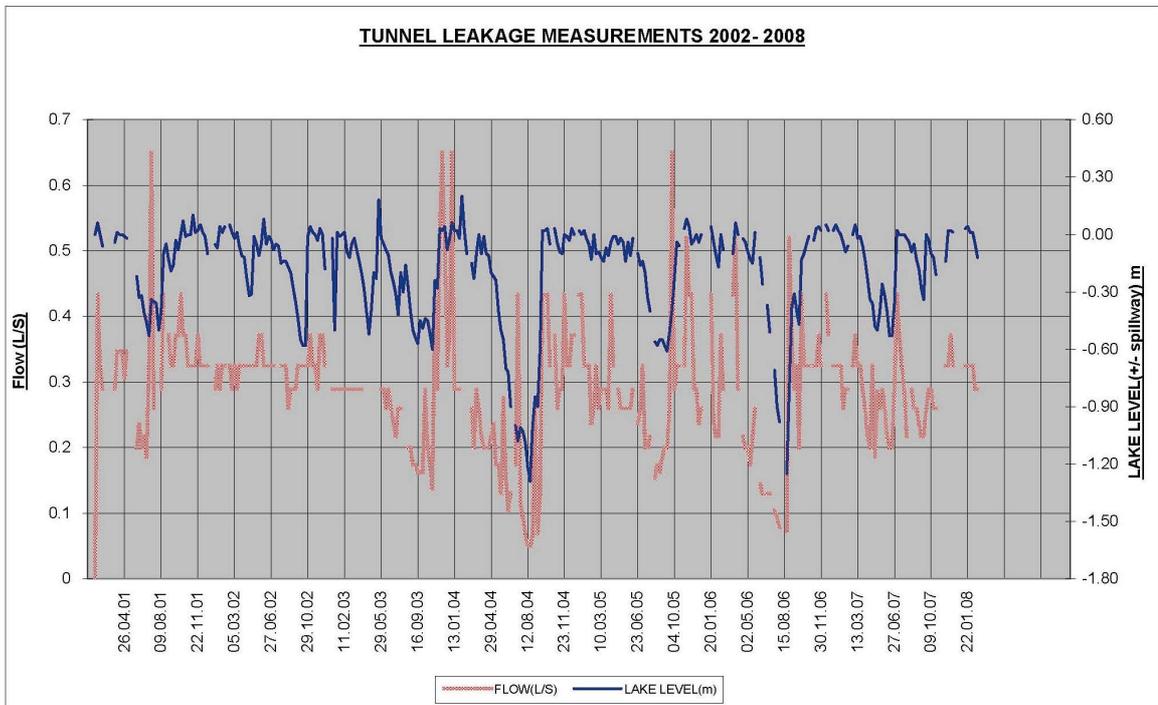
Figure 2 – Leakage into the Outlet Conduit from 2001

The flow into the conduit has been measured since 2001 and the Figure 2 below demonstrates that the flow rate mirrors the changes in reservoir water level with a rate of approximately 0.32 l/s at TWL. This rate has not increased although there are variable higher rates recorded, up to 0.65 l/s in January of 2004 and 2005 which might indicate that surface rainfall into the downstream shoulder influences the flows.

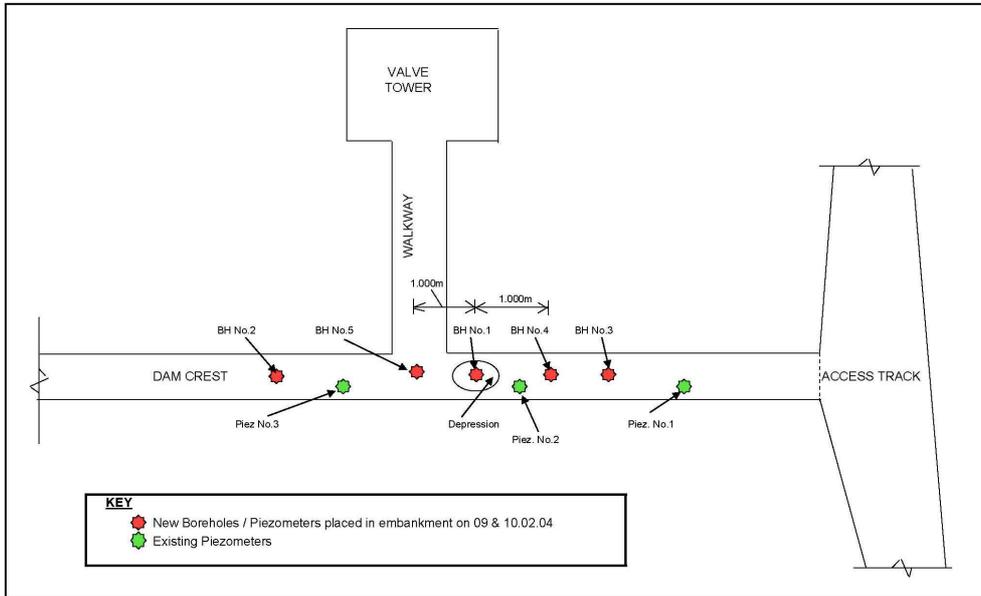
Figure 3 – Plan of Llyn Morwinion - Location of boreholes and piezometers placed in 2001

A preliminary investigation was carried out with boreholes drilled and piezometers placed in locations indicated in Figure 3.

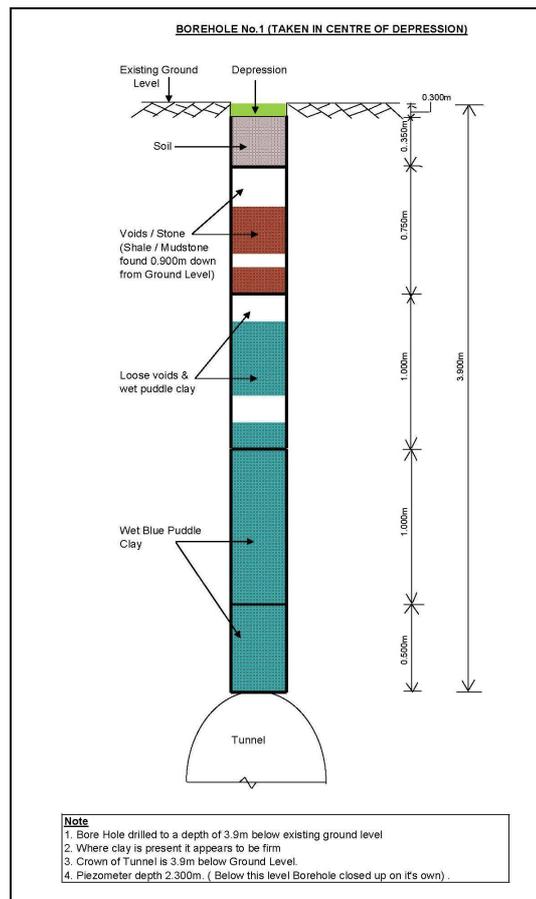
Figure 4 – Schematic log of borehole BH1 in the depression on the crest

A figurative log of the borehole drilled into the depression is given in Figure 4. Worryingly, this identified voids up to a metre below crest level and wet

blue puddle clay above the crown to the conduit. The piezometers again mirrored the water level in the reservoir with a rapid response to changes in water level. At the same time survey pegs were installed in the locations shown in Figure 5.

The results from the earlier ground investigations highlighted the voids and “changed” materials above the outlet conduit shown in Figure 4, but further information was required.

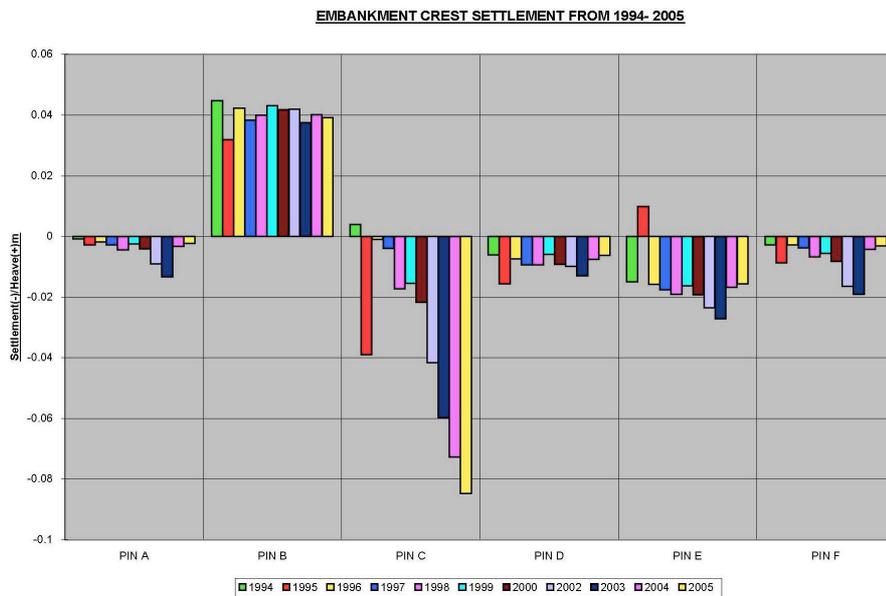
Figure 6 – Crest Settlement 1994 to 2005

The levels of these pins have been taken since 2001 and their rise or fall has been charted as shown in Figure 6. Apart from the pin in the depression, Pin C, which shows downward movement, the crest is shown to be not moving. Pin C however shows a continuous year on year fall of some 10mm/year that suggests a loss of material from this zone in the core, into the conduit.

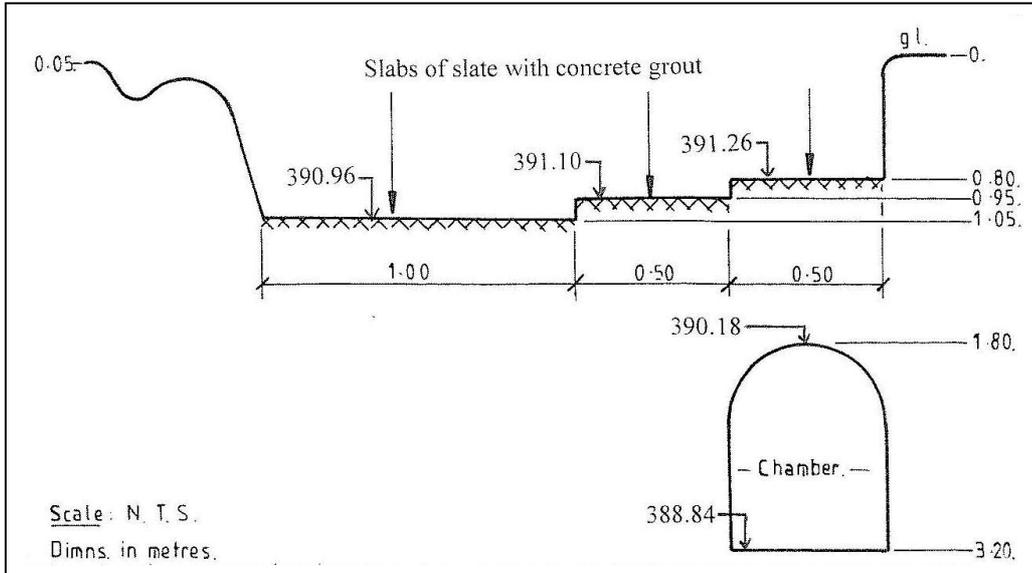
Figure 8 – Log of Trial Pit Downstream of the Embankment

A log of the trial pit excavated on the downstream section of the conduit below the embankment is given in Figure 8. Whilst the internal condition of the conduit is in good condition, the information from the trial pit introduced uncertainty into the composition and condition of material above the soffit of the conduit as well as that on the sides of the conduit appears to be constructed into an excavated trench in the rock foundation. (The rock profile is shown in Figure 1).
