## **Locating the leakage route at Torside Reservoir using the Willowstick AquaTrack system.**

V.O. KOFOED, Willowstick Technologies, Utah, USA.

K.D. GARDINER, United Utilities, Warrington, UK

A .A. GEORGE, Montgomery Watson Harza, Warrington UK

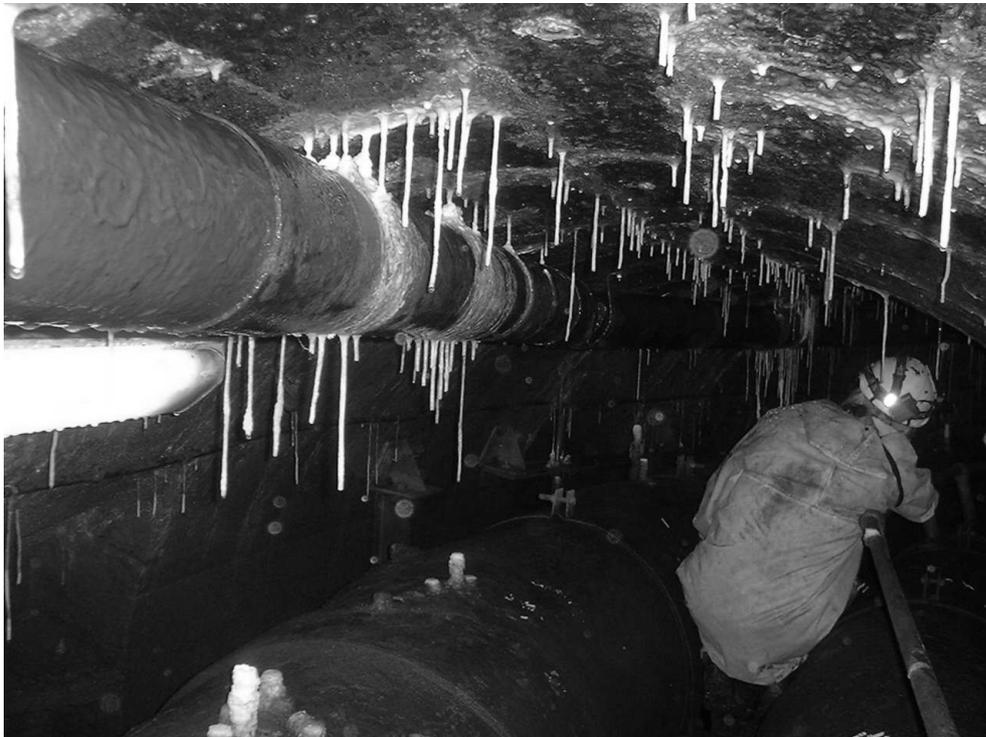
Photo 1 - Stalactites and stalagmites in the drawoff tunnel.

Prior to 2004 the leakage had been quite steady but a rapid growth of stalactites and stalagmites had been observed in the tunnel. A stalagmite 60mm long had been observed growing on a stainless steel pipe strap that had only been installed 6 months earlier. It was speculated that acid water from the reservoir was dissolving the lime from the cement in the grout injected into the rock in 1950.

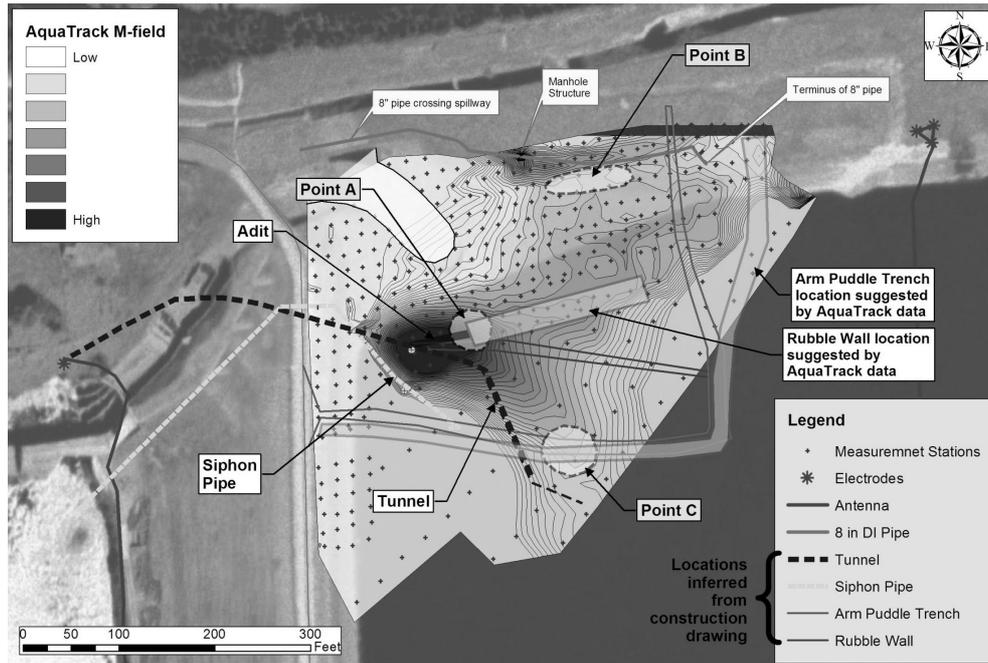
The first source of water, observed to be seeping into the rubble drain, appeared to be flowing from the north hillside (see Figure 1). This water is trapped between the clay blanket liner, clay core of the dam and puddle filled arm trench. This trapped groundwater flows into the rubble drain trench and is conveyed westward via the adit into the drawoff tunnel.

The second source of water identified in the survey data appeared to be flowing from the reservoir through a breach in either the puddle filled arm trench and/or the clay blanket liner.

Point A, in Figure 1, represents the location where water is seeping into the adit. This location is confirmed in both the Phase I and Phase II

investigations. Point B represents an area where groundwater from the north hillside is highly concentrated and channelised. This location is above high water level where groundwater may be intercepted from the hillside in an effort to reduce groundwater flow into and beneath the reservoir's clay bottom liner. Point C represents an area where water from the reservoir appears to have broken through the clay blanket liner and/or puddle arm trench.

Figure 1 - Plan of the survey area with Phase II Interpretive Results

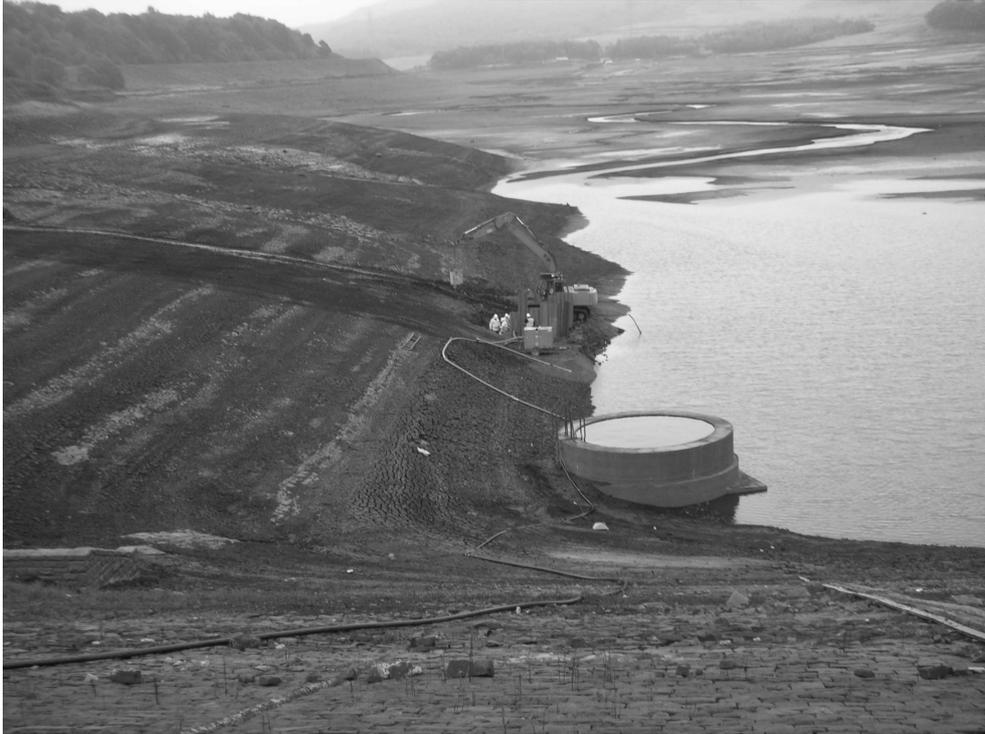
During the dry spring of 2007 the reservoir was progressively lowered in an attempt to find a surface feature that might indicate the position of a defect in the clay liner. On 23 April 2007 the reservoir was lowered below the 18m level to reveal a 4m diameter, 1.5m deep, hole where the pitching had collapsed. This coincided with the point where the line of the leak predicted by the AquaTrack survey crossed the line of the arm trench. However, the exceptionally wet summer of 2007 meant that it was almost impossible to hold the reservoir at this level and it was September before works to investigate and repair the hole and the defect beneath it could commence.

Photo 2 - Excavation at the site of the hole viewed from dam crest.  
Upstream valve chamber in foreground.

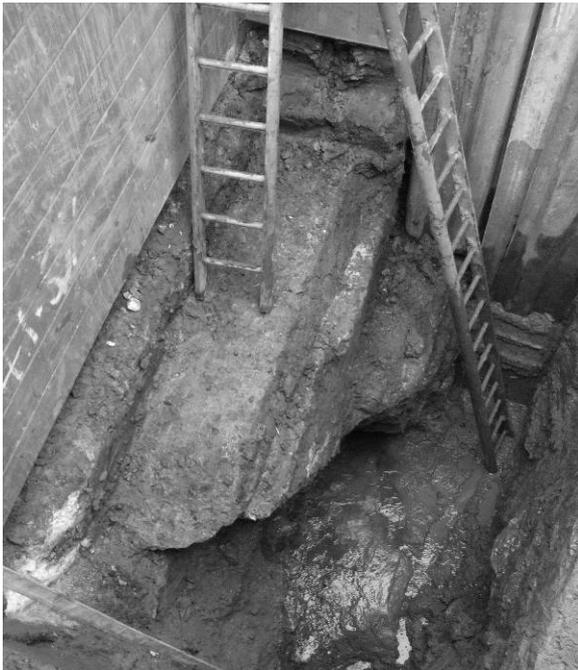
Photo 3 -

View into excavation looking east showing the north face of the arm trench.

The concrete forms a cantilevered overhang below which a void had filled with ballast and clay materials.

Bedrock was encountered behind the overhang

It is postulated that, under pressure from the reservoir, clay was pushed into the fissures in the rock causing settlement and shear cracking in the deep puddle-clay filling to the arm trench. Water seeping through these cracks softened the clay and washed it further into the rock fissures causing further slumping of the clay and the eventual collapse of the masonry pitching. Eventually the flow of the acidic moorland water was sufficient to erode a path through the cement grouted rock until it eventually reached the rubble drain and the draw-off tunnel.

The arm trench, including the void to the rock face behind the concrete facing, was backfilled with in-situ concrete up to the upper elevation of the vertical concrete facing. The existing clay liner, exposed around the periphery of the swallow hole, appeared to be in good condition so a new section of clay was keyed into this making the blanket continuous once more. The repair work was designed by Montgomery Watson Harza (MWH) and supervised by Mr I C Carter, an All Reservoirs Panel Engineer employed by MWH. The Contractor was Eric Wright Construction of Preston, Lancashire.
