The Discontinuance of Hameldon Reservoir

SYNOPSIS. Hameldon reservoir does not have an Undertaker and its condition has gradually deteriorated over the recent years. This deterioration was such that it was causing concern about the overall integrity of the embankment dam. This paper describes the reservoir, a brief resume of its history, how the Environment Agency became involved and under what powers the Agency has operated. The paper also discusses the remedial options reviewed before concluding with an update on the recent construction works.

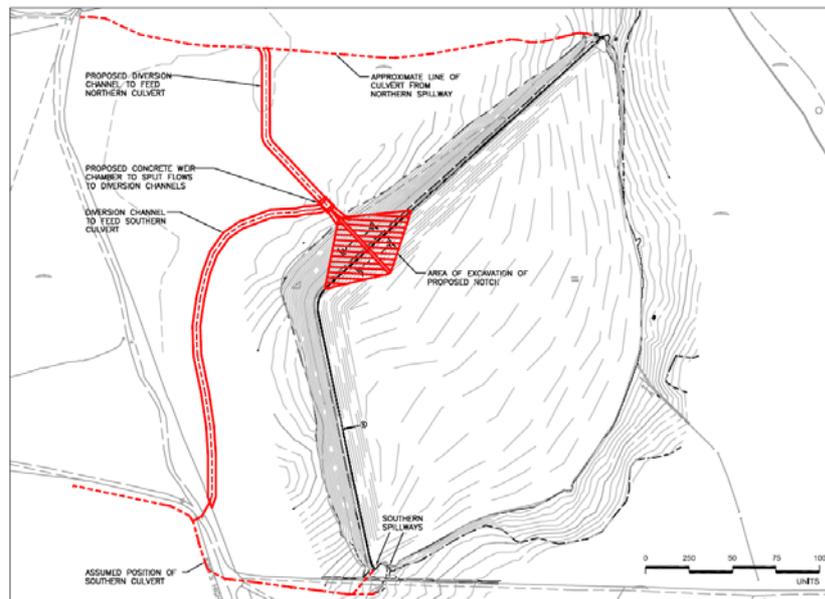
Figure 2. General Arrangement of Preferred Option in study (2a) (full height notch with diversion channels to north and south culverts)

To maintain an approximation of the existing flow regime, Option 2a included a new concrete weir chamber near the notch which would split the water flows to mimic the original split between the northern and southern spillways as shown in figure 2.

Of the three variants of the full height notch option, the arrangement of flows through the weir chamber and diversion channels in Option 2a presented the closest approximation to the existing flow regime and as such was the preferred Option. The recommendations of the options study were also consistent with the recommendations of the Inspecting Engineer. The general arrangement of Option 2a is shown in Fig 2.

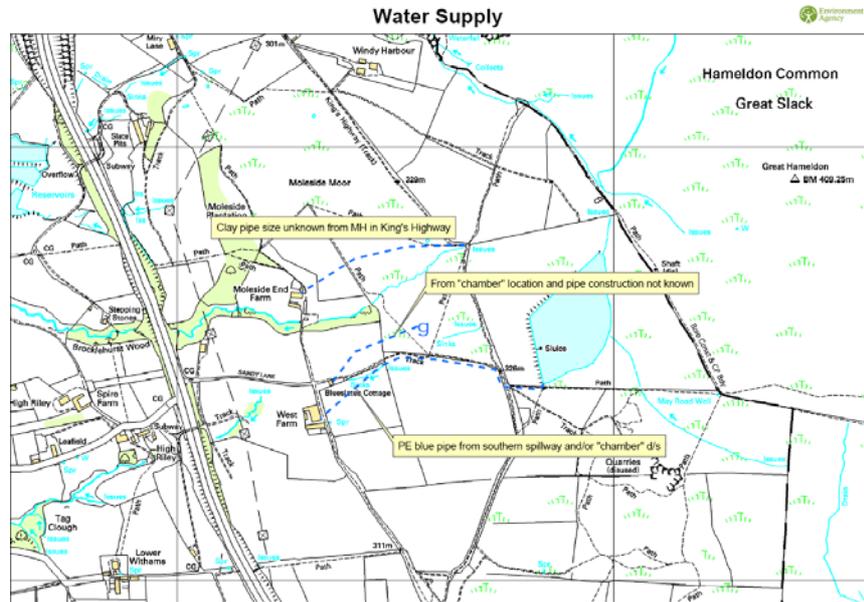
Figure 3: Assumed water supply route to properties downstream of Hameldon reservoir

Of the three properties, the southernmost (West Farm) had the most obvious feed from the reservoir water, with all domestic (to three residents) and livestock supply (up to 200 cattle) coming from a single pipe tapping the southern culvert. As most outflows exited through the southern culvert, the reservoir clearly provided a secure and reliable all year supply to this property, and a drawdown plan would have to include alternative provisions for when the reservoir level dropped below the southern spillway. While the outline designs for the preferred option had included the permanent diversion channels which would pass inflows to the culverts again, the attenuation benefit of the reservoir would be permanently lost. There were also concerns that the quality of the reservoir outflow water would be impaired due to the loss of the reservoir's function in settling out solids and metals. Overpumping to the southern culvert during the drawdown (to maintain the supply) was thought to be of limited use since the water quality would deteriorate with depth.

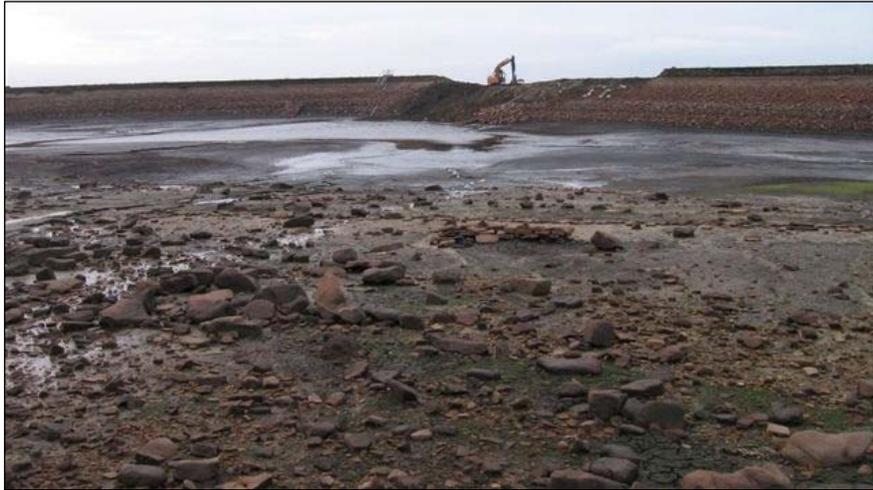
Figure 4. Reservoir emptied, notch cutting works commencing

Following some delays with the provision of temporary/alternative water supplies to the affected properties the drawdown of the reservoir started on 29 July 2009. (The construction of diversion culverts began shortly after). The excavation of the notch was also delayed for the same reasons and did not commence until 28 October 2009.

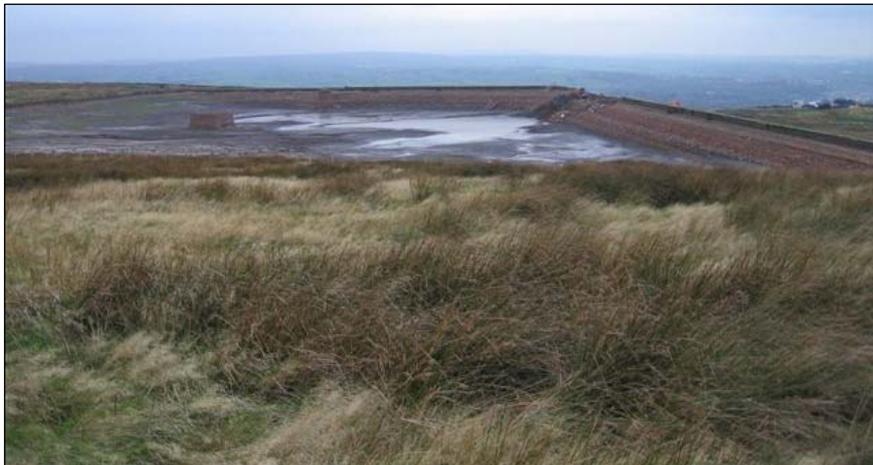
Figure 5. Reservoir emptied, notch cutting works commencing

Given the remote location of the reservoir and its elevation it suffers the full effect of the weather and as winter progressed it became harder and harder to work with the material being excavated from the notch. Ultimately the Environment Agency was left with no choice other than to close the site down in mid December 2009, leaving the pumps on site to ensure that water levels were kept drawn down over the winter. Site works are expected to recommence in the late spring 2010.
