## **Roadford Dam - 20 years of monitoring**

**SYNOPSIS** Roadford dam, located in the south west of England, is one of only six dams in the UK that have upstream asphaltic concrete membranes. The embankment is constructed of a low grade rockfill. The dam was extensively instrumented during construction and many of these instruments are still being monitored 20 years after installation. The paper discusses the instrumentation and geochemical monitoring, and the value of the observations in assessing dam performance. Monitoring has indicated the chemistry of the drainage waters has remained within acceptable limits and is related to rainfall and water level, and varies over wide ranges. These unique long term measurements demonstrate the value of a well designed system and conscientious monitoring on the part of the owner.

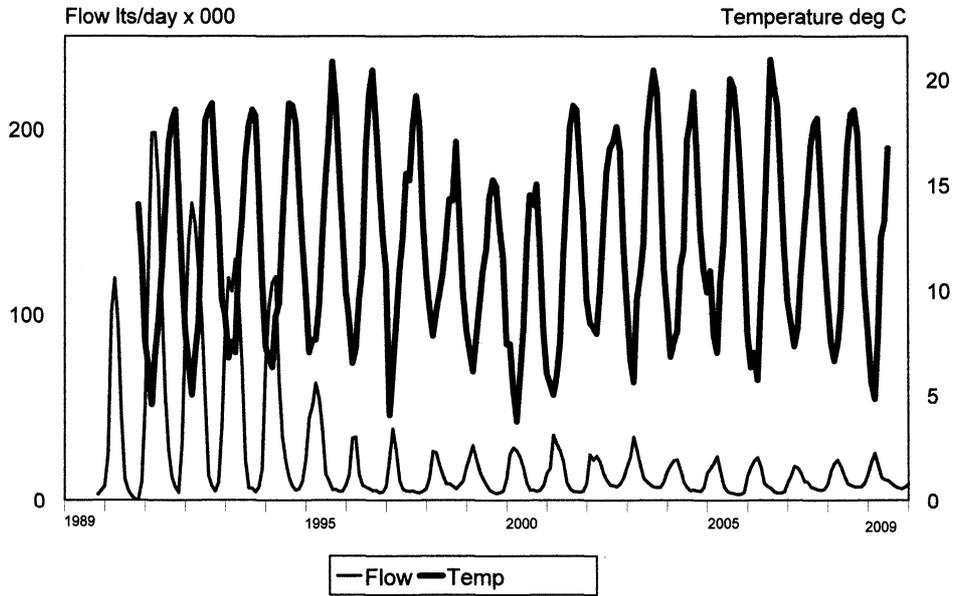
Figure 2. Membrane drainage flows

From small flows observed from the membrane drains shortly after impounding, during the first winter in 1989/90 membrane drain flows increased significantly in line with rising water level. Flows virtually ceased during the next summer. During the next winter, when the reservoir approached full, flows increased significantly, with flows the following summer again virtually ceasing. This trend has continued although winter drainage flow peaks have generally been on a gradually reducing trend with some correlation with water level. Water temperatures vary between approximately 20°C in summer, corresponding to minimal flow in the membrane drains, to 5°C in winter when flows are at a maximum. The

majority of the membrane flow originates from the area between the access tunnel and the centre of the dam.

It has been suggested<sup>9</sup> that the leakage may be a function of the thermal expansion/contraction of the asphaltic concrete when local imperfections open during cold weather with a corresponding increase in leakage. The gradual decline in maximum membrane leakage rates suggests that these local imperfections self-seal with time. A crack along a vertical day joint in Panel D47 about 5m to 8m below the crest has been observed. This is in the area of membrane flows into the gallery.

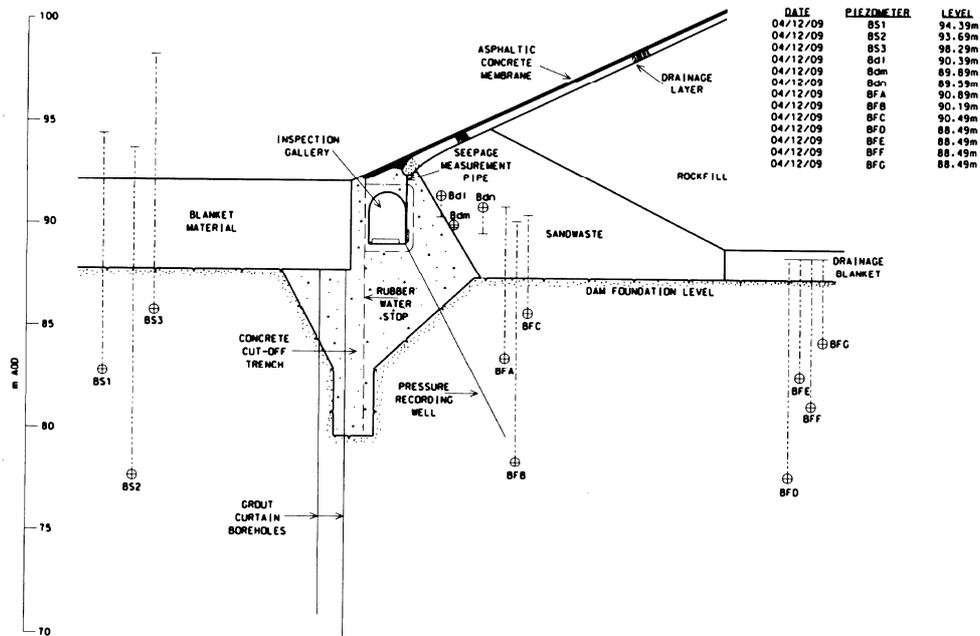
Figure 4. Piezometric Profile

Piezometer readings have been stable in all three of the monitored zones of the embankment fill. Two piezometers in Zone B, which are in the same area as gallery segments 25 and 26 where the main drain flows are recorded in winter and early spring, also show similar seasonal trends.

Monitoring of pore pressures has confirmed that there is no build up of water within the embankment and the dam is still functioning as designed. See Figure 4.

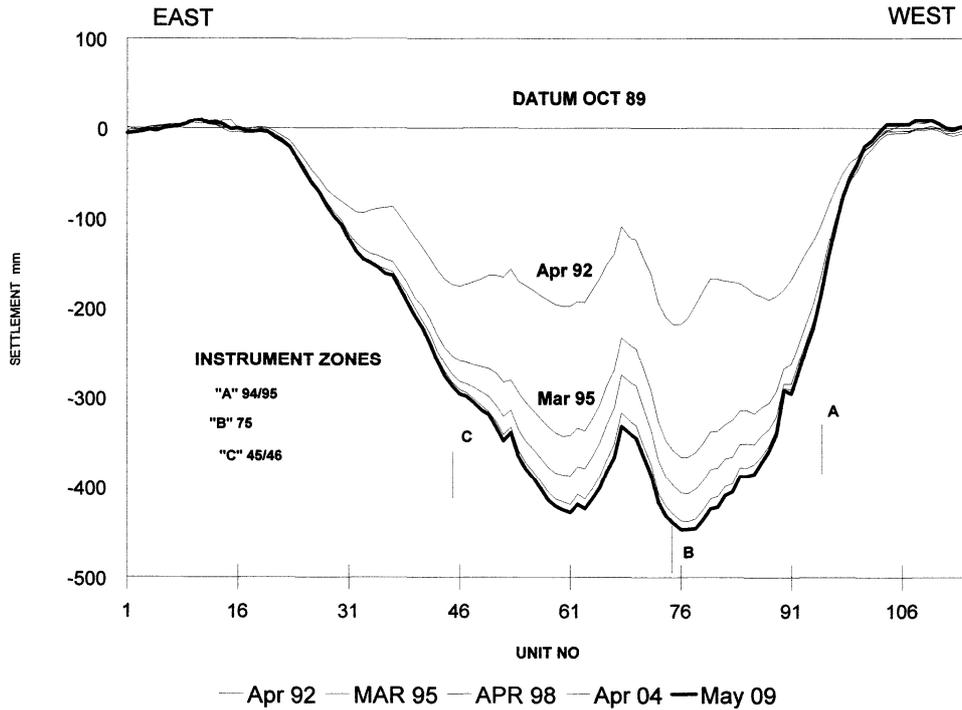
Figure 5. Crest settlement

Crest coping levels have indicated a reducing settlement trend with time. Maximum settlement at the crest copings since impoundment in October 1989 has been 447mm. This is well within the freeboard design allowance of 981mm. Similar measurements have been recorded by the vertical magnet settlement gauges for the same period. An additional 110mm settlement was measured by the settlement gauge prior to impounding.

The twin settlement troughs either side of the centre of the valley, clearly identifiable in Figure 5, are visible in the parapet wall. It is believed these are an indication of collapse compression coincident with higher water content of the fill. Zones of higher settlement are coincident with areas of membrane drain flows. See Figure 6.

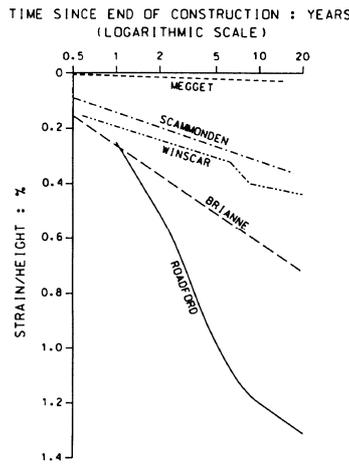
Figure 7. Post construction long-term settlement of crests (after Charles<sup>8</sup>)

Roadford has shown considerably more settlement than Brianne, Megget, Scammonden and Winscar dams which have also been monitored for long periods<sup>8</sup>. The data is plotted in Figure 7 as vertical strain. Maximum settlement since end of construction corresponds to a vertical strain of 1.32%.

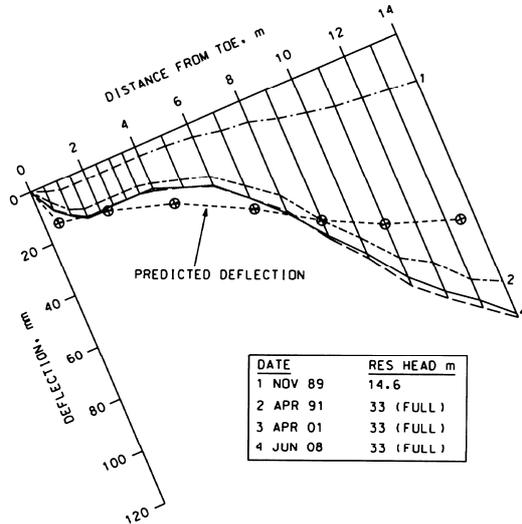
Figure 8. Deflection of the asphaltic membrane

To monitor deflection at the sand waste transition zone at the toe, an electro-level system was installed immediately under the membrane at the three instrumented sections along the dam<sup>7</sup>. Details of the system and observations for the first five years are described by Tedd et al<sup>10,11</sup>. The deflections of the membrane normal to the slope and relative to the toe of the dam are shown in Figure 8 for different times after impounding. The largest deflections occurred between the toe and 1m up the slope (17mm per m) and at the sand waste/rockfill interface (12.5mm per m). There has been very little differential deformation over the area where the sand waste was placed. Figure 8 also shows a simple prediction of the membrane

deflections based on the compressibility of the sand waste from 1m oedometer tests.

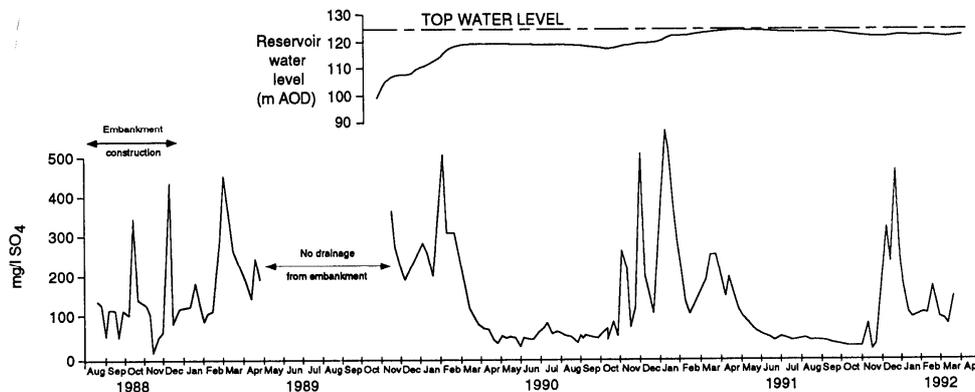
Figure 9. Sulphate content of embankment drainage (after Davies<sup>5</sup>)

A clear seasonal trend was apparent in the embankment drainage from the start, with much higher concentrations of sulphate, calcium, magnesium and

manganese in winter than summer. This reflects greater percolation of rainwater through the rockfill during the winter months.

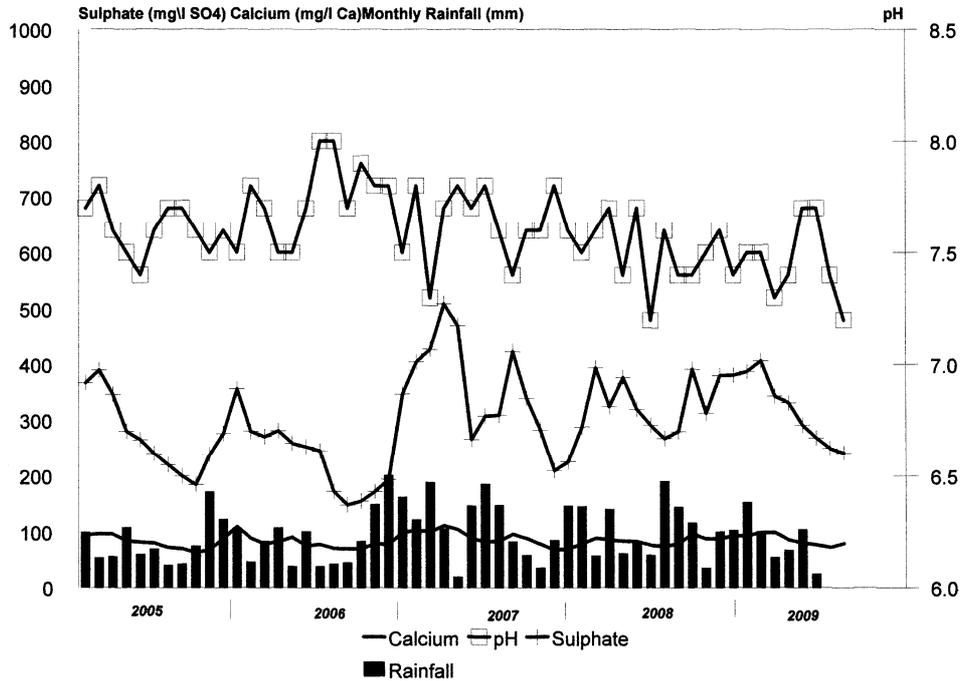
Figure 10. Manhole W6 sulphate, calcium and pH 2005-2009

The pH value shows an inverse relation to sulphate (see Figure 10), dropping when sulphate is high and rising when it is low. Calcium shows much less variation, indicating that the drainage water is saturated with calcium carbonate due to dissolution of calcite from the foundation blanket. Estimates of the amount of pyrite and calcite removed by weathering are calculated from the calcium and sulphate concentrations and the drainage flows on a quarterly basis. The rate of loss of material has remained roughly constant on an annual basis, though the amount in any quarter or year is affected by the rainfall.

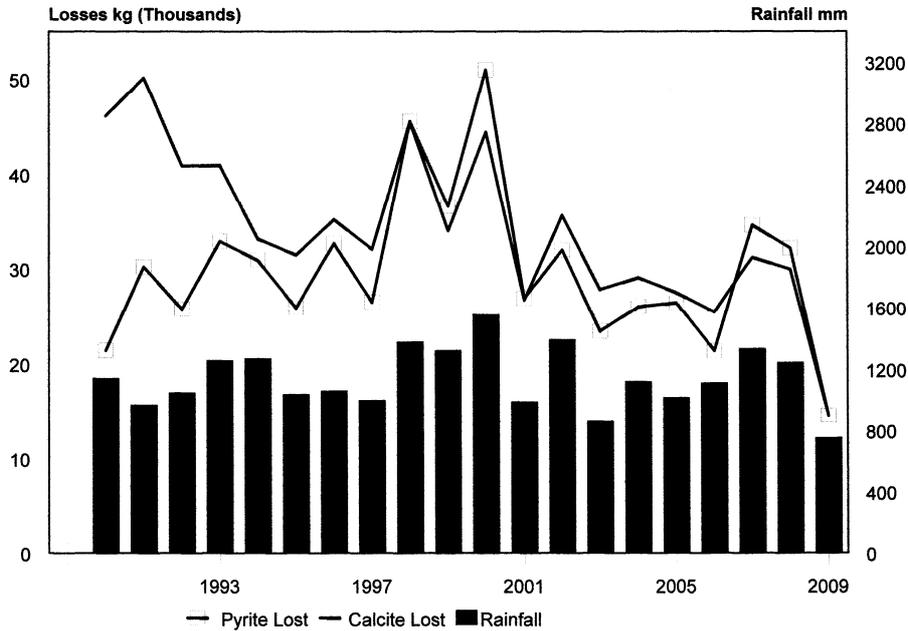
Figure 11. Annual loss of pyrite and calcite

The calculations suggest that in the 20 years to the end of June 2009, 2.7% of the pyrite and 4.7% of the calcite has been consumed by chemical reactions. The figures should be regarded as estimates, but help to indicate the scale of the reactions. The figure for calcite is of greatest concern as if the readily available calcite was used up, there would be a rapid drop in the pH of the drainage and a rise in sulphate and metal concentrations, with implications for the treatment of the drainage waters before release to the River Wolf. The figures indicate that this is unlikely to occur in the medium term, but could occur when the dam approaches 200 years in use.

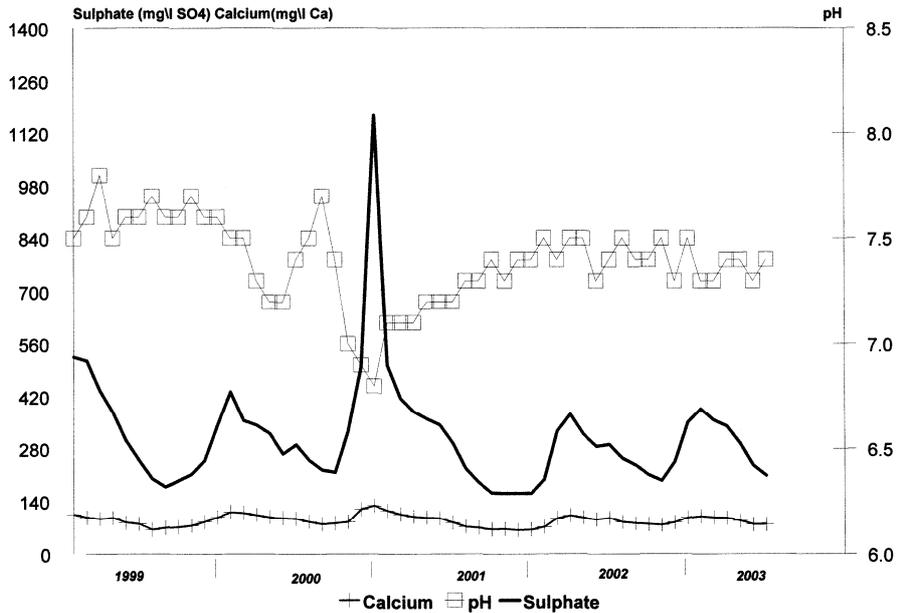
Figure 12. Manhole W6 sulphate, calcium and pH 1999-2003

Over the 20 years since impounding started, the dam has experienced a wide range of weather conditions, from very wet years in 2000/01 to extended droughts. Geochemically, the greatest concern is during sustained wet periods as the rate of leaching of weathering products could exceed the ability of the foundation blanket to neutralise them. This would be shown by a rapid drop in pH and rise in sulphate and metal concentrations. During the very wet period of 2000/01, the pH values of the embankment drainage dropped below 7.0 (neutral) for a period, though they subsequently recovered when the rainfall decreased.

In order to guard against this possibility, chemical monitoring of drainage waters is continuing. However, the extent of this has been decreased considerably over the years as knowledge of the variation of the chemistry has increased. For some years now, limiting values have been set for two key parameters; pH value and conductivity (this relates directly to sulphate and is easier and quicker to measure). If the pH value of monthly samples

falls below 7.0 or if the conductivity exceeds 1500  $\mu\text{S}/\text{cm}$ , monitoring of the full suite of parameters will be resumed and the situation reviewed. These parameters were breached in 2000/01, but have not been exceeded since.
