Design of Rehabilitation Works at Ulley Reservoir

SYNOPSIS. Ulley Reservoir, near Rotherham in South Yorkshire, suffered serious damage during a storm in June 2007 and required emergency repairs. As a result of the incident, a Section 10 Inspection was recommended. The subsequent report identified a number of significant matters in the interests of safety.

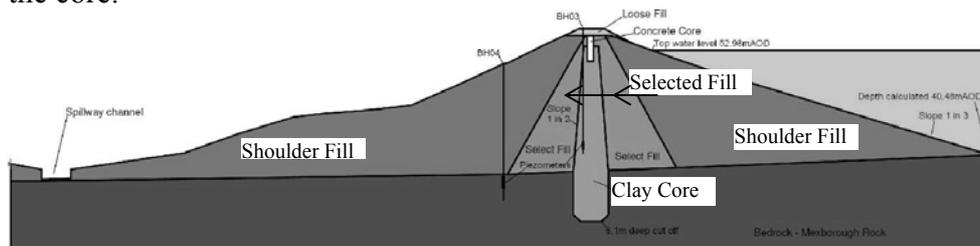
Figure 1. Section through embankment

In 1969 works were carried out to the upper three metres of the core to provide sufficient freeboard between normal operational top water level and the top of the clay core. This work comprised excavating a 0.75m (2.5 feet) wide trench some 1.8m to 3m (6 to 10 feet) deep along the crest and placing a weak plastic concrete above the then top water level. The records show the concrete should have contained 4% of cement and an admixture which is believed to have acted as a retarder. The ground investigation and subsequent construction works found that in many places the plastic concrete was still plastic though elsewhere it had hydrated and formed a weak brittle concrete. Trench sheeting made of corrugated iron was still present and voids were found under the concrete. One of these locations was upstream of the 2007 scour hole where seepages had been observed during the incident. There was enough doubt about its integrity to point towards its removal and replacement regardless of the integrity of the rest of the core.

It was therefore considered that a bentonite cement slurry wall would be most appropriate to achieve a seal with the puddle clay and provide the desired permeability, which should be the same as the original core. This option could accommodate any small ongoing settlement of the embankment and an hydraulic excavator could remove the concrete core raising and install the slurry trench in the same process. A key into the puddle clay core would be required, but this solution would not alter the state of the puddle clay at depth.

In order to facilitate the construction of the bentonite cement slurry wall it was decided to lower the crest level by 0.5m to 54.8m AOD to provide a wider crest width as well as sufficient freeboard during a PMF event based on a normal top water level of 51.75m AOD. Over the years changes to the top water level had resulted in a much reduced crest width.

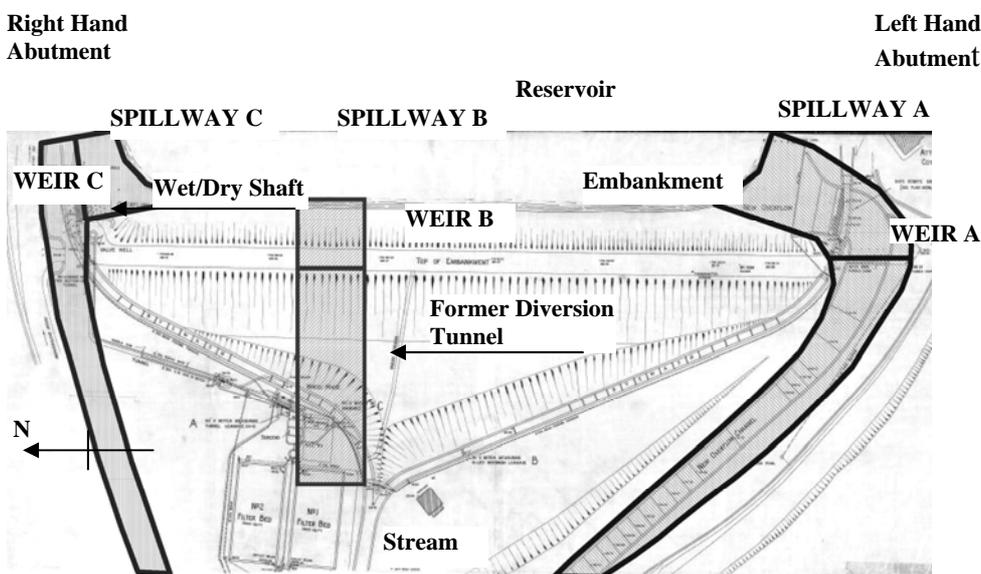
Figure 2. Proposed spillway options

The left hand mitre option, Option A, was rejected both on cost and technical grounds because it required significant excavation of the approach channel, spillweir and chute spillway to lower the ground level by at least 1.2m. It would involve demolition of the existing concrete spillway and construction of the longest chute from the abutment to the downstream watercourse.

The right hand mitre, Option C, was rejected on both cost and technical grounds because it is located in fairly steeply sloping sidelong ground and

The remaining option was to position the spillway on the embankment which is Spillway B in Figure 2. This was considered to be the best option in both technical and cost terms; however it presented the problem of assessing the future behaviour of a structure founded on fill.

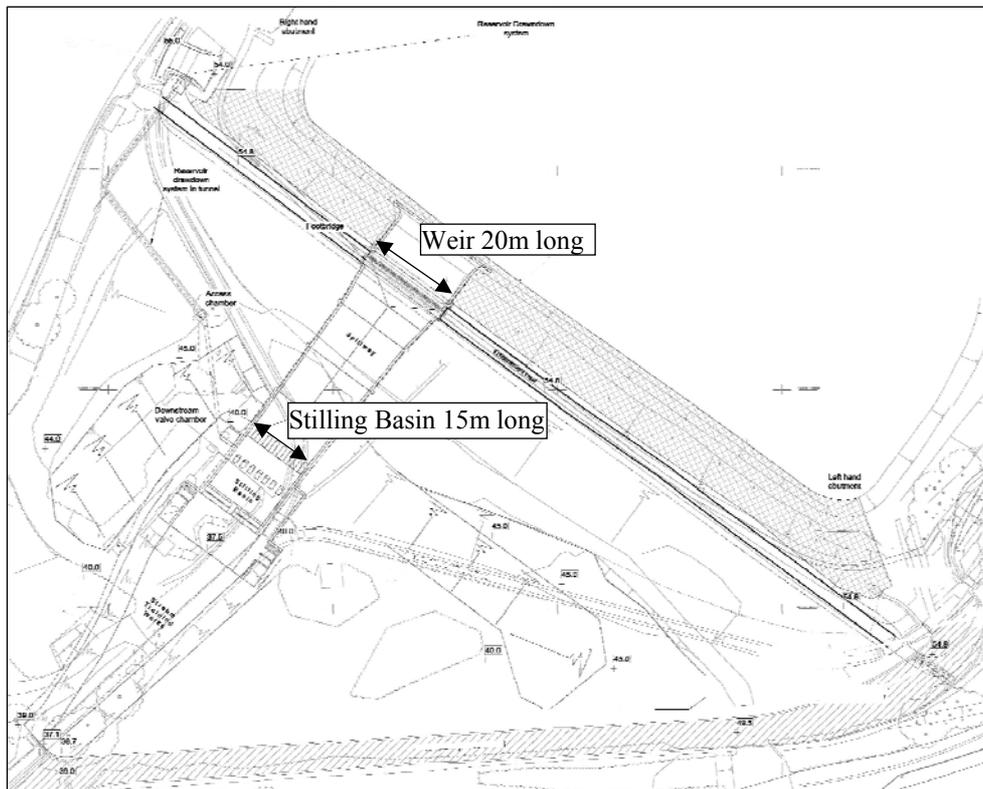
Figure 3. Location plan of spillway and drawdown system

Prior to the 2007 incident the drawdown system was more or less that which had been provided as part of the original construction. The drawdown system was located on the right hand abutment and comprised an upstream intake tunnel driven through the foundation rock in a north westerly direction; a wet/dry shaft upstream of the crest; and a downstream discharge tunnel containing a 15" pipe leading to the former water treatment works as shown in Figure 3. The drawdown system discharged into the former Morthen spillway.

Following the Ulley 2007 incident the Section 10 Inspection identified that the side walls to the Morthen spillway were considered to be unsafe and recommended that the spillway needed to be filled in to protect the integrity

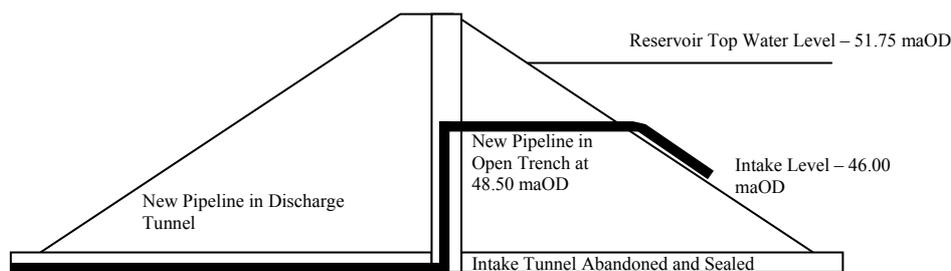
Figure 4. Option A – Combined gravity and syphon system

In the end, three location options were identified. Option A (shown below in Figure 4), was a pipeline in trench along the line of the existing tunnel to the wet/dry shaft at alternative levels of 46.0m AOD and 48.5m AOD for a gravity only option or a combined gravity/ siphon system respectively. The pipework would then be routed through the downstream tunnel to discharge into the stilling basin.

Option A was chosen because it already had a route through the waterproofing via the downstream tunnel. All excavation works would be upstream of the waterproofing and these works could be done independently of the spillway works. The route is longer and has higher losses than Option C; however hydraulic analysis showed that under siphon conditions Option A had the lowest negative (vacuum) pressure. Once the new pipeline had been installed, tested and commissioned the outlet shaft and downstream tunnel were filled with foam concrete.
