## **The identification and sealing of a leak in the Ardnacrusha headrace canal containment embankment**

C. FITZPATRICK, ESB International, Ireland

**SYNOPSIS.** The 11.5km headrace canal servicing Ardnacrusha Hydro Station in Co. Clare, Ireland, was constructed during the period 1925-1929. The canal is partly through rock cut but is largely contained by earthen embankments. Over the lifetime of the headrace, seepage problems have been remedied through leakage route detection and grouting programmes. This paper discusses the recent development of a significant leak and the thermal leak detection procedure adopted to identify the route of the leak through the embankment. The steps taken to seal the leak using gravity cement grouting are also described.

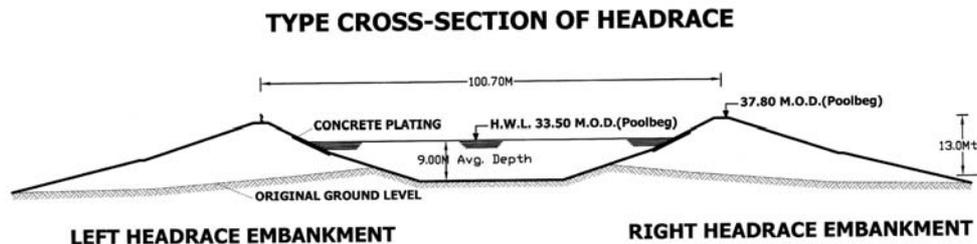
Figure 3. Typical Cross Section

The headrace canal is typically nine metres deep (Figure 3). In general the canal bed level is approximately 24.50m O.D. The minimum normal operating water level is 31.50m O.D. and the maximum normal operating level of the headrace is 33.50m O.D. The typical crest levels of both left and right embankments are 37.80m O.D. The canal bed and sides up to original ground level were given a 0.60m puddle lining on porous soils. Boulder clay and gravel for construction was drawn from several borrow pits and the embankment was tipped directly on original ground after the stripping of humus, roots and organic matter. The embankments were unlined; however, there is a concrete plating on the face of the embankments from 32.50m O.D. to 35.00m O.D. providing protection from wave action to the face of the embankment rather than to provide an impermeable seal.

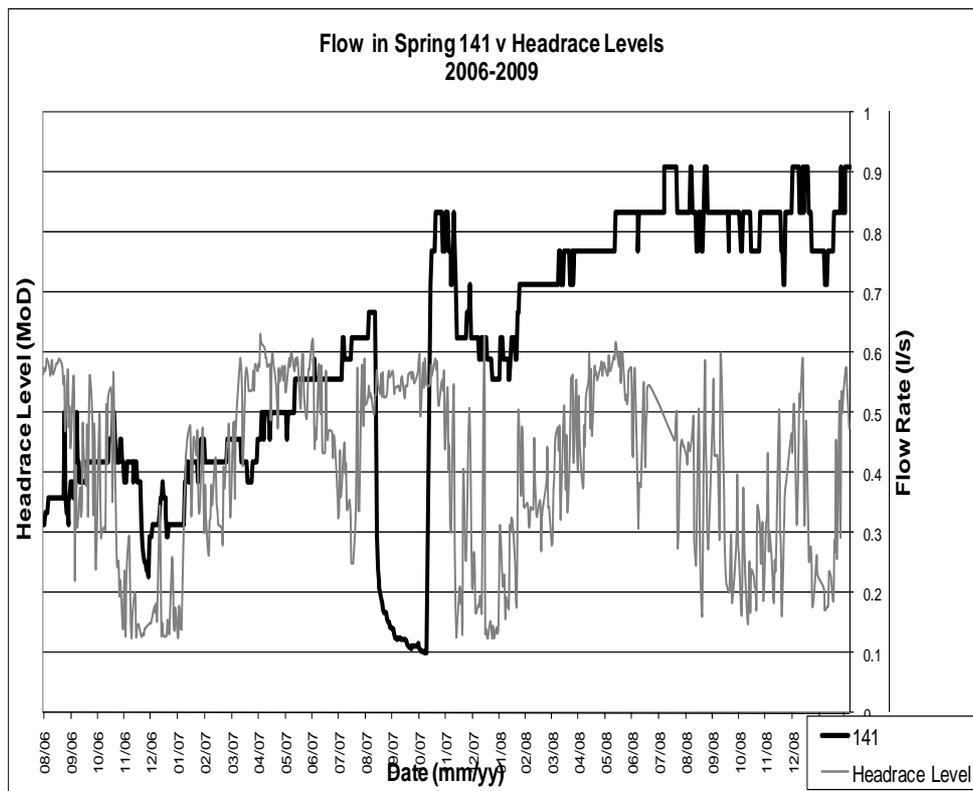
Figure 4. Plot of flow in Spring 141 against headrace levels

In August 2006, a wet area was observed at the toe of the berm at C/s 251 and was labelled Spring 141. Spring 141 is located close to Errina syphon inlet in one of the natural valleys crossing the headrace. It was decided to construct a manhole at the base of the berm to collect the flow through the embankment. The flow was piped via a slotted land drainage pipe to a measuring point. The flow was measured daily and was observed to increase from approximately 0.3l/s to 0.6l/s in August 2007. The flow subsequently decreased substantially to approximately 0.1l/s in October

2007. When investigated it was discovered that the land drainage pipe had become blocked with a silty material. This provided evidence of a wash out of solids from the embankment with the flow. The land drainage pipe was replaced with a solid PVC pipe and the solids were collected at the measuring point and measured once weekly. The flow continued to be measured and was regularly observed to be flowing at a rate of approximately 0.9l/s. The total solids in the flow were estimated at 1 litre per week. When analysed against levels in the headrace, it could be determined that the flow in Spring 141 was influenced by levels in the headrace, increasing with high headrace levels and decreasing with low headrace levels (Figure 4).

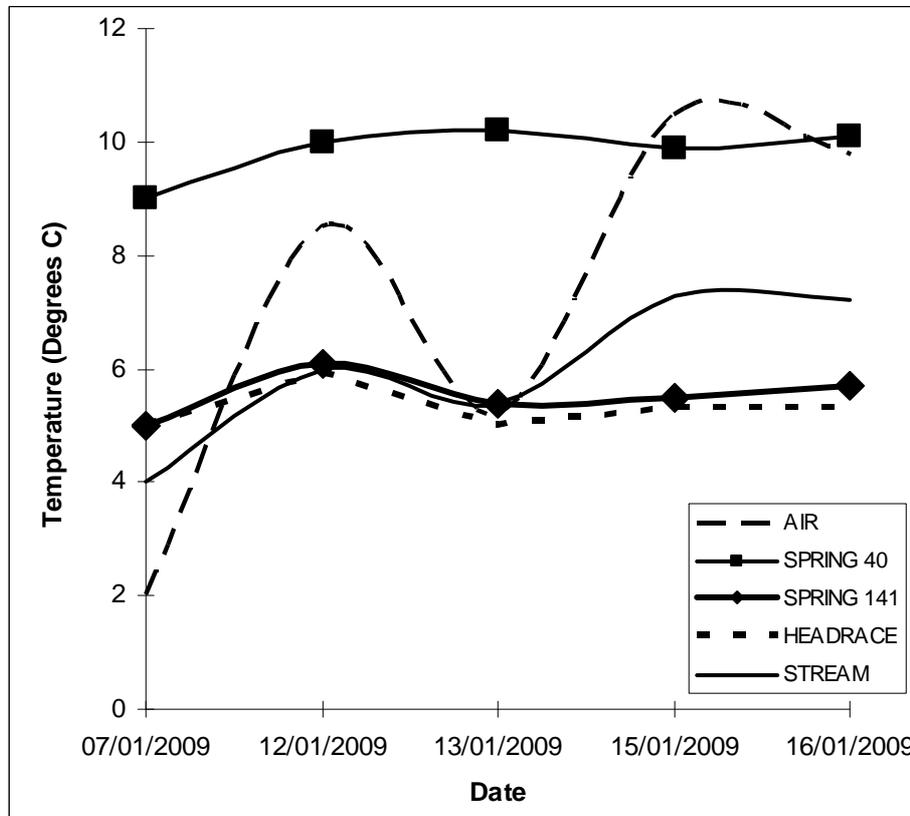
Figure 5. Plot of preliminary temperature analysis

In January 2009, temperature measurements were taken of the flow in Spring 141, a nearby stream, air temperature, the headrace and a nearby groundwater spring (Spring 40). The results of these measurements are illustrated in Figure 5. From this preliminary analysis it was determined that the temperature of the water flowing in Spring 141 matched that of the

headrace water. This provided evidence that Spring 141 was a leak from the headrace.

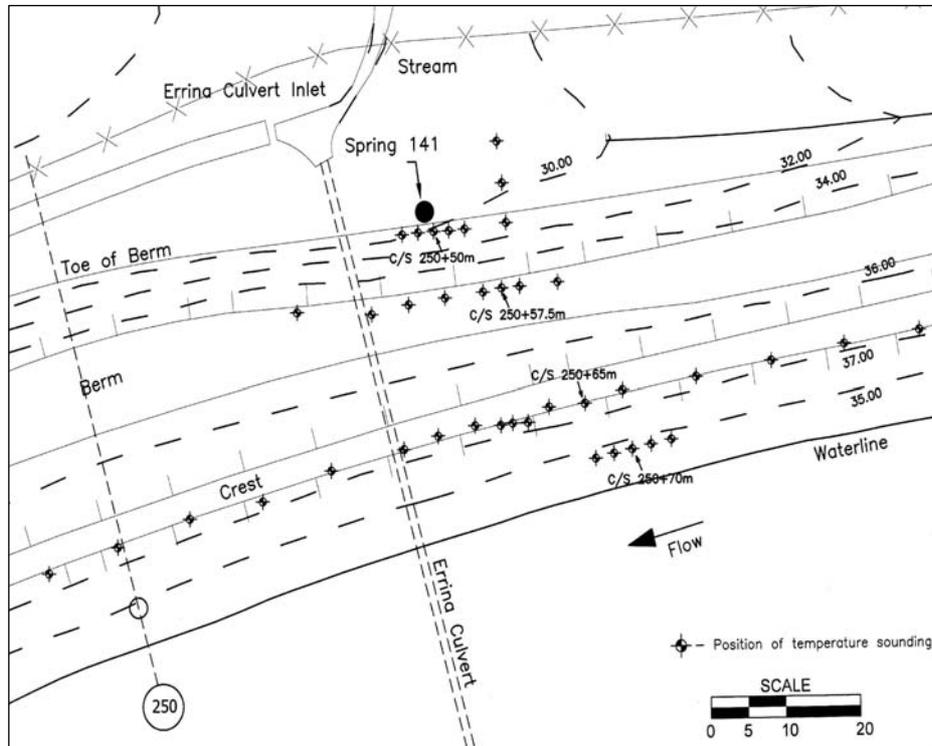
Figure 6. Temperature sounding locations

The investigation revealed temperature anomalies in probes located on the crest, berm, toe and at the top of the concrete plating. On the crest, the anomalies were found at soundings at c/s 250+65m and c/s 250+70m with the maximum disturbance at c/s 250+65m at 9m depth below the crest (Figure 6). The berm profile showed temperature disturbances at soundings c/s 250+55m, c/s 250+57.5m and c/s 250+60m, with the maximum at c/s 250+57.5m in 6-7m depth below ground level. The temperatures at the toe of the embankment were anomalous at the soundings c/s 250+50m and c/s 250+52.5m with the maximum disturbance at c/s 250+50m at 2 to 3m in depth. The fourth profile, above the concrete plating, has disturbed temperatures at the soundings c/s 250+67.5m, c/s 250+70m and c/s 250+72.5m, with the biggest anomaly at c/s 250+70m in 5-6m depth below the top of the plating level. All other temperature disturbances within the investigated embankment sections were considered insignificant.

GTC Kappelmeyer concluded from the results of the investigation that the anomalies observed confirmed the presence of a leak through the headrace. Further, that due to the small lateral extent of the anomalies it could be assumed that the leak was fairly localised. Due to the very clayey nature of the embankment material in the vicinity of the leak, leakage water along its flow path was confined to a small area resulting in “piping”. The route of the leak was envisaged as water entering the embankment at approximately c/s 250+70m at a depth of 5m to 6m, directly above the original ground level and flowing on top of the original ground level in a fairly straight line and within a radially confined space to the area of “Spring 141”, where it emerged at the original measuring point, located in the manhole.

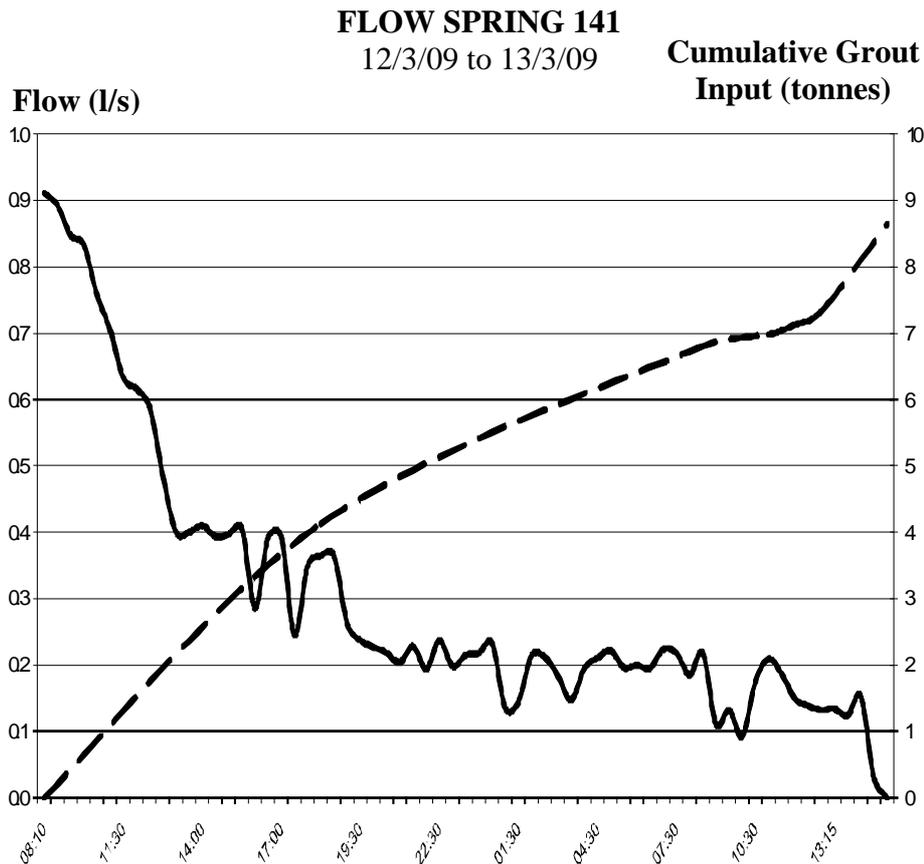
Figure 6. Plot of flow in Spring 141 against grout input

At 19:00 a decision was taken to slow down the rate of grouting. Again, at 08:30 the following morning it was decided to slow down the rate of grout input further. At this point, there were signs that the pipe upstream of the Spring 141 outlet was beginning to block up at times, but freeing itself every so often (Figure 6.).

At 08.00 on 12 March 2009 grouting commenced at a rate of 0.4 tons of cement per hour and a water to cement ratio of 3:1. Grouting continued for the following 31 hours at cement to water ratios and rates of input as detailed in Table 1 below. The flow observed in Spring 141 reduced significantly in the first five hours of grouting, reducing from 0.9l/s at 08.00 to 0.4l/s at 13.00 (Figure 6).

Because the slow-down in rate of grout input was not sealing the leak completely it was decided to thicken up grout at 11:30 and again at 13:30. The leak was completely sealed by 15:00. The total quantity of cement used up to this point was 8.64 tons.
