Underwater repair of a 113 m high CFRD with a PVC geomembrane: Turimiquire

A. M. SCUERO, Carpi Tech, Chiasso, Switzerland

SYNOPSIS. The paper discusses repair of Concrete Faced Rockfill Dams (CFRDs) with geomembranes, with emphasis on a project where a geomembrane system is being installed underwater in 2010, at Turimiquire, a 113m high CFRD in Venezuela, designed by Barry Cooke. An exposed polyvinylchloride (PVC) geomembrane is being installed to restore imperviousness to the deteriorated facing where leakage has reached 9,800 l/s. The 2010 project will cover the area requiring immediate repair, and it is expected that the remaining parts of the upstream face will be lined in subsequent projects.

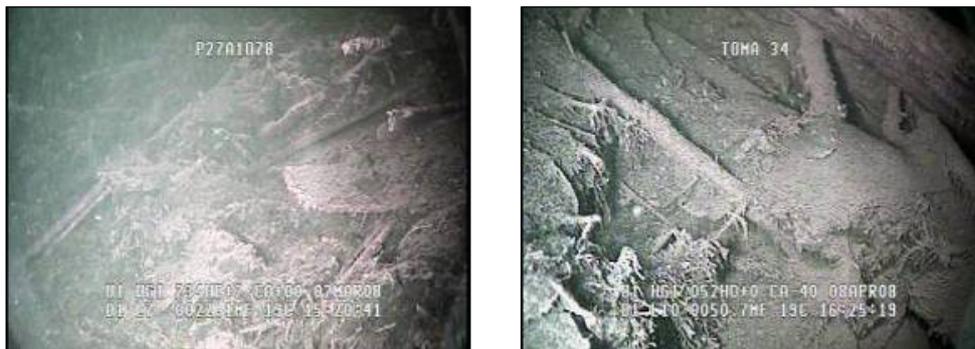
at the toe), an influence of the settlements detected at the crest on the deep slabs. The concrete showed scales and loss of cementitious material in several places (honeycombs). The crater was plugged by tree logs that had penetrated the slab (video evidence). In addition to the erosion on the slabs at elevation 275m to 285m there was a permeable area below the geomembrane placed in 2000. The geomembrane had been locally displaced and formed large undulations and folds. Part of the perimeter anchorage had also been displaced. Foreign material found during the investigation included tree logs and sediments of different types with a solid spongy consistency.

Figures 1 and 2. Various sediments during underwater inspection

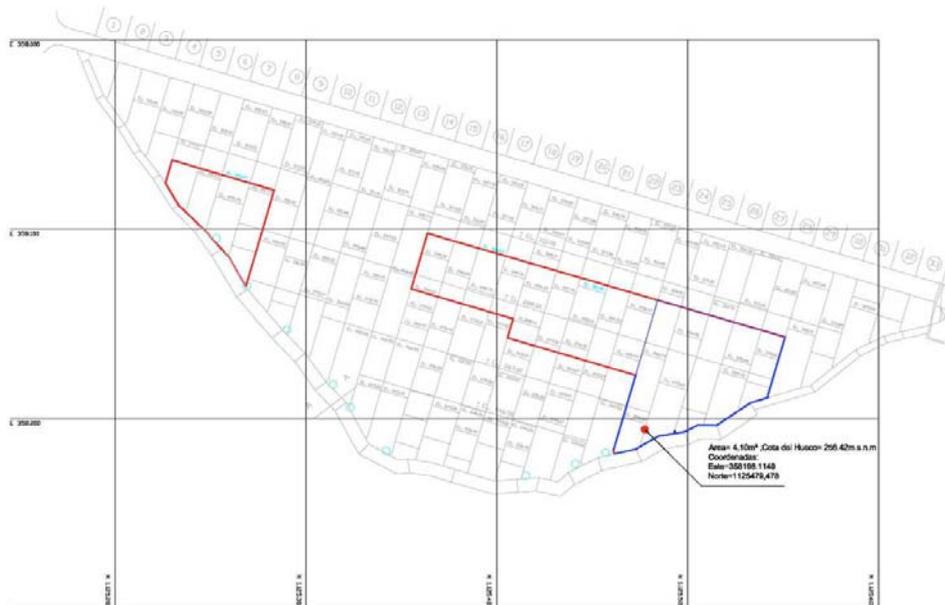
The inspections and the analysis provided unquestionable evidence of the deterioration of the concrete facing, and of the very poor outcome of all repair measures previously adopted. In May 2008 a preliminary decision was taken to install an impervious polyvinylchloride (PVC) geocomposite over the critical areas shown in Figure 3. The residual leakage estimated by the owner after installation of the geomembrane on the critical areas was around 3,000 l/s.

Figure 3. The critical areas to be waterproofed according to the preliminary decision

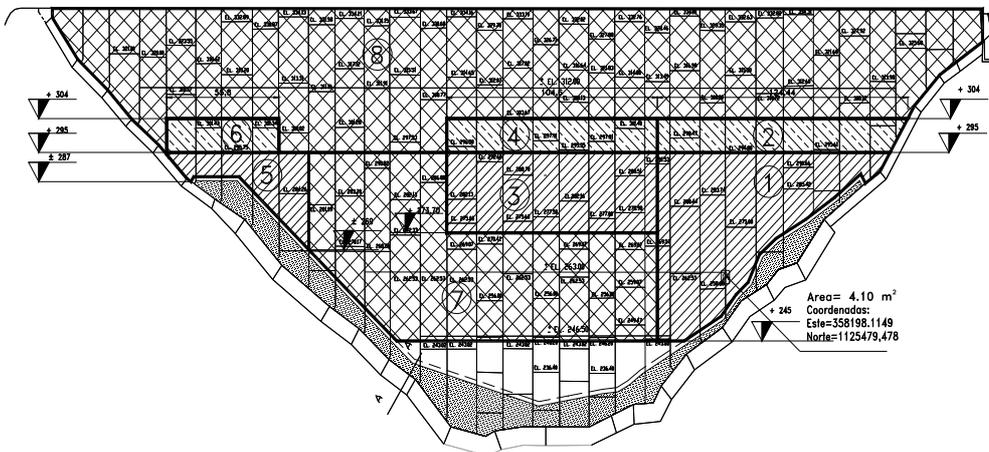
- Areas 1, 2, 3, 4, 5 and 6 (see Figure 4) are to be lined first, under the same contract, from elevation 304m down to elevation 245m. The total acceptable residual seepage is not to exceed 3,000 l/s.
- Areas 7 & 8, being less crucial, are to be lined in a subsequent phase, under a separate contract.

Installation will be carried out in the dry in areas 2, 4 and 6, by technicians working from travelling platforms suspended from the crest, and working underwater in areas 1, 3 and 5 by divers based on floating pontoons moored in the reservoir.

Figure 4. The areas to be waterproofed according to the preliminary design

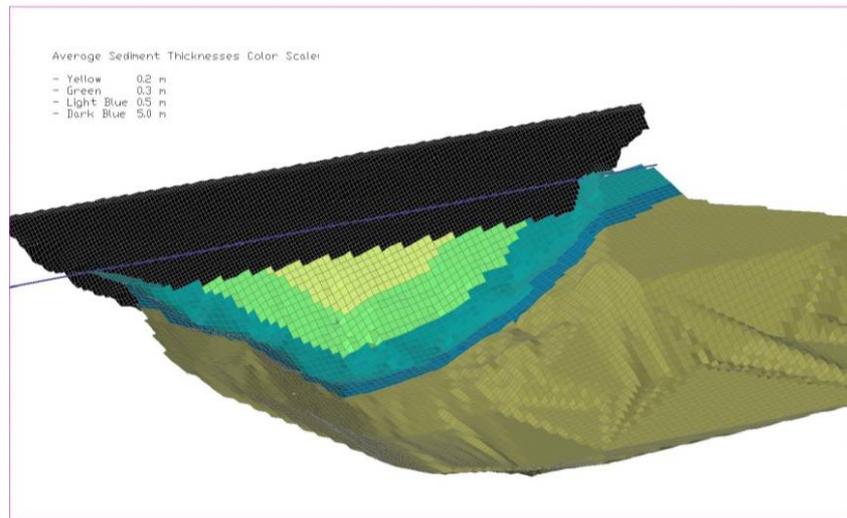
Prior to the final design an underwater inspection was performed, with a multi-directional sonic probe and with multi-beam Sonar Konsberg 974. The survey showed that the thickness of the sediments varied with depth from a zero value a few metres below the normal water level to a maximum of 5m at some locations on the plinth, as shown in Figure 5 (the survey was in an orthogonal direction, with the real thickness derived trigonometrically).

Figure 5. Distribution of sediments from the underwater survey

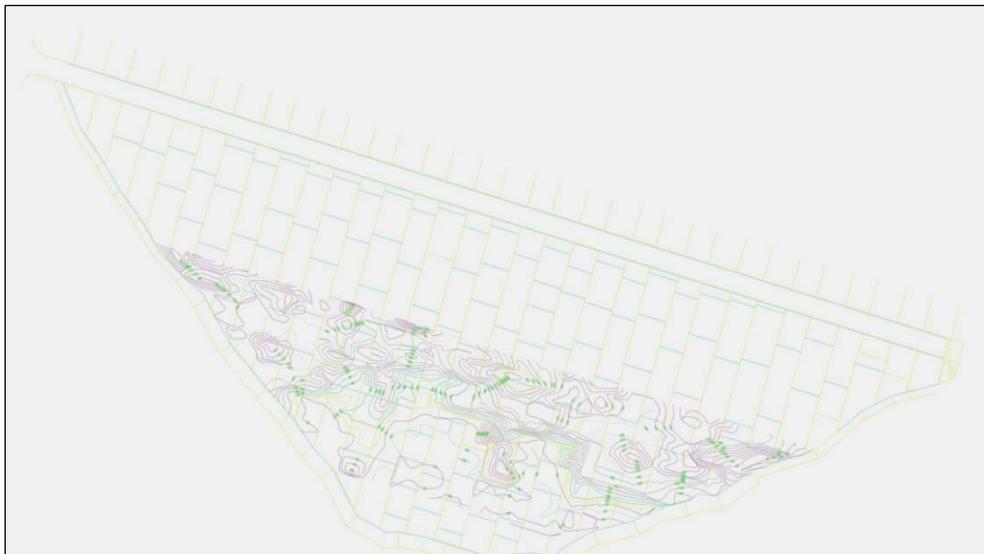
The sonar inspection was difficult due to a “background noise” that did not allow a totally accurate localisation of the patterns of water infiltration. Figure 6 shows the result of that inspection.

Figure 6. Leakage paths according to sonar inspection

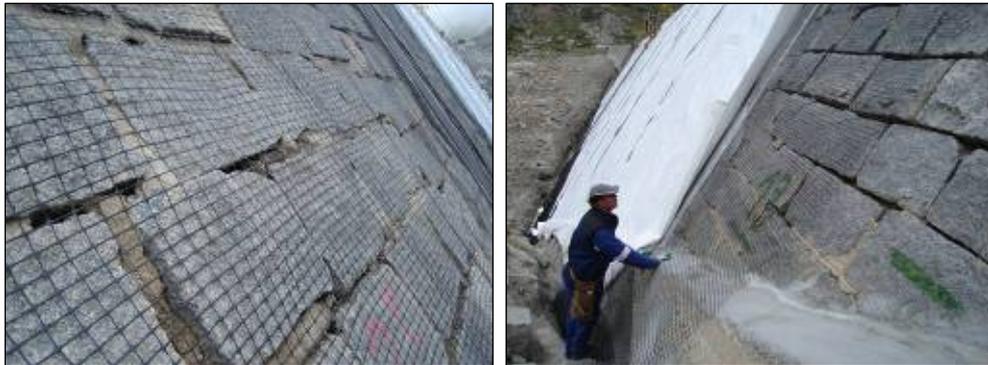
Figures 7 and 8. Support geogrid and anti-puncture geotextile at Karagjol rockfill dam in Bulgaria

The surface of the slabs, after removal of the sediments up to a thickness of 300mm and total removal of the geomembrane installed in 2000, will be cleaned by hydro-jetting. Then a two-layered geosynthetic system will be installed over the entire surface to be lined. This will comprise a support layer, comprising a geogrid with tensile characteristics to provide the required strength over the cavities, and an anti-puncture layer consisting of a 2000 g/m² polyester geotextile that will be installed on the entire surface on top of the geogrid. This configuration has already provided very successful performance in previous repairs, as shown in Figures 7 and 8.

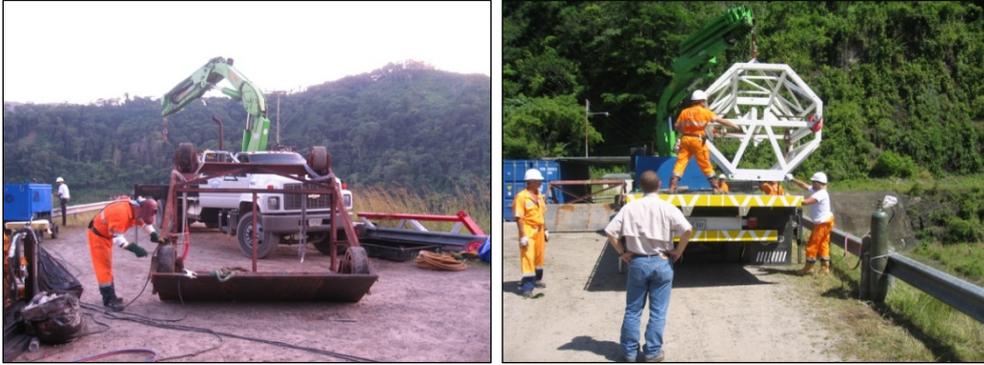
Figures 9 and 10. At left equipment for removal of sediments, at right the structure for placing the waterproofing system, before assembling

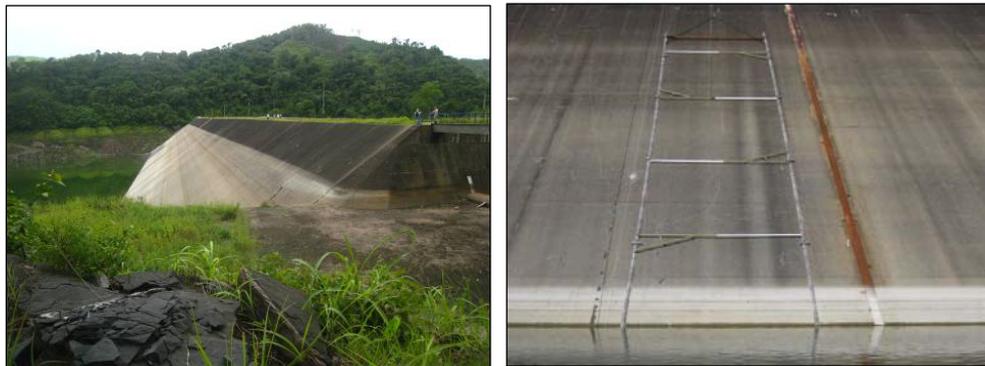
Figures 11 and 12. The vertical anchorage profiles being lowered in to the water

The programme for the waterproofing works showed installation to be carried out first in the underwater part, and the divers' crew mobilized on November 1 2009. Divers started working in Zone 3, with water level at elevation 306m. Elevation 295m, originally established as the limit between dry and underwater installation, should be reached in June or July 2010. Divers will continue work as the water level varies depending on operational needs, and the extent of the underwater/dry installation will be adapted accordingly. By the end of 2009 work completed included cleaning the slabs, removal of sediments having a thickness of not greater than 300mm, and installation of 240m of vertical anchorage profiles.
