## **Remedial grouting works to two dams in Hong Kong**

D. GALLACHER, AECOM, Edinburgh, UK

**SYNOPSIS.** Tai Tam Upper and West Col Dams in Hong Kong had experienced substantial leakage over an extended period. Recommendations were made in the interests of safety for both dams to investigate and carry out remedial grouting works to reduce leakage to acceptable levels. Reference is made to their history and earlier unsuccessful attempts to reduce and control leakage.

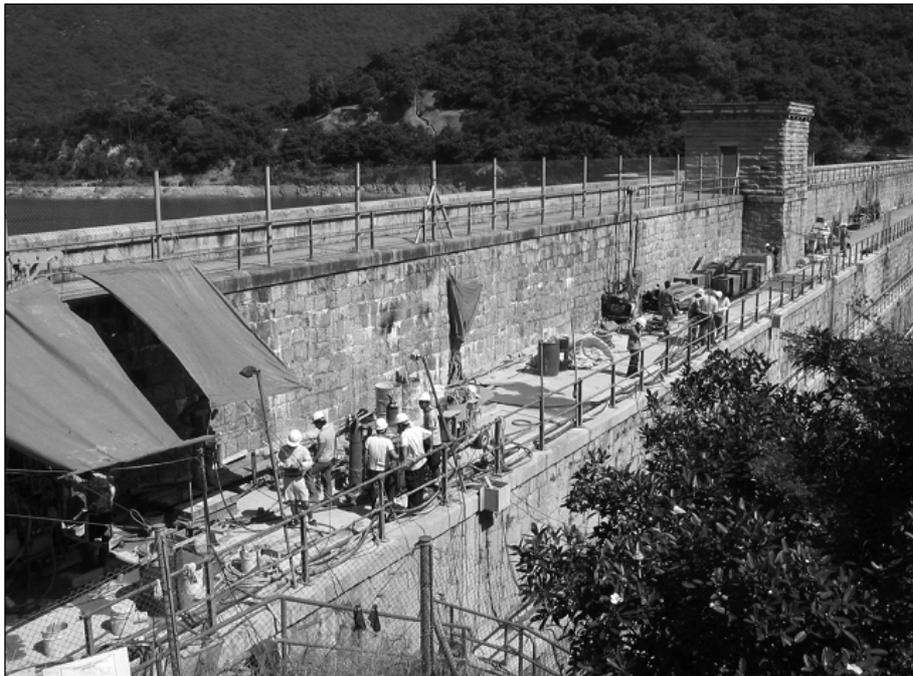
Figure 2. Tai Tam Upper Dam – Grouting at right abutment

There was a history of leakage at the right abutment of the dam since construction, as reported by Mr James Orange (Resident Engineer) in his technical paper to the Institution of Civil Engineers in 1890. References to earlier remedial works carried out just after construction and as recommended in the 1987 Inspection Report are made below. The 1998 Inspection Report found that leakage had increased since the remedial works

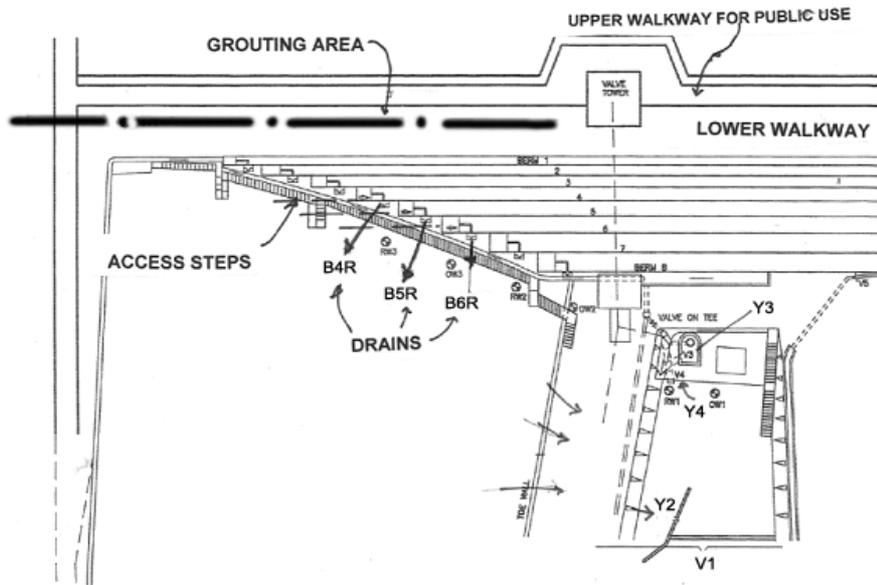
recommended in the 1987 Inspection Report had been carried out. The 1998 Inspection Report recommended that a further leakage investigation be carried out. Positions for monitoring leakage at the dam are shown on Figure 3.

Figure 3. Tai Tam Upper Dam - Plan at right abutment

The 1998 Inspection Report found that leakage at the berm drains (B4R, B5R and B6R) had increased substantially and was still rising. The above report recommended that further leakage investigation be carried out. In the Advisory Report – Advice on Leakage at Tai Tam Upper Reservoir Dam, December 2002, the key findings were that leakage at the key berm drains had increased to 170 l/min and was still rising, and was now about 75% of the pre-grouting leakage amount. The effects of grouting had had been substantially lost by erosion of the grout curtain below the dam and the surrounding ground. Deposits of sand, silt and soft grout were found at the drainage outlets. It was concluded that leakage at the right abutment would be likely to increase at least to the pre-grouting level and erosion of material below the abutment would continue.

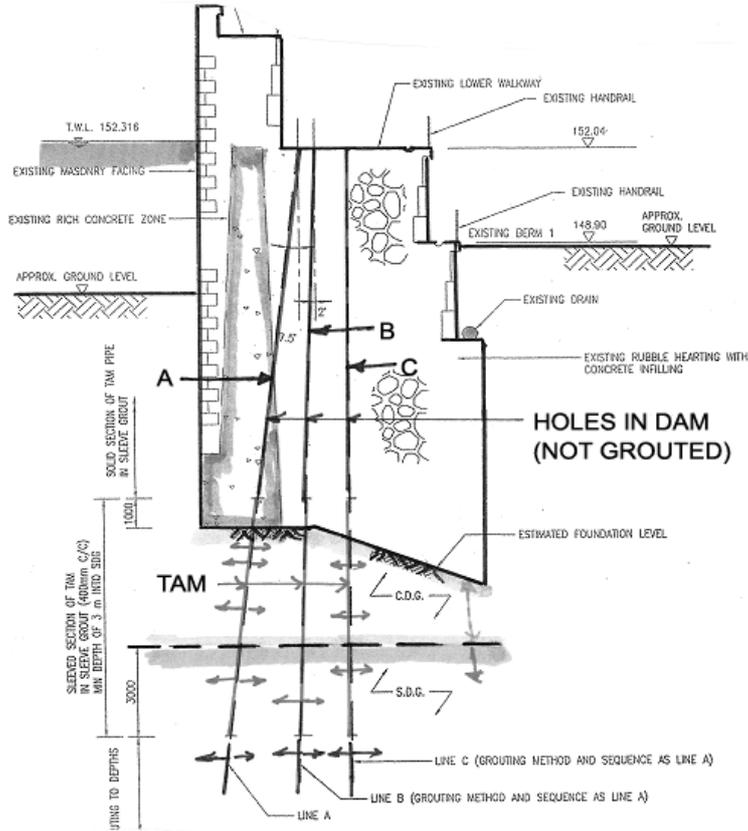
Figure 8. Tai Tam Upper Dam - Typical grouting Section

previous occasion and had not been effective in permanently reducing leakage. A three line grout curtain was proposed for the new grouting works to provide a wider grouted zone, Figure 8, and with grouting works being carried out with the reservoir in service within a range of specified levels in order that effects of grouting could be seen as work proceeded.

Previous unsuccessful grouting at Tai Tam Upper Dam in 1991 and 1993 had been carried out with OPC to BS 12 but on this occasion it was proposed that OPC would only be used for sleeve grout and filling grout holes. The typical grouting cross section is shown on Figure 8 where lines A and C are the upstream and downstream lines and line B is the central line.

TAM primary holes (3m c/c) in lines A and C in the completely decomposed granite (CDG) below the dam were grouted and then TAM secondary holes at 1.5m c/c. TAM holes were extended in stages for fissure grouting in the more solid CDG and slightly decomposed granite (SDG). Tertiary holes for TAM and fissure grouting at 0.75m centres were added as required. Insta Grout and RheoChem 900 cement were normally used for TAM grouting and RheoChem 650 and 900 cements for fissure grouting. Where sleeve opening pressures in TAM grouting were high in CDG, “open hole” fissure grouting in downward stages was adopted for more effective grout penetration. About 45m of the foundation below the dam was grouted plus an angled section into the abutment beyond the dam. High grouting pressures were used to maximize grout penetration.

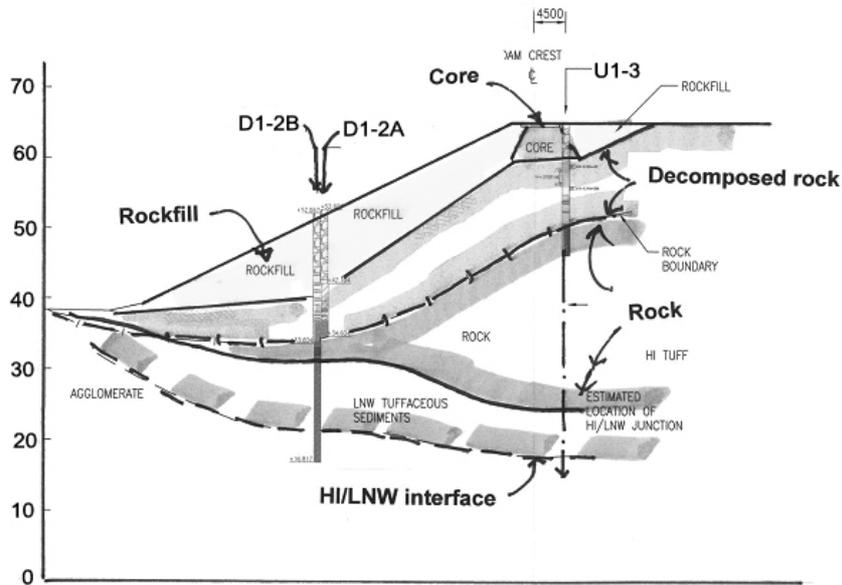
The dam at the platform is underlain by porphyritic tuff of the High Island Division, and the depth and degree of weathering below the dam varies, see Figure 9. The High Island Division is underlain by Lan Nai Wan Division which consists of rhyolitic agglomerates in this area which outcrop at the platform at the downstream side of the dam. There are tuffaceous sediments at the junction between the High Island and Lan Nai Wan Divisions.

Figure 9. Ground condition below the dam

It was found that the additional grouting did not reduce seepage at the reservoir levels for which comparisons were available. Grout stages with high Lugeon values were found in upper zones of decomposed rock and in the region of the High Island and Lan Nai Wai junction. Grout takes in the latter stages were very low indicating that grout could not penetrate

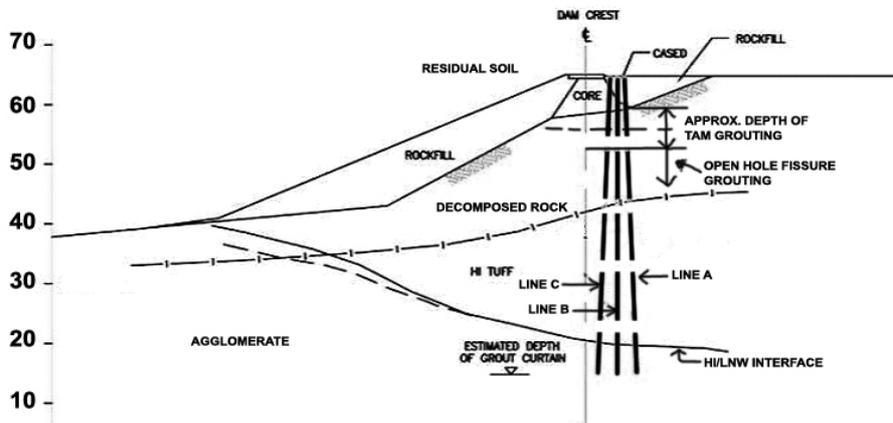
Figure 10. West Col Dam - Typical grouting section

The same grouting materials were specified for the contract as had been used successfully for Tai Tam Upper Dam. A grouting typical cross section is shown in Figure 10, with lines A and C being the upstream and downstream lines respectively and line B the central line. It was specified that the reservoir water during the grouting works should be kept above 55m PD (that is about 6m below overflow level) to check the impact of grouting during grouting works. The minimum level of 55m PD was later changed to 50m PD because of low reservoir levels when grouting started.

TAM primary holes (6m c/c) in lines A and C in residual soil and decomposed volcanic rock below the dam were grouted and then TAM secondary holes at 3m c/c. TAM holes were extended in stages for fissure grouting in the more solid volcanic rock. Tertiary holes for TAM and fissure grouting at 1.5m centres were added as required. Insta Grout was used for TAM grouting immediately below the clay core with pressures up to 4-6 bar for about 4-5 stages of 0.4m depth. Ultrafine cement grout
