Stability issues at Intake UD

A. ROWLAND, Black & Veatch, Redhill, UK
Dr C.F. WAN, Black & Veatch, Hong Kong

SYNOPSIS. Intake UD in the New Territories of Hong Kong diverts water from a rocky stream into a tunnel system feeding into High Island Reservoir. The majority of the diversion structure is a siphon weir with a height of 9m above downstream ground level. The structure is constructed predominantly of mass concrete with reinforcement provided only in the siphon inlets and hood.

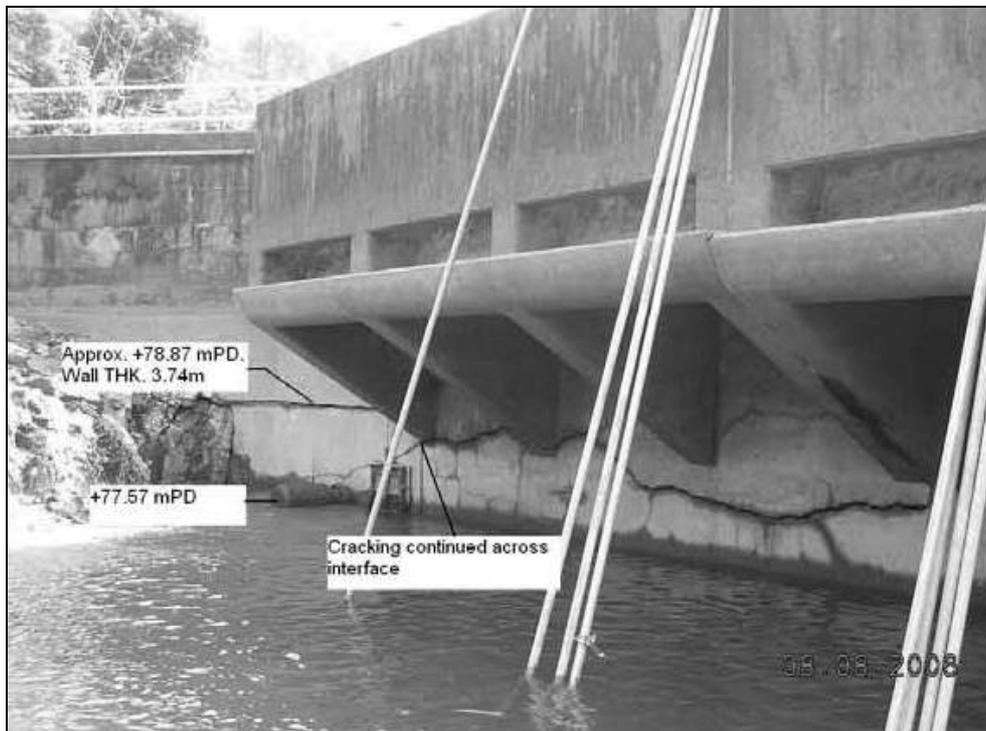
Plate 1. Left end of siphon unit and left abutment wall

During an inspection of the structure in 2006 a crack was observed in the upstream face of the gravity weir, just below the springing point of the cantilevered side wall of the inlet structure. As can be seen in the photographs, the crack is continuous across the front of all three blocks, but is widest in the left hand block. There is also cracking in the adjacent wing wall just above the penstock that can be seen in the photograph.

There is very clear movement of the top of the units relative to each other and to the abutment walls, consistent with upward movement of the upstream side of the structure. The amount that the structure has lifted appears to be roughly consistent with, but perhaps slightly greater than, the width of the main crack:

- left unit relative to left abutment wall 30mm
- left unit relative to centre unit 20mm
- right unit relative to centre unit 20mm
- right unit relative to right abutment wall 10mm

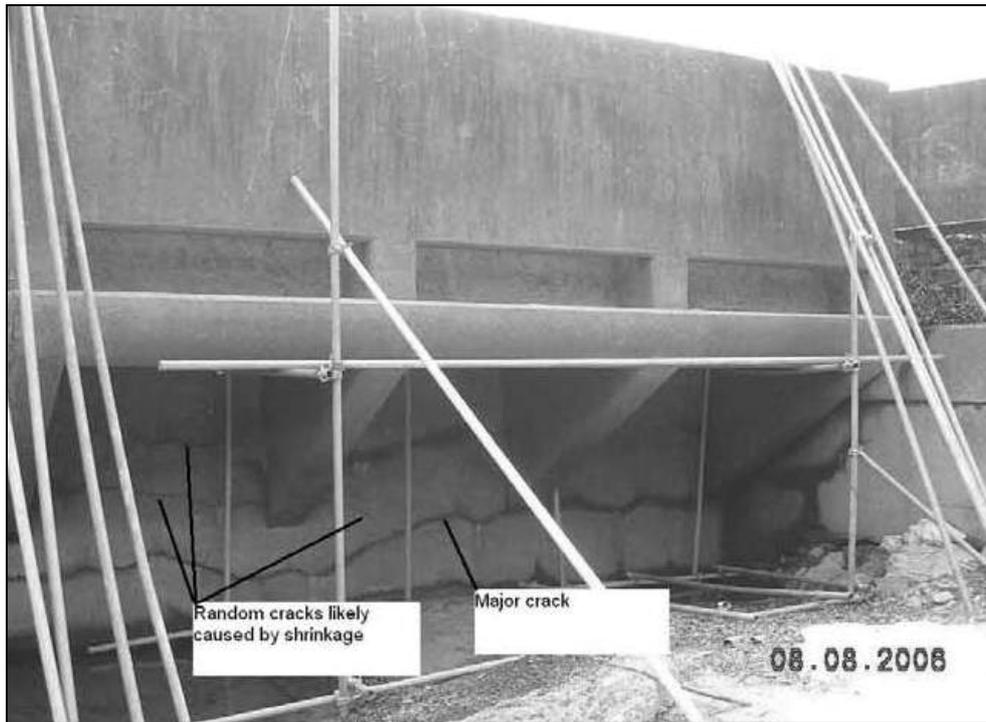
Plate 2. Right end of siphon unit

Apart from the major horizontal crack across the whole length of the three siphon blocks, random cracks, probably caused by shrinkage, were observed on the upstream face of the blocks (Plate 2).

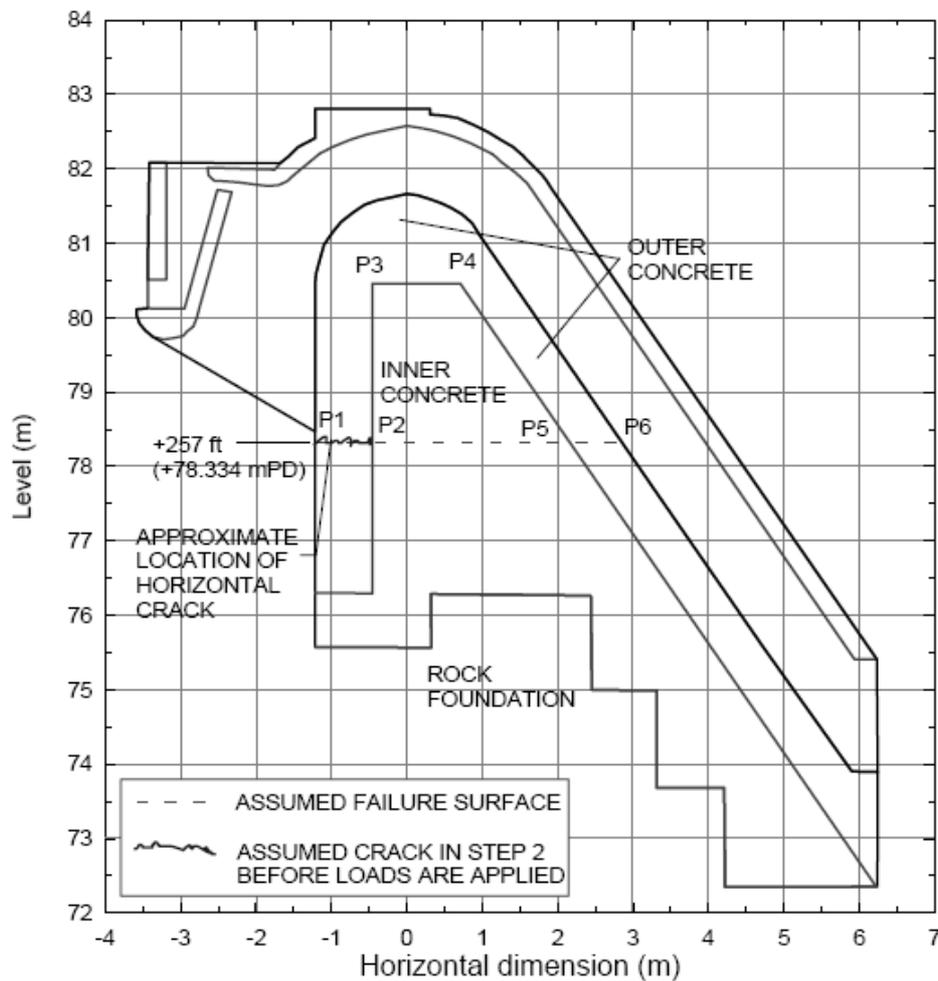
Figure 3. Failure surface for Steps 1 and 2

The analyses reveal that minor tension begins to develop at the upstream face at the analysis level when water level rises above + 83.1 mPD (c.f. top of hood at + 82.808 mPD). If the stress is high enough to initiate tensile cracking at the upstream face, increase of uplift pressure along the crack and

While the FoSs for shear failure and bearing failure remain very high at all water levels up to +83.8 mPD, the FoS against overturning about the downstream toe at location P6 will become only marginally greater than unity when water level is at about +83.8 mPD, about 1m above the top of the hood. In other words, the siphon section would only be at the verge of overturning if the water level should rise to this unlikely level.

The tensile stress at the upstream face remains quite low (less than 34.5 kPa) at a high water level of + 83.8 mPD. The chance of tensile cracking in the concrete due to the applied dead loads and hydraulic loads should, therefore, be very low, as good quality plain concrete can easily withstand a tension of 500 kPa without cracking.

Results of the analysis in Step 2 indicate that the increase in the initial uplift pressure due to the crack only reduces the FoSs slightly at low water levels, when the applied hydraulic loads are not high enough to cause cracking further than through the 0.762m thick skin concrete. At water levels higher than + 83.3 mPD, the FoSs obtained are the same as those obtained in Step 1.

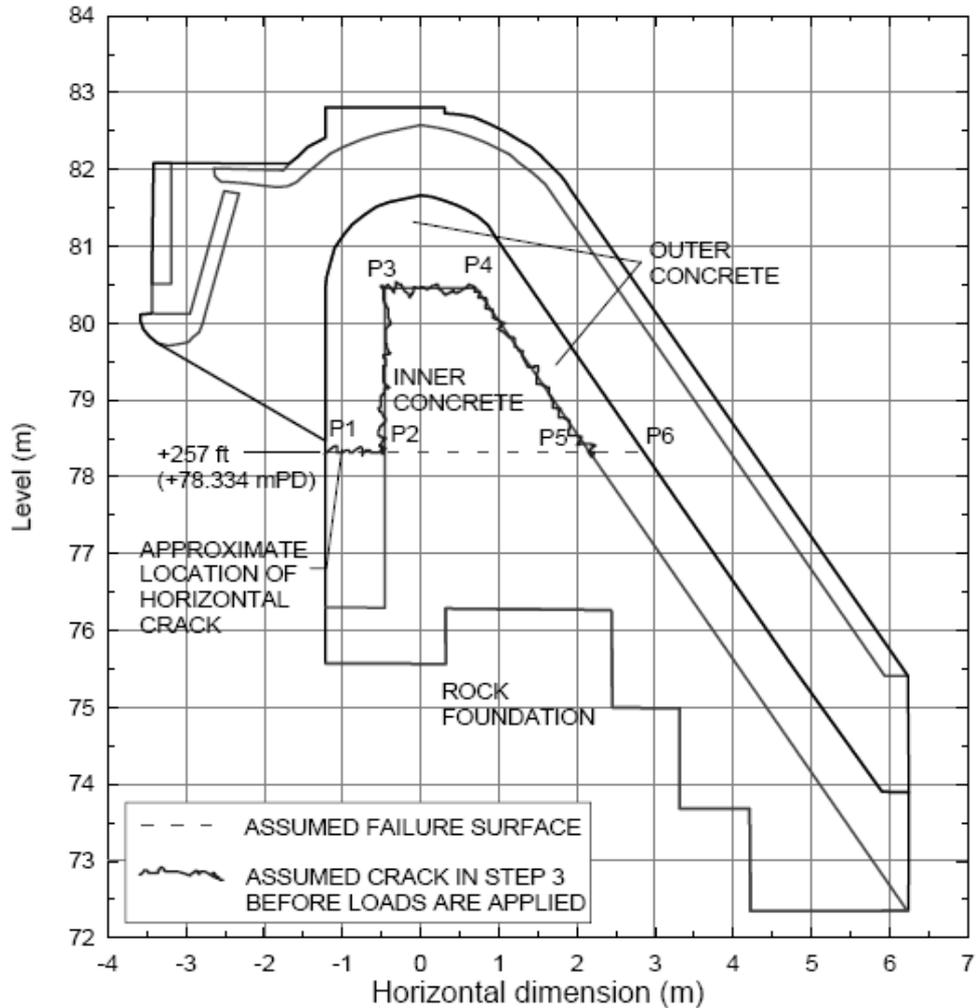
Figure 4. Failure surface for Step 3

The assumed failure surface for the analyses in Step 3 is shown in Figure 4. Analyses in Step 3 assumed that the outer concrete of the siphon block was detached from the inner concrete along points P1, P2, P3, P4 and P5. Full uplift pressure was assumed to develop along the separation before other loads were applied.

Due to the assumed detachment of the outer concrete from the inner concrete, the weight of the inner concrete core was not taken into account when assessing the FoS against overturning about point P6. Results of the stability analyses indicate that the FoS against overturning is significantly reduced when compared with the results of analyses carried out in Step 1 and Step 2, and is reduced to unity when the water level reaches about +83.3 mPD (about 0.5m above the top of the siphon hood). At about the same water level, detachment of the outer concrete from the inner concrete will extend beyond point P5, resulting in even higher uplift pressure than estimated.

The FoS against shear failure along a plane at elevation + 78.33 mPD remains very high for a water level up to + 83.3 mPD, as the shear resistance of the inner concrete is taken into account in the stability analysis.
