Leakage Remediation Works at the Hampton Distributing Reservoir

S QI, AtkinsRéalis

SYNOPSIS Hampton Distributing Reservoir is a non-impounding reservoir built in 1900s and located in Hampton, southwest London. The reservoir, formed by a typical puddle clay core embankment, has a total perimeter of 800m and a storage capacity of 32,000m³.

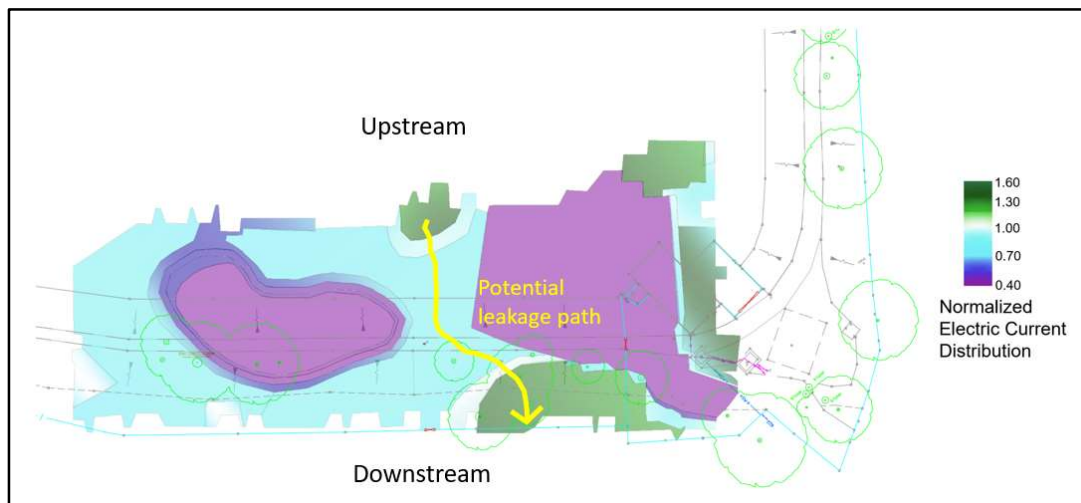
Due to a continuing trend of settlement, in 2020 the reservoir Supervising Engineer (under the Reservoirs Act) requested a geophysical seepage survey in order to investigate potential leakage problem in that section of the embankment. The survey identified a zone of leakage extending some 20m on the south side of the dam (Figure 2) at the same location where the larger settlement was recorded.

Seepage survey results showed the leakage at a depth of approximately 9m below the crest level which corresponds to the bottom of the puddle clay trench. It was suspected that the leakage passed through the clay core at the interface with the London Clay formation. The concentrated leakage paths could lead to internal erosion of embankment materials. If the

Figure 2. Geophysical seepage survey showing the leakage zone

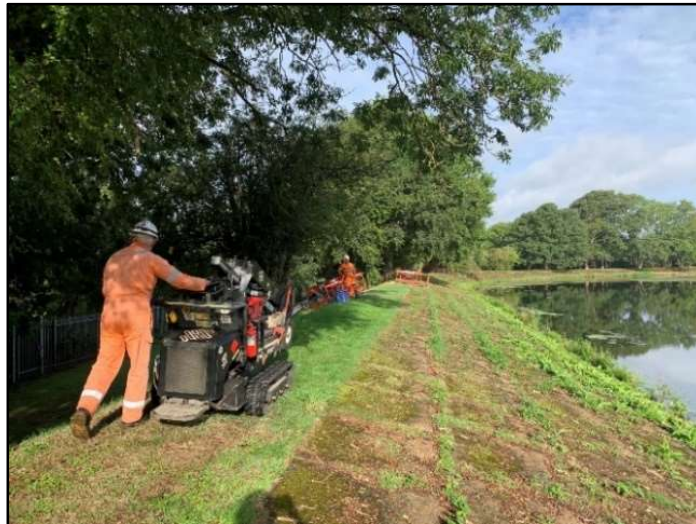
Difficult site access and limited working space were the main challenges in the project. The width of the embankment is only 1.8m. The embankment slope and downstream toe are populated by some large trees and vegetation which limits the headroom on crest, as shown in Figure 3 below. The reservoir area is a Ramsar site and a 'Site of Special Scientific Interest (SSSI)'.

Figure 3. Small portable drilling rig on narrow crest

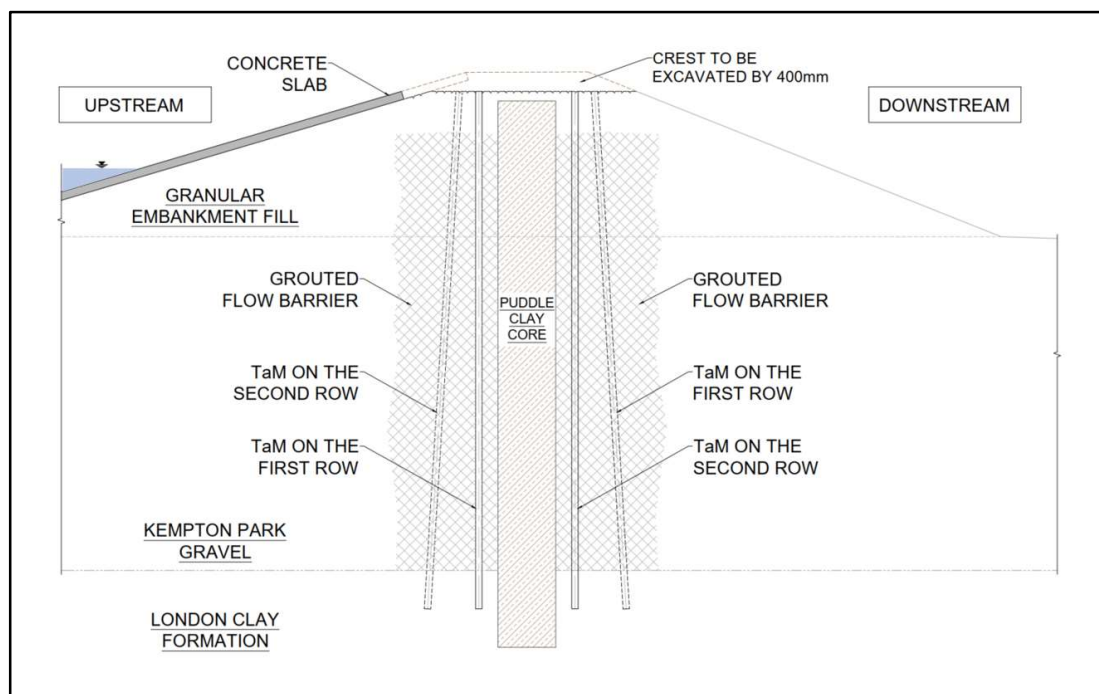
A cross section of the proposed target zone for permeation grouting is presented in Figure 4. Two rows of TaM pipes were installed upstream of the dam core and two more rows were installed downstream of the core. The inner row grout holes were vertical. However, due to the limited crest width, the grout holes on the outermost row were inclined ('raked') with an angle of 10° which provided a broader grouted zone at the base where leakage was predicted to be most pronounced. This approach provided sufficient space for personnel to safely work on the crest.

Figure 4. Grout injection zone within the dam

The grout holes were provided with a minimum 1m toe-in to the London Clay in order to achieve a good contact. The findings from the GI works indicated that the leakage zone may extend higher than the most pronounced paths determined by the geophysical survey. Therefore, the targeted zone of grouting was 8m deep extending from the dam shoulder into the London Clay formation, below the base of the Kempton Park Gravel.

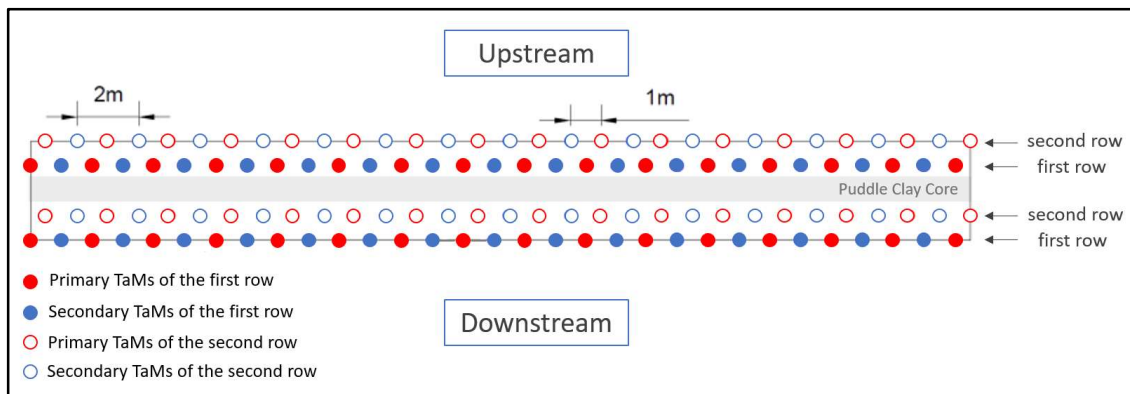
A plan view of the grout hole arrangement on the embankment is presented in Figure 5. Two rows of TaM pipes were installed on an equilateral triangular grid on each side of the puddle clay core. The holes were spaced at 1m centres, in line with the CIRIA C774 (CIRIA, 2018) recommendation for medium to fine sand permeability ranges between 10^{-4} and 10^{-5} m/s.

Figure 5. Grout borehole arrangement

The grouting works were carried out in five phases in the following sequence:

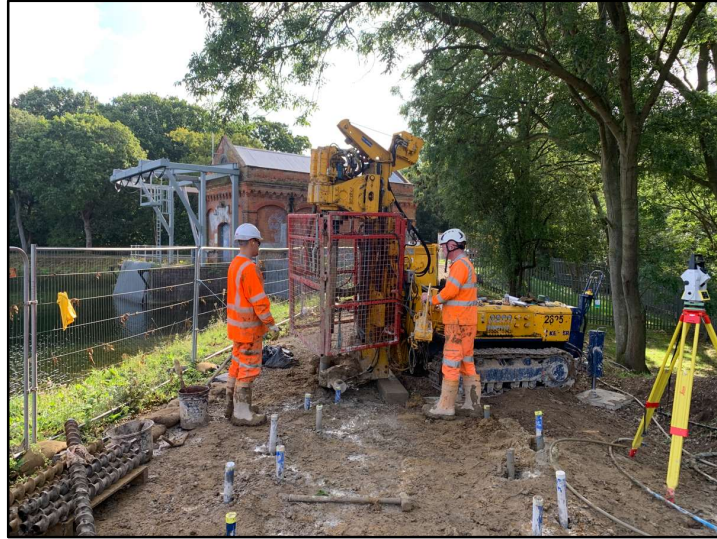
Because of the requirements of maintaining freeboard and allowing for sufficient cover to the puddle clay core, the maximum depth of excavation to create a wider working platform was limited to 400mm. Due to limited working space and difficult access, the geotechnical contractor used a small drilling rig (Klemm 702) with a width of only 750mm when it is tracked into position, which helped to overcome the accessibility constraints (Figure 7).

Figure 7. Drilling works on the crest

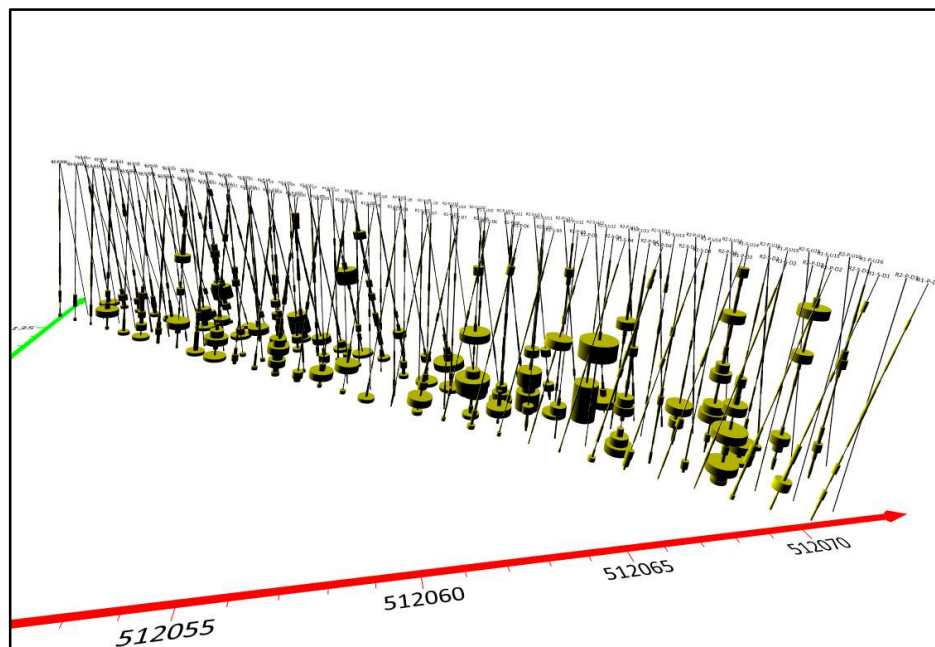
Following the completion of daily grouting work cycle, grout data saved in the pump module was extracted and subsequently fed into a 3D model. Graphical output from the 3D model was generated to present the injection parameters at the as-built locations of each grout port. This allowed daily recording and monitoring of grouting parameters as the work progressed. It also facilitated the effective use of the observational approach, in which regular reviews of the grouting data was used to determine the extent of the subsequent grout injections. Figure 8 shows the graphical output of the 3D model which presents grout volume at each TaM sleeve.

Figure 8. Graphical output from 3D model showing volume of grout take at each port

Generally, high injection volume was observed in the leakage zone in all four phases of grouting. However, there was an obvious trend of decreasing injection volume in each sleeve as the grouting works advanced. After the completion of all four phases, there was a small number of sleeves where high injection volume was recorded. Additional reinjection was conducted in the selected sleeves where both high grout volume and high flow rates were observed. The volume of grout take in the regouted sleeves was small (<10L per sleeve). It was then considered that no further grouting would be practical or required.
