Leakage Remediation at a Small Heritage Reservoir

P D DOWN, Mott MacDonald

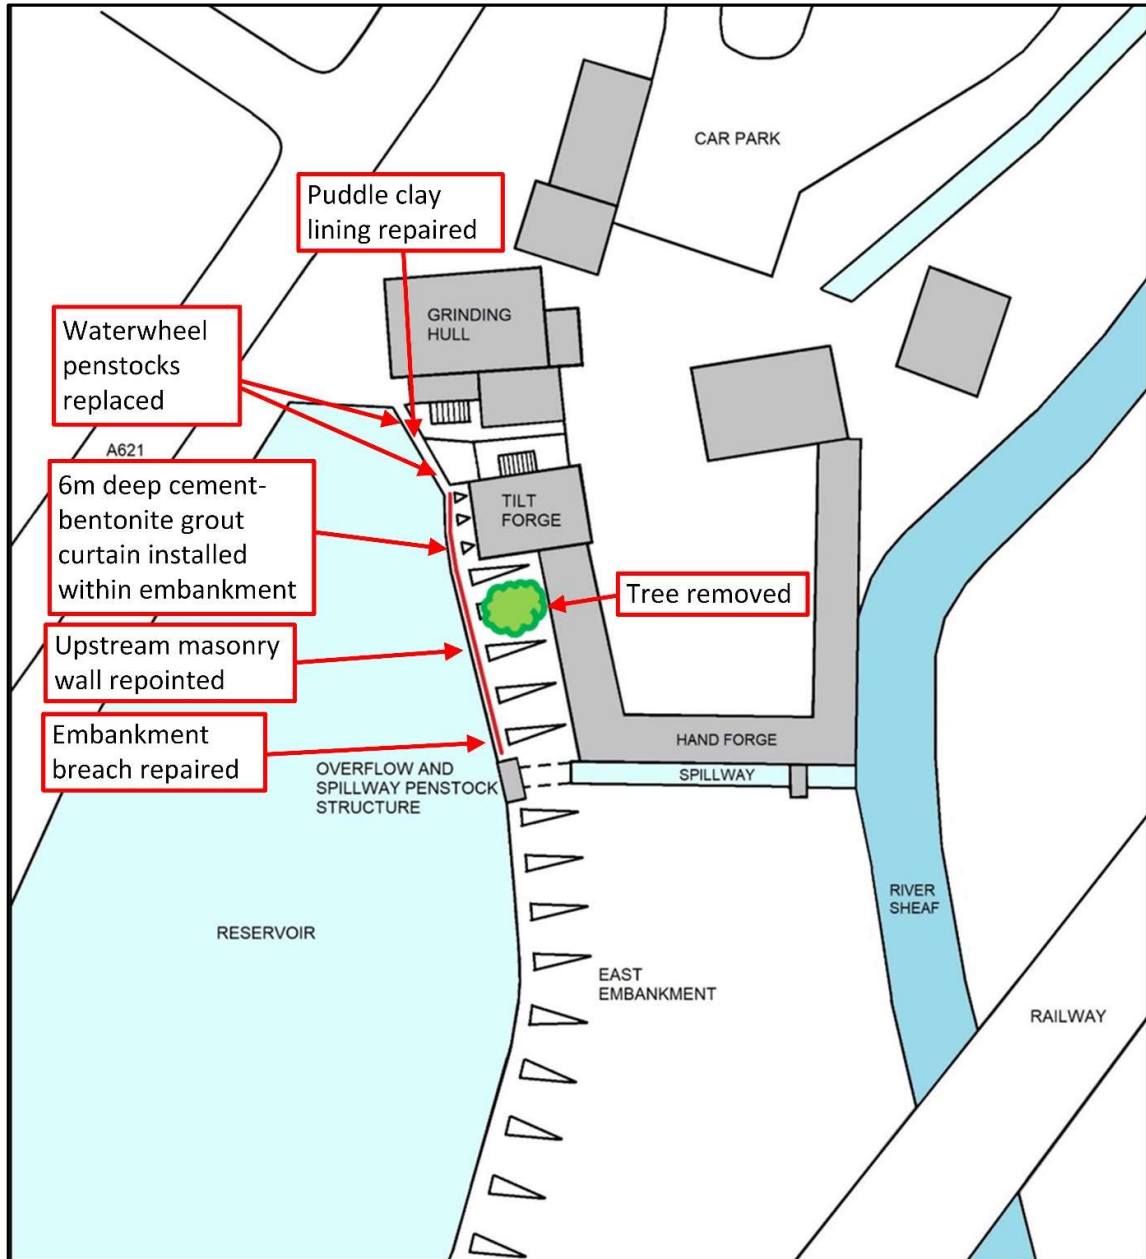
The remedial works performed in 2014 were due to the following issues experienced:

- A breach of the East Embankment, adjacent to the 'Overflow and Spillway Penstock Structure', and erosion of the embankment surface due to flowing water.
- Voids in the upstream vertical masonry wall along the East Embankment.
- A void in the reservoir clay lining immediately upstream of the penstock gate for the 'Grinding Hull' waterwheel.
- Leakage of reservoir water into the 'Tilt Forge' building.
- Leakage of reservoir water into the 'Grinding Hull' building.

Figure 1. Abbeydale Industrial Hamlet, remedial works performed in 2014

The following remedial works were recorded (Figure 1):

- Removal of a mature tree within the East Embankment adjacent to the 'Tilt Forge' building.
- Installation of a 26m long, 6m deep cement-bentonite grout curtain within the East Embankment, from the 'Tilt Forge' building to the 'Overflow and Spillway Penstock Structure'.
- Repair of the breach to the East Embankment left (north) of the 'Overflow and Spillway Penstock Structure'.
- Packing and repointing of the perimeter wall masonry along the East Embankment.
- Replacement of the penstocks to the 'Grinding Hull' and 'Tilt Forge' waterwheels. The upstream aprons were also improved.
- Puddle clay repairs – exact location(s) and extents unconfirmed.

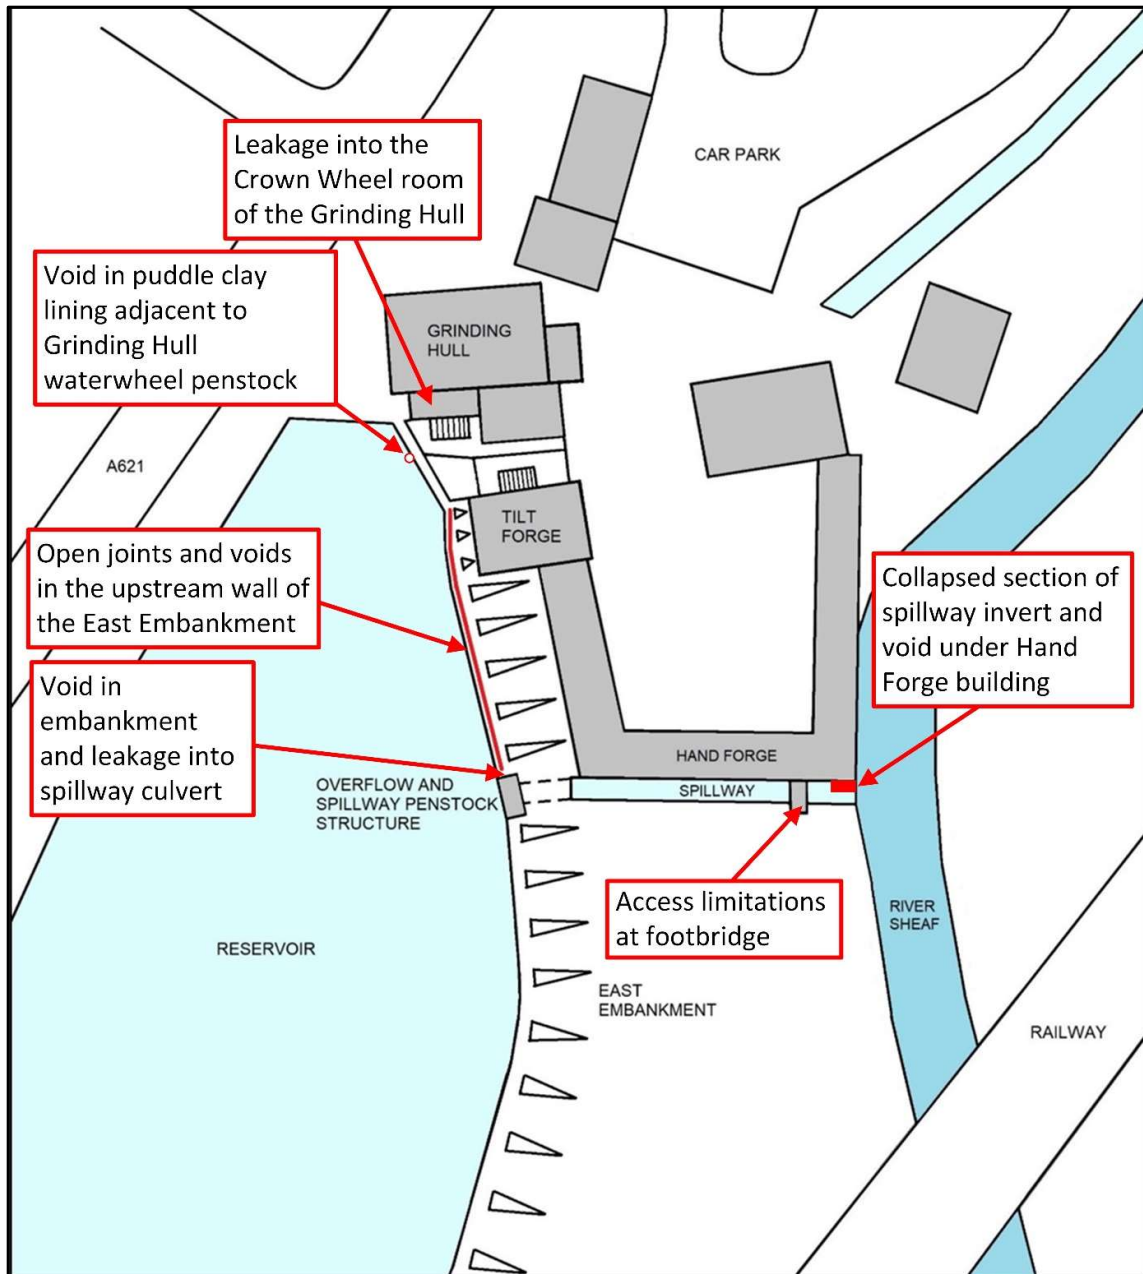
In November 2022, a request was received from the Client to visit the site, assess the situation and provide advice for any remedial works required. During the subsequent visits, the following issues were identified (Figure 2):

- Damage to the downstream end of the masonry spillway channel.
- A void under the 'Hand Forge' building adjacent to the spillway.

- A void and flowing water within the East Embankment crest adjacent to the 'Overflow and Spillway Penstock Structure'.
- Poor structural condition of the masonry spillway culvert. Ingress of water was observed through the culvert wall.
- Historic movement of the upstream vertical masonry wall along the East Embankment.
- Minor ingress of water into the 'Tilt Forge' building.
- Reports of ingress into the 'Grinding Hull' building with damp areas observed.

Figure 2. Abbeydale Industrial Hamlet, damage and leakages in 2022-23

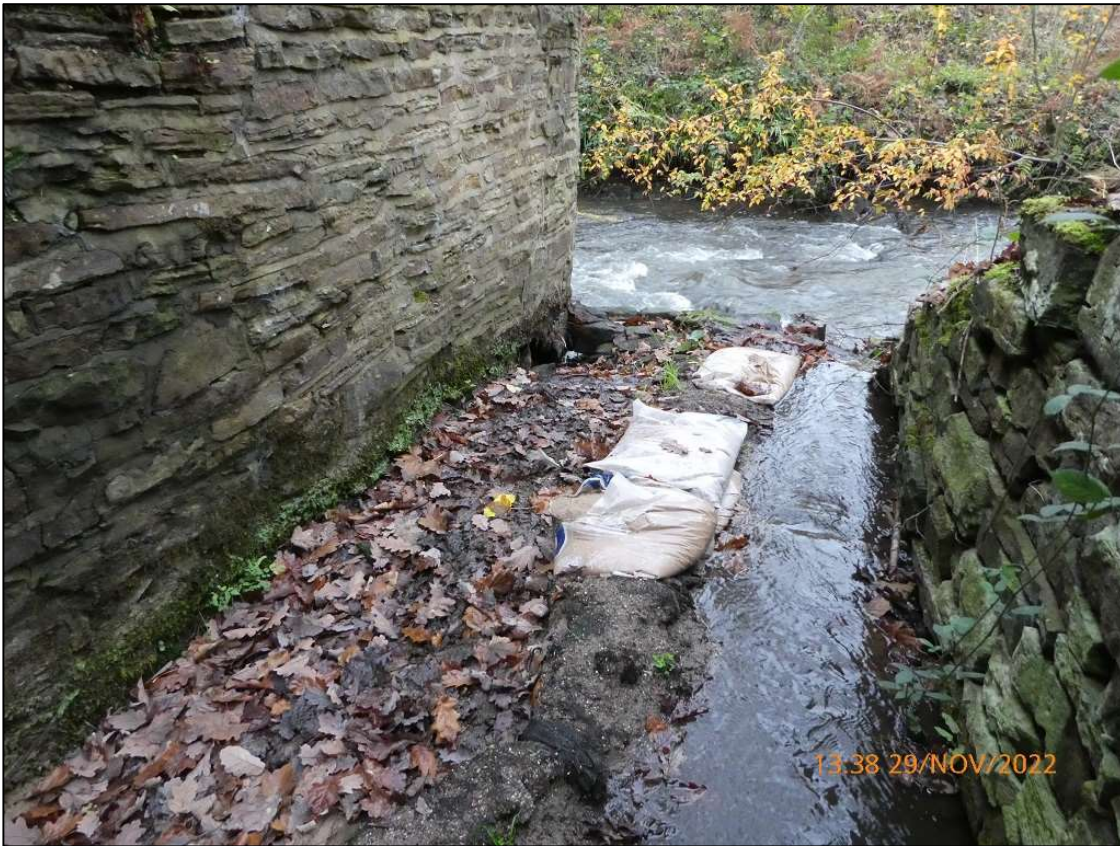
The damage to the downstream end of the spillway comprised a collapsed section of the masonry invert approximately 1.2m long, 1.0m wide and 0.3m deep (Figure 3). There was damage to the end of the spillway, with missing stonework, where it discharged into the River Sheaf. It appeared the action of flows along the River Sheaf had damaged the downstream end of the spillway and washed out material from beneath, creating a void into which the invert collapsed. Within the river channel, immediately adjacent to the downstream end of the spillway, a scour hole, approximately 300mm deep below the water level, was present. A void extended from the spillway under the south-east external corner of the adjacent 'Hand Forge' building. This did not appear to have affected the structural integrity of the building and there were no obvious signs of distress.

Figure 3. Damage to the downstream end of the spillway channel

- Removal of masonry from the end of the spillway channel and erosion of material from beneath the spillway and 'Hand Forge' building due to the action of flows along the River Sheaf. The risk of damage is highest during flood events when there is localised turbulence at the end of the spillway and along the Hand Forge building.

- Spillway Channel: Removal of the downstream end of the existing spillway channel and provision of a concrete foundation slab and wall backing upon which the masonry will be reinstated. At the downstream end, the concrete will extend below the riverbed to provide a scour protection key. The void under the 'Hand Forge' building will be infilled.

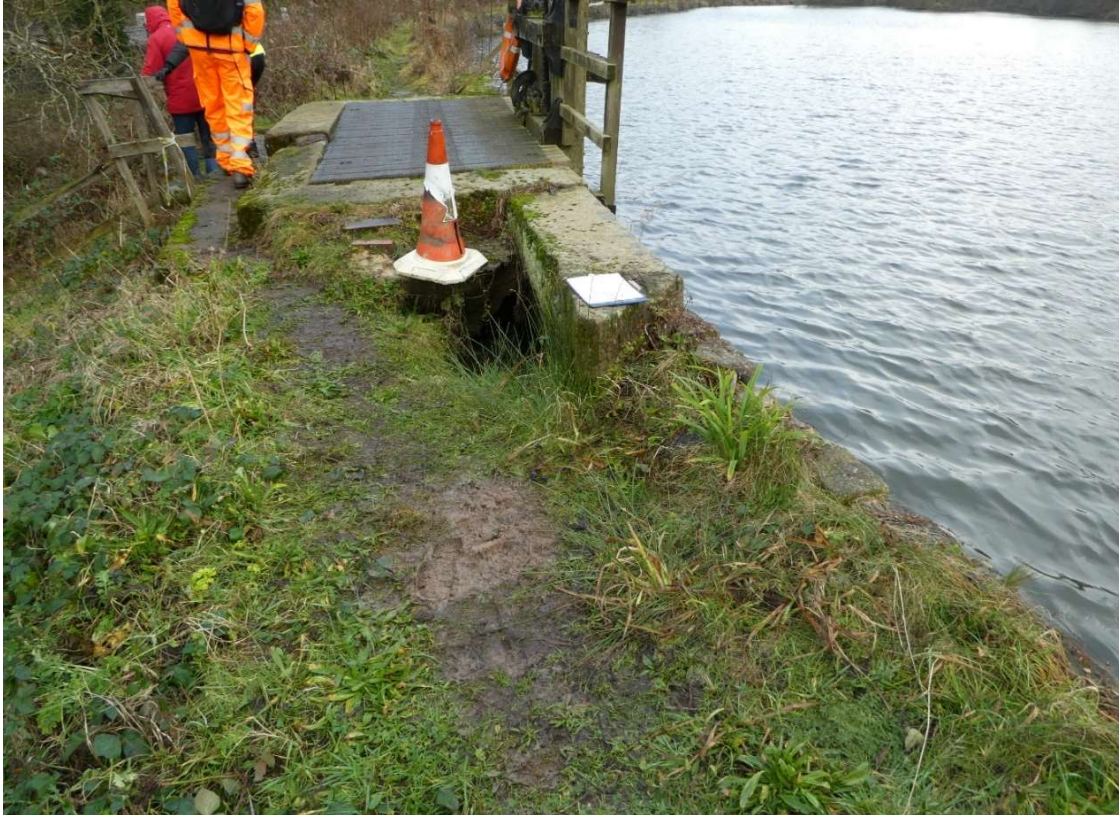
The void within the East Embankment crest was at the same location as experienced in 2014 and there was evidence of previous remedial works (Figure 4). During examinations between November 2022 and July 2023, it appeared to increase in size. At the latter visit, the void measured 1.6m long by 0.8m wide and its base was 0.9m below the adjacent top of wall level. Water was entering the void directly through the upstream wall of the East Embankment. It also entered the void from beneath the adjacent section of embankment crest indicating leaks from the reservoir at other locations along the upstream wall. The water flowed towards the 'Overflow and Spillway Penstock Structure' where it then disappeared into the body of the embankment. This flowpath differed to that experienced in 2014.

Figure 4. Void within the East Embankment adjacent to the overflow and spillway structure

- East Embankment: Grouting of the void that extends down the side of the 'Overflow and Spillway Penstock Structure'. Fast-setting chemical grout is proposed to seal the lower part of the void adjacent to the spillway culvert and address the risk of grout loss into the spillway and River Sheaf. It is anticipated this work will be performed in advance of, or in parallel with, the embankment reconstruction.

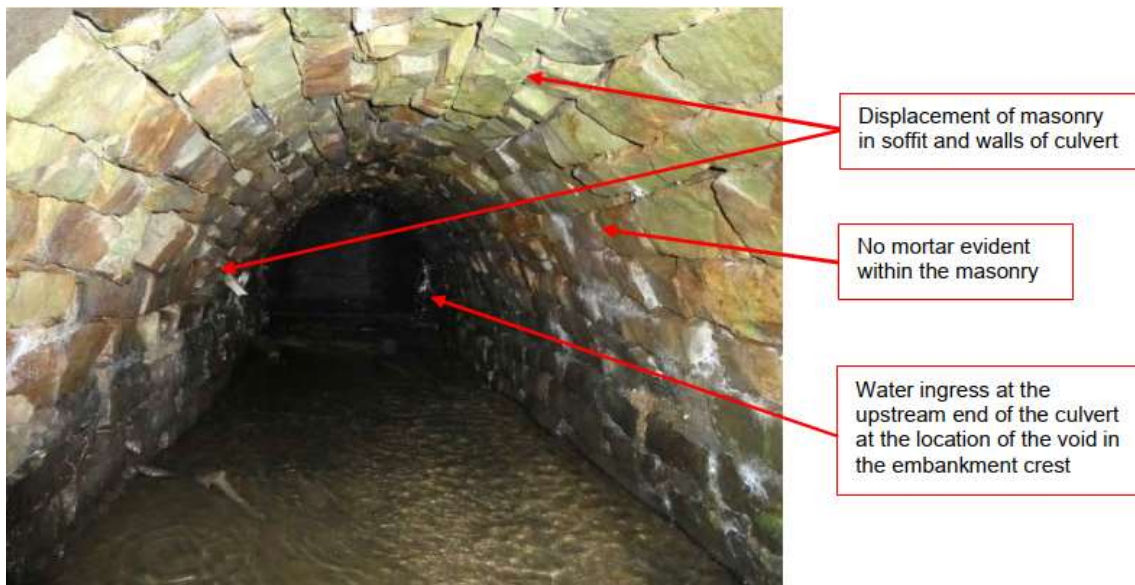
The spillway culvert was arch-shaped with a flat, stone-lined bed and of aged condition. It was approximately 8m long, 1.4m wide and 1.1m high. There was no mortar visible in the joints and some displaced masonry was evident, especially to the soffit and to the right (south) wall (see Figure 5). Towards the upstream end, ingress of water was observed approximately half-way up the left (north) wall, coinciding with the location of the void in the East Embankment above.

Figure 5. General condition of spillway culvert

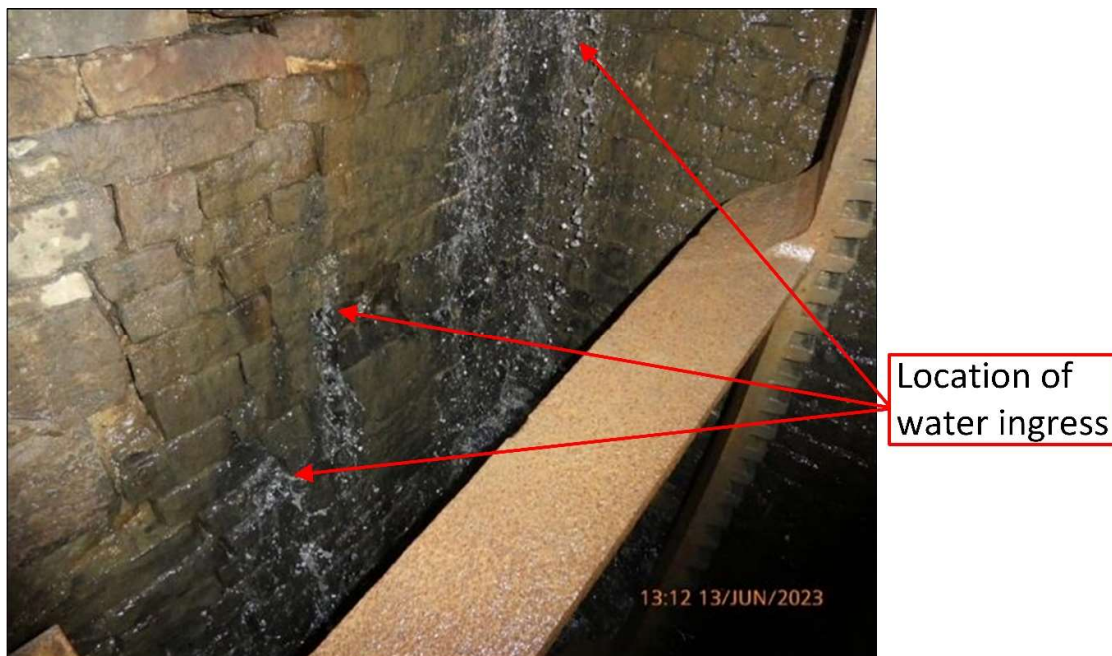
During the initial visits, the museum staff reported water ingress within the 'Grinding Hull' building. The walls of the 'Crown Wheel' room, adjacent to the waterwheel and closest to the reservoir, were damp at the time but no notable water ingress was observed there or elsewhere in the building. There was evidence of historical movement of the south (external) dividing wall between the 'Crown Wheel' room and the waterwheel pit. The masonry to the end of the wall had been displaced towards the opening for the waterwheel axle. In addition, there was displacement and bulging of the wall face into the 'Crown Wheel' room.

Figure 6. Significant water ingress through the walls of the 'Grinding Hull' building

At the end of May 2023, there were reports of notable water ingress into the 'Grinding Hull' building. A subsequent visit confirmed significant ingress of water through the masonry walls of the building, especially in the 'Crown Wheel' room (Figure 6). The source of the leakage was undetermined at that time. It was obvious that the situation had substantially changed and a leak from the reservoir was suspected. Emergency remedial action was required and the Client was requested to arrange draw-down of the reservoir as quickly as possible, monitor the situation and provide regular updates.

Water ingress had filled the cavities within the 'Grinding Hull' building walls, pressurising within them, and escaping through open joints in the masonry. There was concern this would cause further displacement and damage to the walls with the potential for their failure. This would be catastrophic for the Listed building and risked an uncontrolled escape of reservoir water. Due to the potential heritage and environmental impacts, a site meeting to discuss and agree emergency remedial action was urgently arranged and attended by representatives of Historic England, South Yorkshire Archaeological Service, the Environment Agency and other key stakeholders.

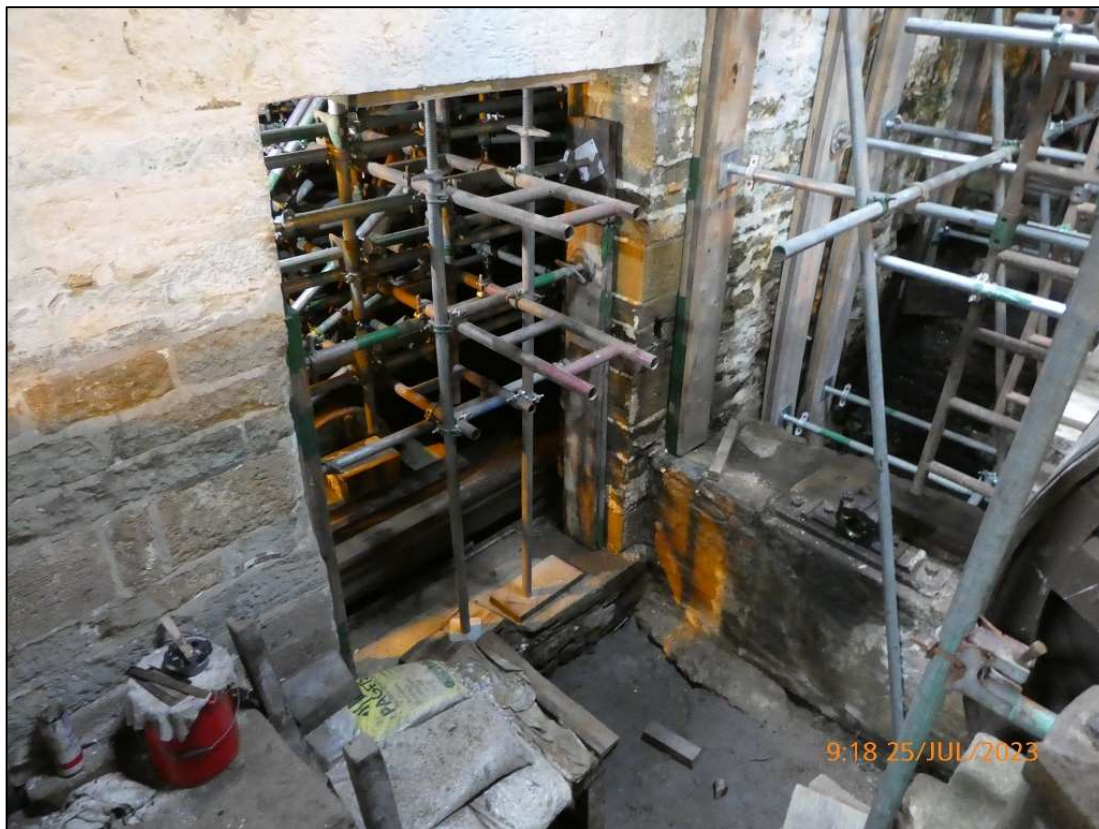
Figure 7. Scaffolding support to the walls of the 'Grinding Hull' building

Due to the urgent need to safeguard the heritage assets, as well as address the risk of a reservoir breach, agreement was gained during the site meeting to install emergency propping to the structure. Scaffolding was installed relatively quickly with associated notification to Historic England (Figure 7). As much of this was in and around the 'Crown Wheel' room, the waterwheel was rendered inoperable. In addition, due to concerns about vibrations affecting the structures, instructions were given to the museum staff to not operate the 'Tilt Forge' waterwheel. The 'Grinding Hull' building was closed to staff, except for regular monitoring of the leakage situation and remedial works, and to the general public.

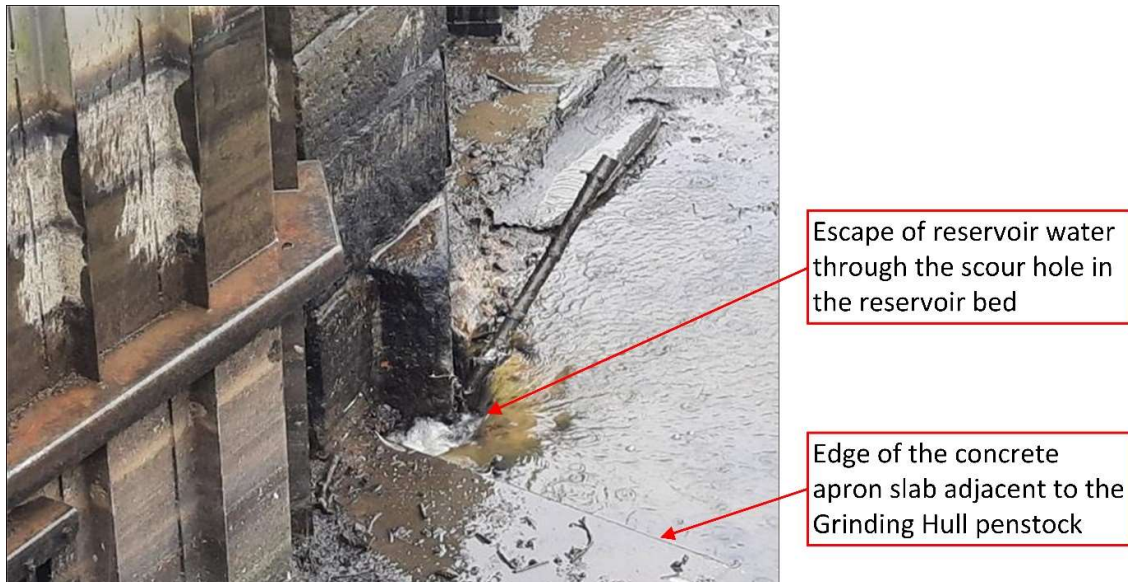
Figure 8. Void in the reservoir basin's puddle clay lining adjacent to the 'Grinding Hull' penstock

Once there had been a sufficient draw-down, a void was observed in the edge of the reservoir basin's puddle clay lining, adjacent to the 'Grinding Hull' waterwheel penstock, with water

discharging into it (Figure 8). This appeared to be the source of the water leakage into the 'Grinding Hull' building and was at a similar location to that prior to the remedial works in 2014.

- 'Grinding Hull' and 'Tilt Forge' penstock structure: Provision of a concrete cut-off beam between the concrete aprons, located upstream of the penstocks, with reinstatement of the puddle-clay lining above. The aim is to reduce the risk of a flow-path between the edge of the puddle clay lining and the face of the existing structure.

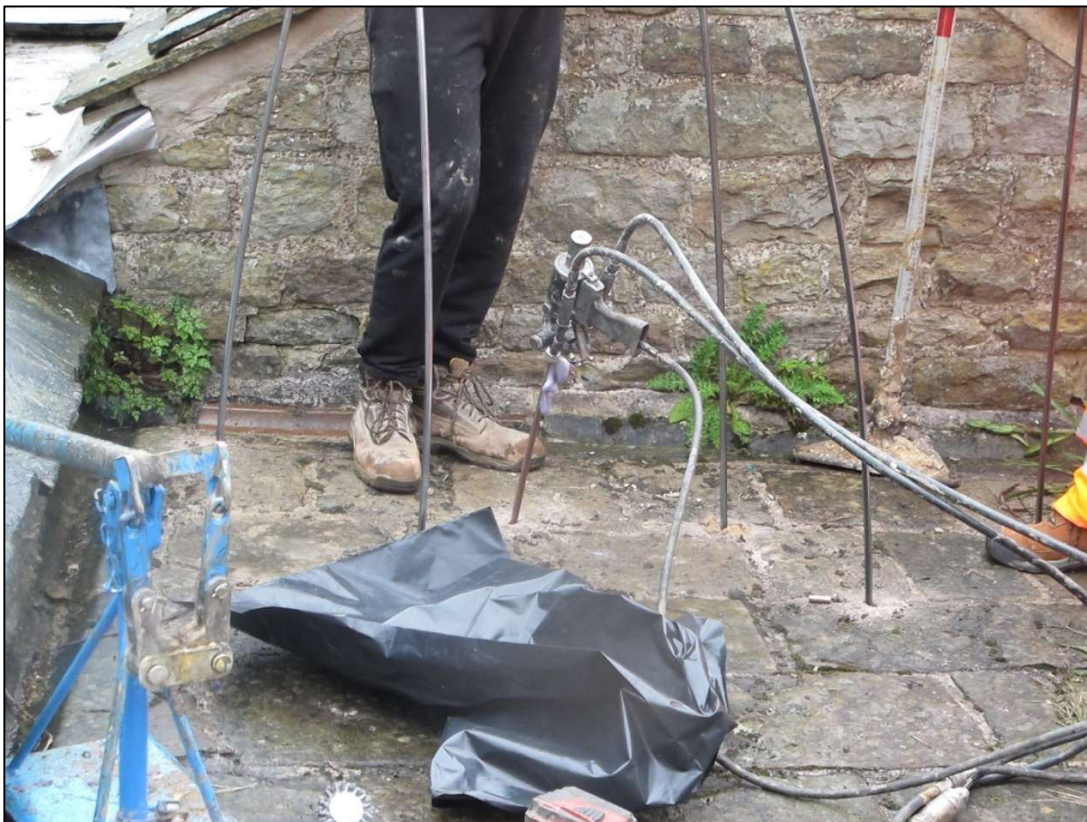
Figure 9. Chemical injection grouting adjacent to the 'Grinding Hull' building (courtesy of Sheffield City Council)

Due to the low level of the leakage location, there was concern that a draw down significantly below this level would expose the puddle clay lining creating a risk of it drying and cracking. Conversely, rainfall events could result in inflows greater than the discharge capacity of the pump, thus, resulting in an increase in reservoir levels. As a result, in August 2023, chemical injection grouting of the area between the reservoir and the 'Grinding Hull' building was performed to minimise the leakage risk should the reservoir level rise (Figure 9). During these works, the Contractor reported significant voiding immediately adjacent to the 'Crown Wheel' room and at another location nearby. The total volume of the voids was estimated to be 11.5m³. To grout the deeper voids, the Contractor requested to work from within, and drill through the masonry of, the 'Crown Wheel' room. However, this was not possible due to the presence of the scaffolding supports and the heritage impact. Therefore, grouting was restricted to those areas that could be accessed from outside of the building. On completion, the emergency chemical injection grouting was seen to be successful in controlling water ingress into the 'Grinding Hull' building.
