Design of Dam Safety Measures for three Dams in Zambia

P M DICKENS, Arup
V K MARTIN, Arup

SYNOPSIS Arup was commissioned by the United Nations Office for Project Services (UNOPS) in 2022 to design measures for improvements to the safety of three dams in Zambia. The three dams were all homogeneous earthfill dams, but with differing geometries and spillway forms. All three dams share the common problems of inadequate flood capacity, lack of freeboard, scour damage and irregular dam construction with excessive seepage in places, but they differ in the hazard they pose to the downstream population.

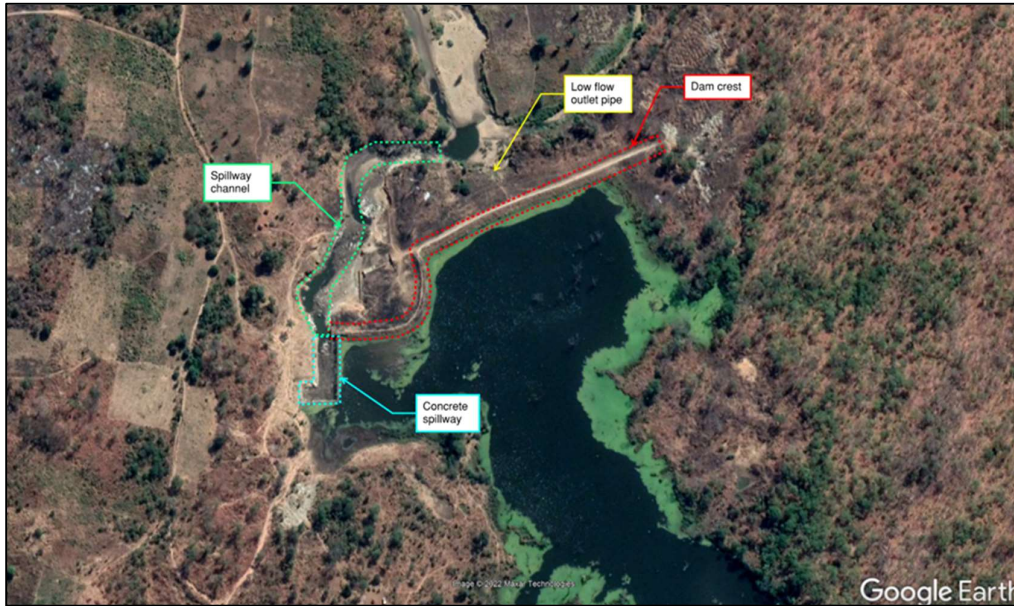
Figure 1. Dam A Site arrangement (Google Earth, Arup elaboration)

On the west side of the site there is an L-shaped concrete service spillway 110m long with a sloping concrete wall and masonry crest; the structure appears to be founded on rock. Low areas of dam crest were observed next to the weir abutment walls.

spillway, leakage in the low level outlet, and extensive scour in the downstream channel. Seepage was noted as upwelling a few metres downstream of the dam toe in a single location.

Therefore raising the dam with use of the existing spillway was found to result in the need to raise the dam by approximately 3m and to reinforce the existing spillway and abutments with new structures to permit the raising of the dam crest and filling in the existing low areas of crest. It also required the widening of the downstream channel to prevent submergence of the weir. This option was selected as the most economic.

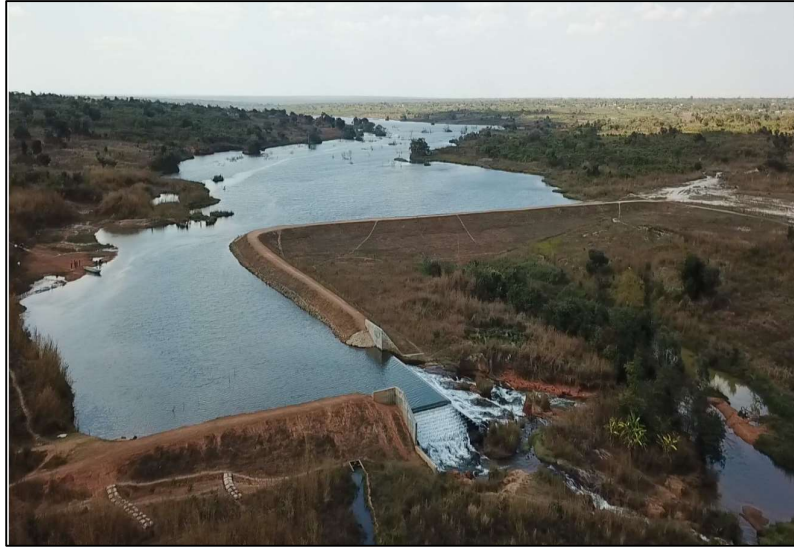
Figure 2. Dam C Site arrangement (© UNOPS)

The dam alignment has a 90-degree bend to accommodate the service spillway approach channel and weir. The design is understood to have been changed during construction to locate the spillway weir on a rock outcrop. There is a secondary embankment to the right of the primary spillway weir with low areas in the crest adjacent to the primary spillway. For the main east-west dam the existing upstream and downstream slopes are typically at a gradient of 1:3. The embankments north and west of the spillway are steeper at around 1:2; visibly steeper than the main dam geometry and with a narrower crest.

The service spillway is a weir L-shaped in plan, 32m long, with stepped chute. There is a partially completed emergency spillway to the left-hand side of the embankment, however the crest level of this emergency spillway area is only marginally below the dam crest and concerns were raised about the lack of capacity and freeboard.

The site had been inspected by UNOPS in November 2021 following a 5m long crack being identified in the crest of the steep sided embankment to the left of the spillway approach, which had apparently been repaired prior to the arrival of UNOPS engineers. It also noted undercutting of stone pitching, abutments and training walls at the spillway and excessive leakage at a valve chamber. The dam was otherwise found to be in fair condition though some seepage was noted downstream of the dam toe.

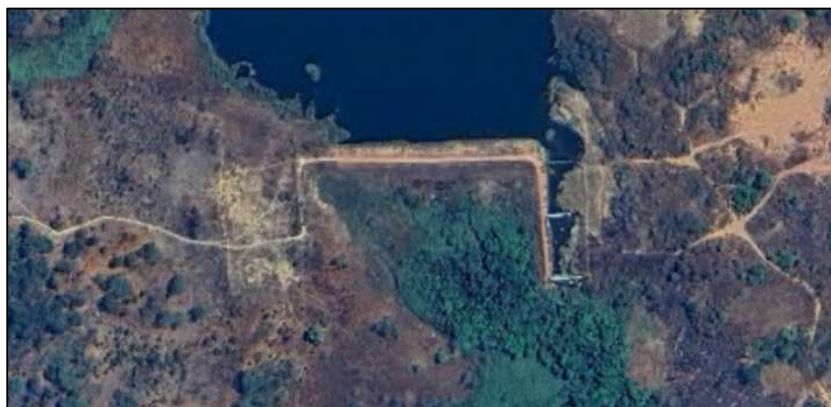
Figure 3. Dam K Site arrangement (Google Earth)

Dam K is a 9m high earthfill embankment dam in the Copperbelt Province of Zambia. The overall dam storage capacity has previously been estimated to be 2,030,000m³, with the surface area of the reservoir being approximately 63ha and a catchment of 287km². The main embankment length (running from west – east) up to the west side of the service spillway is approximately 210m. A marshy area was identified downstream of the dam and no toe drain could be identified.

There is a service spillway on the east side of the dam (left bank) with a three-stage unlined drop structure with three straight concrete weirs. The overall discharge structure length is approximately 105m, with weir lengths of 30m. There is scour undermining around the drop weirs and the training banks along with potential seepage. The spillway discharges into a vegetated channel and flows in the south-westerly direction towards a culvert that passes underneath a major highway. There is an incomplete emergency spillway on the west side of the site. The incomplete spillway is covered by vegetation and the current ground level has not been lowered, resulting in minimal freeboard between this channel and the dam crest.

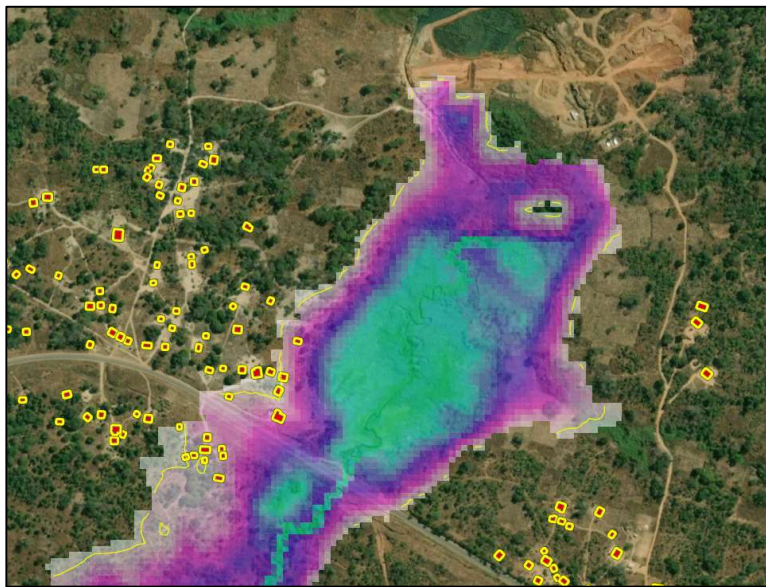
Figure 4. Dam K Rainy Day Flood Extents and Affected Properties with Buffer Zone

The consequences were plotted on an F-n Plot for both dams to assess the Hazard Category. Dam C showed high consequences and justified the selection of Class 1 by the Kabell system, as originally it was qualitatively assessed. Dam K was on the borderline between ALARP and unacceptable safety risk for a safety check event of 2000-year return period, and unacceptable for a return period of 500-year event. Combined with the damage on the major road downstream, it was decided to keep Dam K as Class 2.

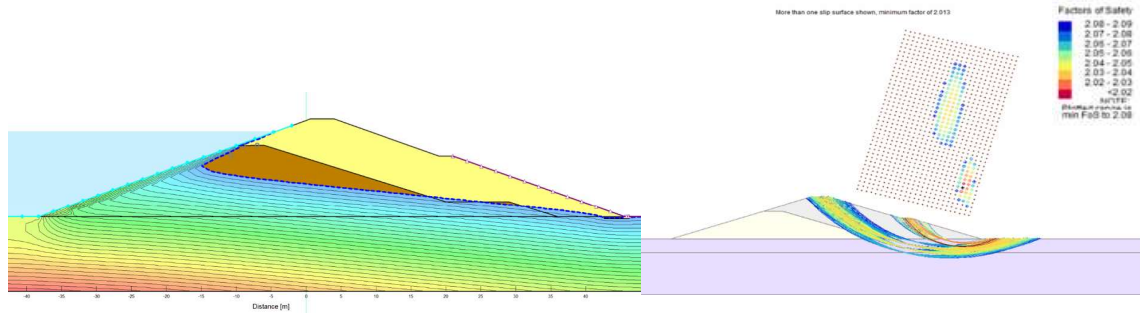
Figure 5. Dam C Seepage and stability analysis

The three dams were all found to be homogeneous despite drawings suggesting impermeable cores. Otherwise the dams were found to be well compacted. We carried out slope stability analysis and found that the dams achieved acceptable factors of safety in all load cases with the exception of areas where the slopes had been over-steepened. We also carried out seepage analysis based on both laboratory testing of the existing dams and back analysis of the seepage observed on site to calibrate the seepage rates used. The analysis was then repeated for the raised dam and flood cases. The planned raising of the dams allowed us to regularise the slopes at 1:3 (v:h) and incorporate a downstream filter layer and toe drain. The seepage would therefore remain, however the material had been found to be non-dispersive and with the filter layers the risk of migration of fines and internal erosion was mitigated. Additional works included providing a rock armour protection to the faces of the dam to provide protection from waves and cattle, which had been observed at all sites.

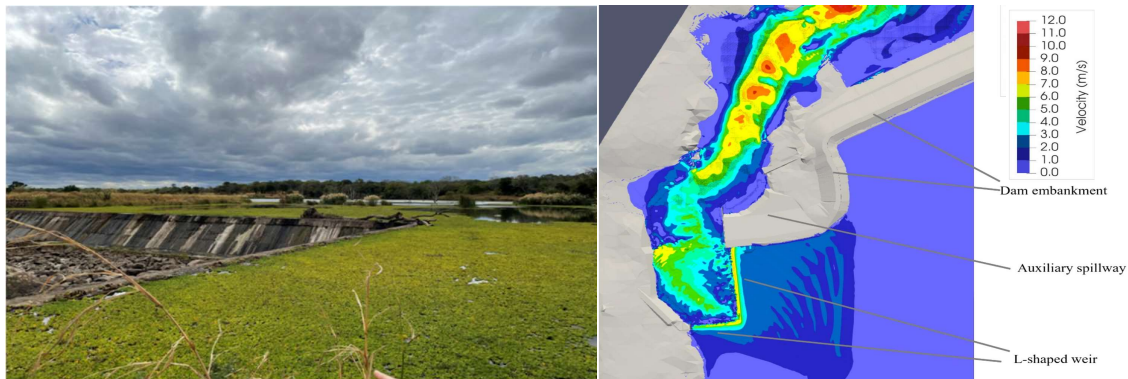
Figure 6. Dam A weir and CFD results

to be a credible estimate of the spillway discharge capacity. However, an assessment of the tumble bay and downstream channel suggested submergence of the weir, reducing its capacity. This was supported by video evidence from the client, showing a past flood event where only shallow overtopping of the weir occurred but the downstream channel could be seen to be full.

To improve weir capacity we widened the downstream channel. This was analysed treating the downstream channel as a side channel weir to capture the water profile downstream of the L-shaped weir. Widening the channel also allowed us to re-line the channel bank protection to prevent scour. Given the importance of the downstream water level and preventing submergence of the weir and the complexity of the downstream geometry we carried out CFD modelling which allowed us to reduce channel excavation and identify the requirements for bank protection.

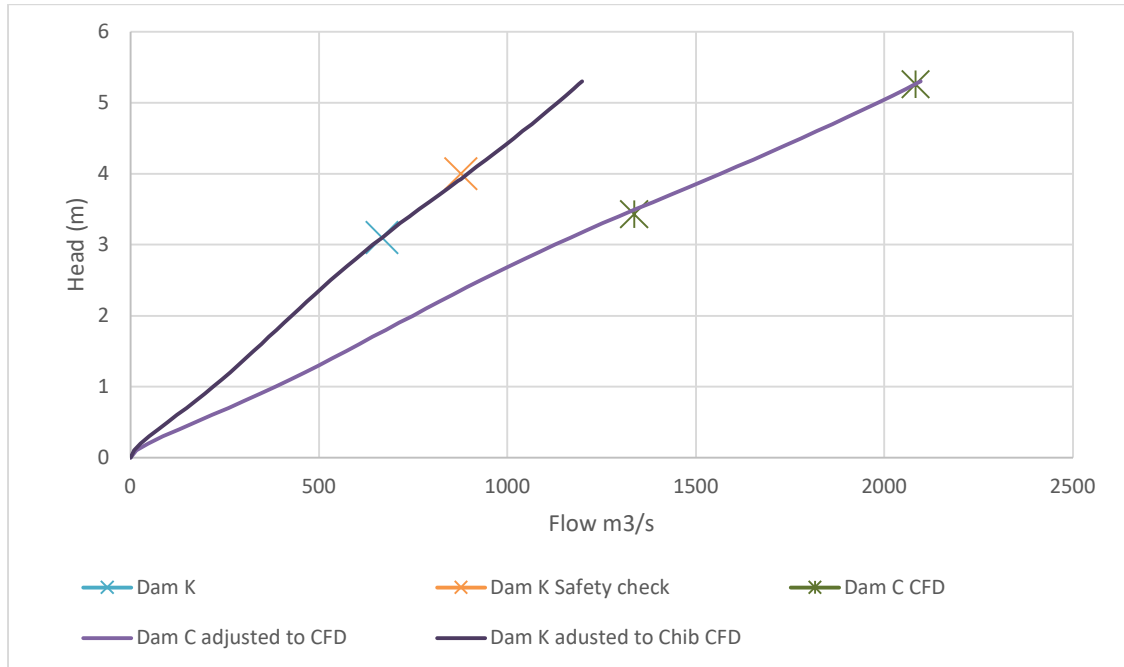
Figure 7. Rating curves with CFD results

This allowed us to undertake a single CFD model for Dam C and then use these results to verify the performance at Dam K. We found that the upstream reservoir water level was higher, at 1192.85mEL, than we had predicted in the calculations (1192.3mEL). We determined that this was likely due to the large head, around the maximum from the research studied, resulting in slightly greater interference over the labyrinth than predicted, but also due to the approach conditions to the weir. As a result, the wingwalls were flared to reduce the entry losses; the wall height had been set as a parapet height of 1.2m following the dam face profile, partly to provide edge protection but also to allow some overtopping to ease the approach to the weir but keeping the flow above the dam to reduce scour risk. This amendment was successful in reducing the peak safety check reservoir still water level to 1192.56mEL, however with reservoir attenuation this reduced to 1192.23mEL, within the original target.
