Managing risk at Victoria Service Reservoir

SYNOPSIS Victoria Reservoir is a reinforced concrete service reservoir located in the heart of Bristol. Constructed in 1914, it is one of the oldest reservoirs of its type in the UK. It was constructed on the site of an earlier open service reservoir. During the second world war, the reservoir was damaged and repaired on account of bombs being dropped on it during the Bristol Blitz. In more recent decades, a series of investigations and repairs have been carried out to assess and maintain its structural condition and operational performance. This paper will describe and discuss the various challenges faced by the operator in managing the safety and operational risks associated with a very old reinforced concrete service reservoir.

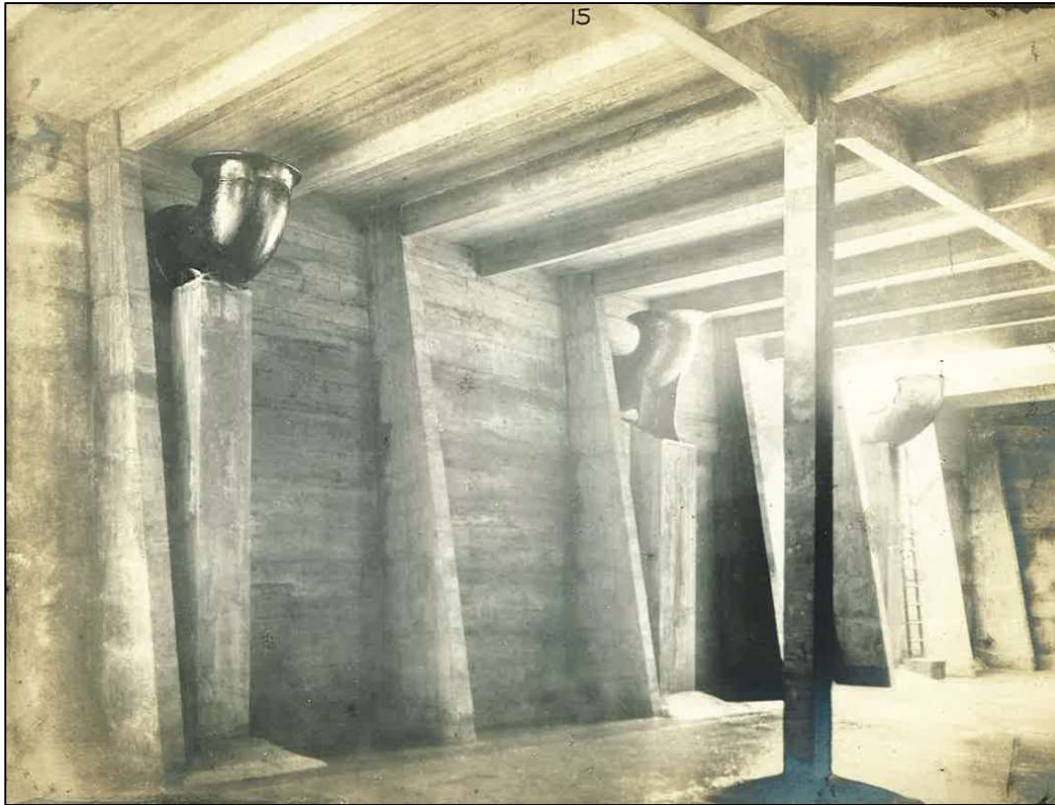
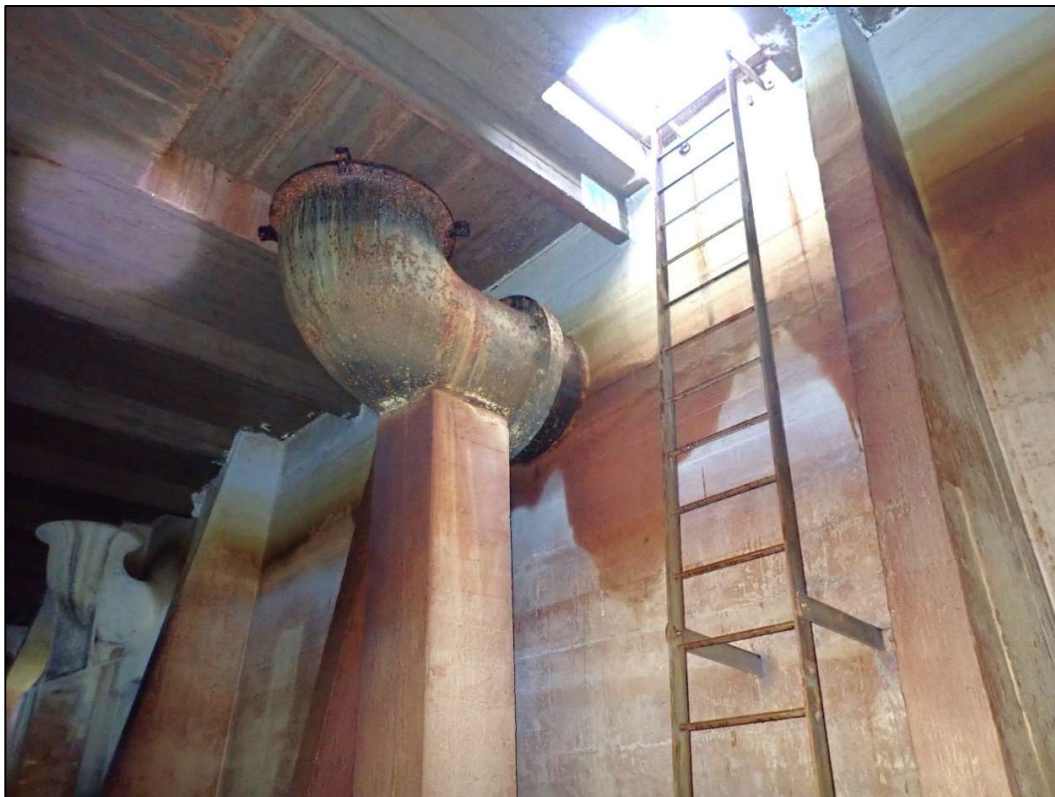
Figure 3 shows an image of the inlet pipework and concrete from the time of construction and a similar image taken in 2023. It can be noted that the concrete elements generally remain in very good condition after more than 100 years in use.

Figure 3. Southern wall and inlet pipework in 1915 (above) and 2023 (below)

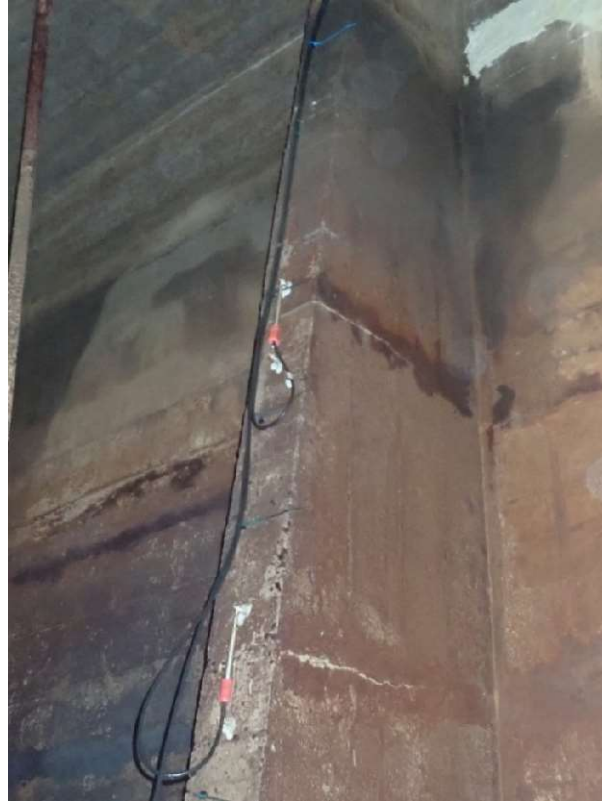
Inspection of the northern compartment in 2013 revealed fresh horizontal cracks through some of the internal buttresses. It was speculated that exceptionally hot weather in Bristol in 2006 may have instigated the cracking through thermal expansion of the roof slab. The roof slab has a surface layer of 100mm of gravel and 75mm of grassed topsoil above the bitumen membrane. Instrumentation of the compartment was recommended in the interests of safety to better understand how the cracking may have occurred and whether the crack widths are increasing over time. In 2017, a number of tilt beams and strain gauges were installed (Figure 4).

As would be expected with roof expansion forces being transmitted into side walls, greater strain values were detected towards the top of the wall buttresses than at cracks lower down the buttresses. Tilt beam readings were also greater near the roof. Actual deflections across the cracks were however quite modest with the greatest values being less than 0.5mm and more generally the readings were less than 0.2mm. The variations in strain did not correlate well with changes in reservoir water level, indicating that thermal gain is the primary driver for the wall cracking. The investigation results, reviewed as part of the 2023 statutory inspection, gave no immediate concern for the safety of the reservoir although some form of roof insulation may be considered by the operator going forward, especially in light of climate change.

Figure 4. Strain gauge installations across two new horizontal cracks extending partly through an internal wall counterfort.
