Ground Investigation through London's raised reservoirs with a summary of ground investigation risks and recommendations, citing techniques used at two sites.

H E FISHER, AtkinsRéalis

Managing Risks for Dams and Reservoirs

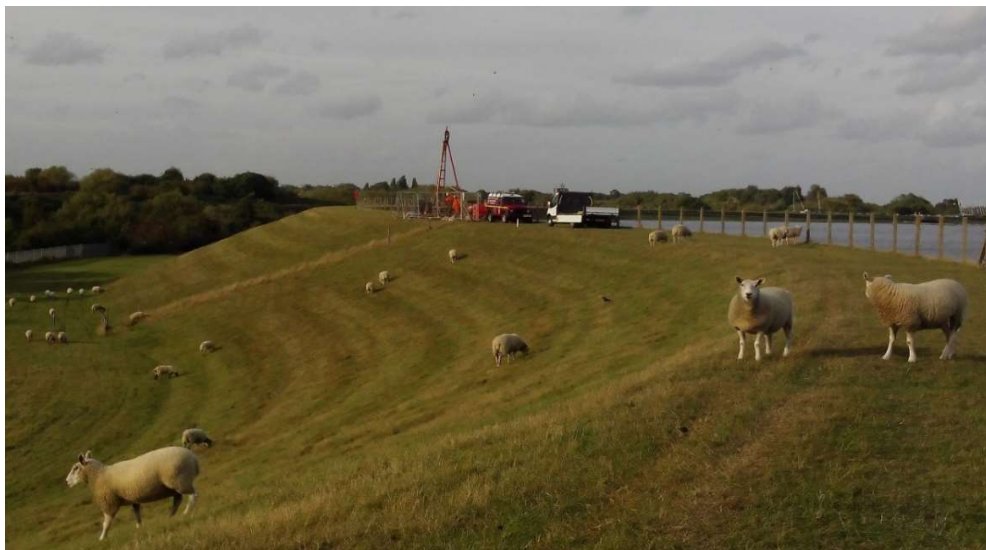
Boreholes were undertaken at three locations around the reservoir which were identified as leaking from the geophysical survey. The investigation included seven 150mm diameter, fully cased cable percussion boreholes (Figure 1) which were undertaken through the core to depths of up to 24.5m below ground level (bgl).

Figure 1. Cable percussion borehole through Island Barn embankment dam.

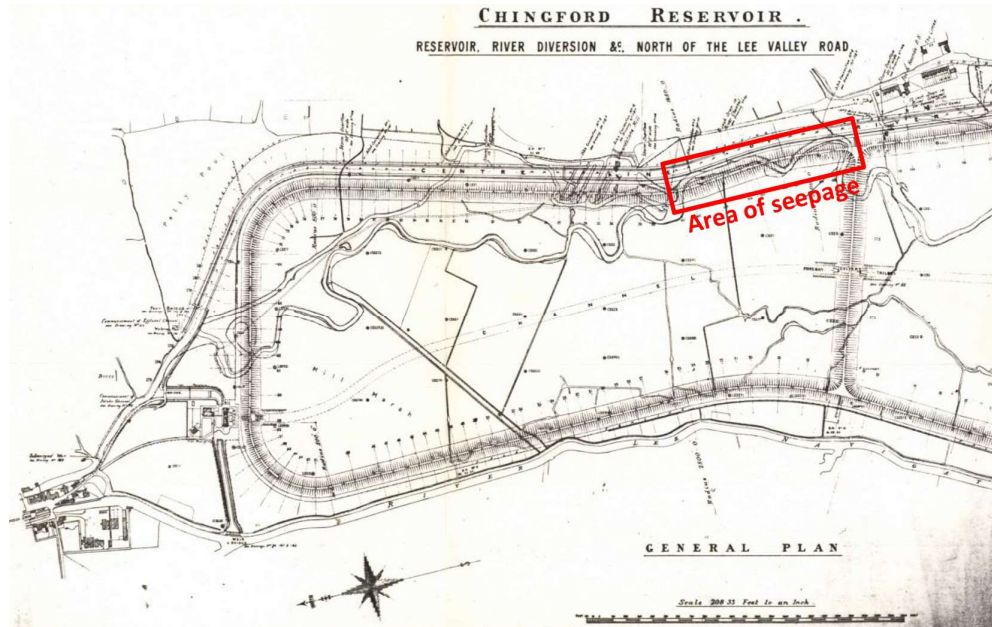
The geophysical survey procured by Thames Water showed that the dam was leaking through its foundation at a localised section of the northern cell. By comparison to historical drawings, it was determined that the leak coincided with the original path of the River Lea which was diverted northwards during the construction of the reservoir in 1912 (Figure 2).

Figure 2. Historical plan of KGV.

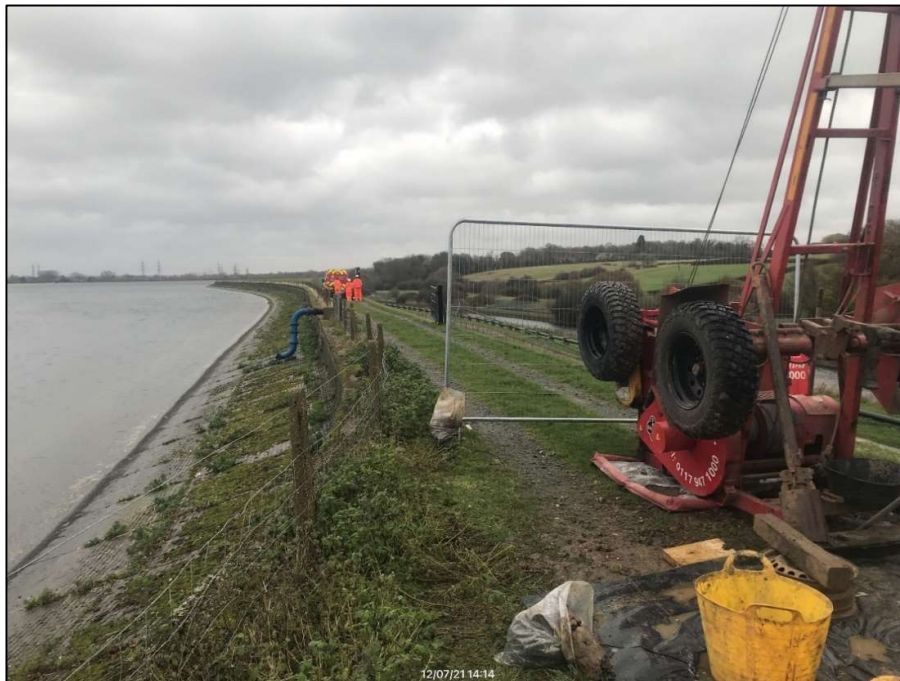
Following the success of Island Barn Reservoir GI, whilst a different Principal Contractor was involved, the same GI contractor was appointed to undertake the works at KGV (Figure 3).

Figure 3. Cable percussion borehole through KGV embankment dam (provided by MWHT).

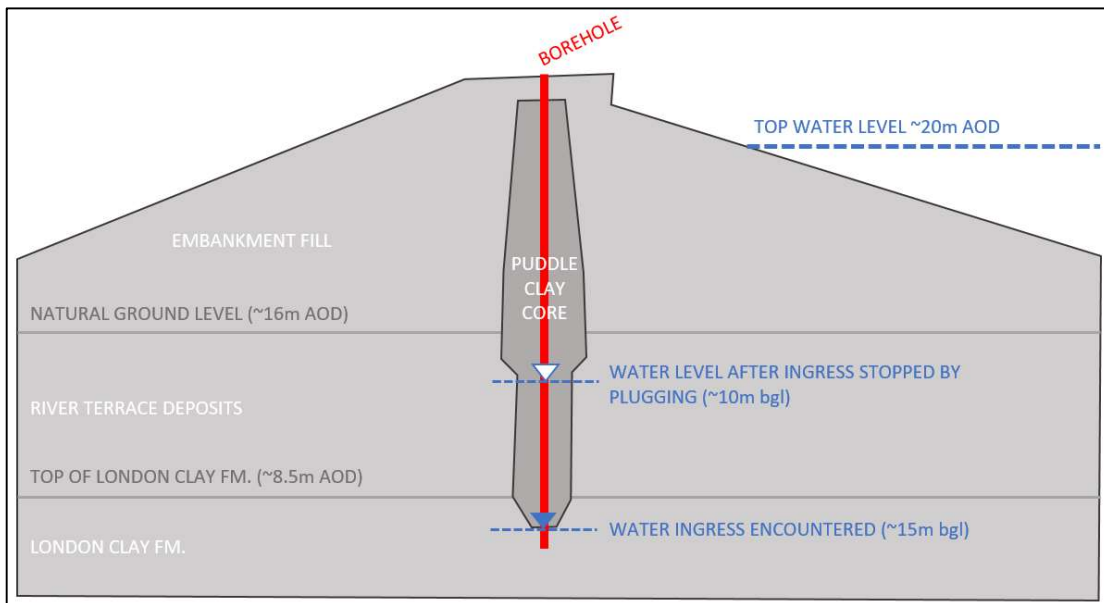
During the drilling of the first borehole through the core, the driller did not maintain a balanced head of water and this was not identified by the Designer's representative on-site. Significant water ingress was encountered at approximately 15m bgl, a depth roughly consistent with the base of the puddle clay core (Figure 4); this water was under pressure (suggesting it likely came from the reservoir itself as opposed to natural groundwater) and rose up the borehole at a significant rate. The representative on site informed the named Investigation Supervisor who instructed for the hole to be plugged immediately to stop further ingress (also informing the Principal Contractor, the Client and the QCE.)

Figure 4. Schematic cross-section of the KGV embankment dam and water ingress incident.

A subsequent investigation into the cause of the incident found that, whilst the same GI contractor was engaged, a different drilling team (from that which undertook the works at Island Barn) was employed due to availability. It had been assumed that the new team had been suitably briefed regarding the specification for the works and the need to maintain a balanced head for dam safety but it had not. Furthermore, the methodology for undertaking the borehole was changed by the GI contractor without notifying the Designer or the QCE (and this was also missed by the Designer's site representative).

The base of the hole was plugged using bentonite pellets. The remainder of the hole was backfilled using a bentonite/cement mix slightly thicker than the puddle clay consistency (in order to displace the water in the borehole). For the duration of the remaining works, the borehole was monitored for any evidence that water ingress had continued – no further ingress or other issues with this hole were recorded and therefore no further action was called for by the QCE.

Following the incident, the GI contractor was not confident in their own ability to safely continue with the second borehole, even if the original methodology (successful at Island Barn) was followed. In order to limit delays to the programme (relating to demobilisation and procurement of an alternative GI contractor), an open discussion between all parties was arranged. It was agreed that changing the remaining borehole to a static piezocone CPT was suitable (given the available historical GI data) and was suitably low risk for the GI contractor.
