Upper Carno: A case study of multidisciplinary remedial works to an embankment dam

J SWETMAN, Mott MacDonald Bentley
M McAREE, Mott MacDonald Bentley
B COTTER, Dŵr Cymru Welsh Water
R WILLIAMS, Stantec

SYNOPSIS Upper Carno is a 14m high embankment dam in south Wales. Items of remedial work had been identified by Dŵr Cymru Welsh Water (DCWW). Investigations undertaken by Mott MacDonald Bentley (MMB) to inform the remedial works highlighted risks, and a subsequent Section 10 inspection resulted in eight measures in the interest of safety concerning the spillway condition and capacity, embankment stability, and drawdown condition and capacity. The resultant suite of remedial works required careful management of interfaces between the various workstreams throughout design and construction, to reduce the risk of failure to acceptable levels and to improve the working life of an aging asset.

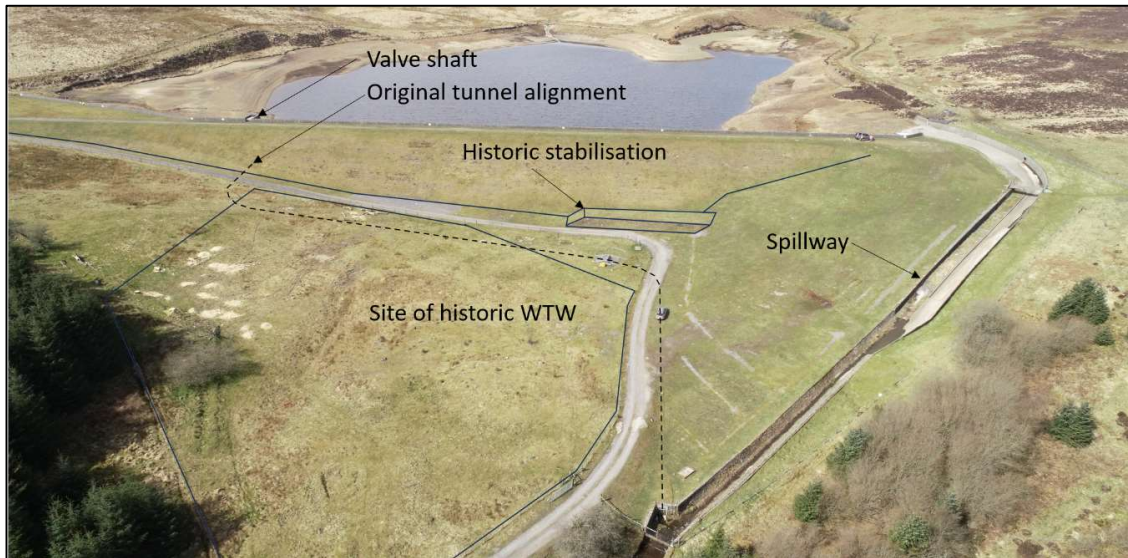
The dam at Upper Carno is a 14m high, 270m long Pennine-type embankment (Figure 1) with a central puddle clay core. The reservoir is fed via direct and indirect catchments and has the facility to divert some indirect catchment flows around the reservoir in a bywash channel which discharges to the spillway. An overflow weir is situated at the left abutment, at the top of the 190m long spillway. The original draw-off arrangement was via a valve tower in the upstream shoulder and a brick-lined tunnel containing a supply pipe with an offtake to Carno WTW, which ran in a straight line underneath the embankment from the valve tower to the dam toe, and then bent to follow the line of the toe towards the spillway and discharged to the downstream end of the spillway.

Figure 1. Upper Carno before works (MMB)

A 2016 Section 10 report noted no excessive settlement of the embankment, and the embankment was seen to be in good condition. However, the steep 1V:2H slope of the downstream shoulder was a cause for concern, and there were indications of poor drainage near to the toe of the highest part of the dam.

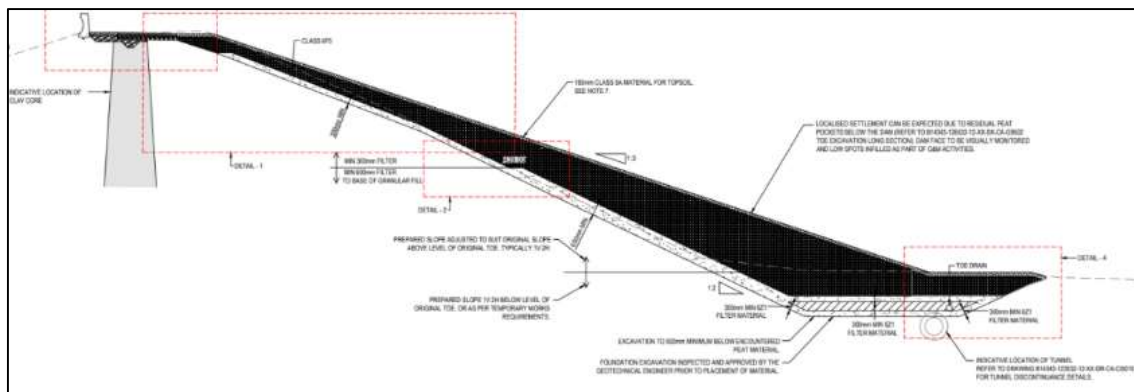
The results indicated that the dam at Upper Carno did not meet the required FoS in the downstream shoulder under normal, flood and pseudo-static conditions. The upstream slope was found to meet acceptance criteria in all cases.

Figure 2. Slope stabilisation typical cross-section (MMB)

A number of options for improving the downstream shoulder stability FoS were considered. Options that were considered feasible and found through further stability analysis to meet the same acceptance criteria were: slackening of the downstream shoulder; construction of a berm; and permanently reducing the reservoir TWL. The preferred option was agreed as slackening the slope from 1V:2H to 1V:3H over the full height and length of the downstream face. This option allowed the installation of a filter between the existing and new works over the full height of the structure without extensive excavation to the existing embankment face, thus preventing failure by internal erosion. A typical cross-section of the slope stabilisation is shown in Figure 2.

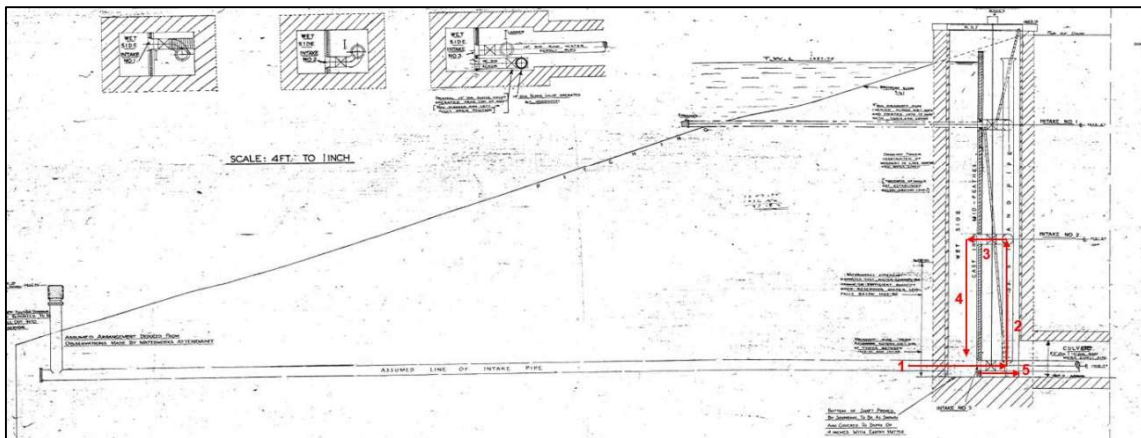
An underwater survey of the wet well carried out by Edwards Diving Services (EDS) found that the lower reservoir inlet did not discharge into the wet well, as indicated in the 1952 drawing, but passed straight through the wet well, connecting directly to the supply main. It was therefore concluded that for reservoir levels above the middle offtake that the wet well was filled by reservoir head driving flows through the lower inlet, upwards through the stack and out through the middle inlet into the wet well, and thus the reservoir could only be drawn down using the scour to empty the wet well as low as the middle inlet, in a ‘loop-the-loop’ arrangement (Figure 3). The upper reservoir inlet was confirmed as indicated on the 1952 drawing during partial drawdown, but several underwater searches were unable to locate the lower inlet.

Figure 3. Assumed ‘loop-the-loop’ draw-off arrangement. Extract from 1952 drawing (DCWW)

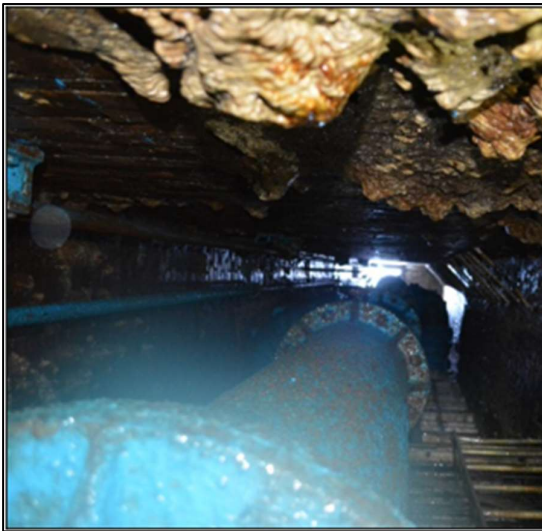
The valve tower was a congested space, with only half of the 2m x 3m plan area being the accessible dry side, which also included a pipe stack and valves restricting access considerably (Figure 4). It was therefore proposed to remove the dividing wall and convert the tower to a fully dry tower and to provide new access metalwork ladders and landings to ensure safe operation for future use.

Figure 4. ‘Dry’ well tower access (looking up) prior to works (MMB)

The cover slab was removed from the valve tower and a temporary scaffold and lifting system was erected to enable the removal of all historic pipework and the dividing wall. Removal of the “feather” was an onerous task due to its embedment into the brick structure and the heavy weight of 3ft deep, 2” thick cast iron panels.

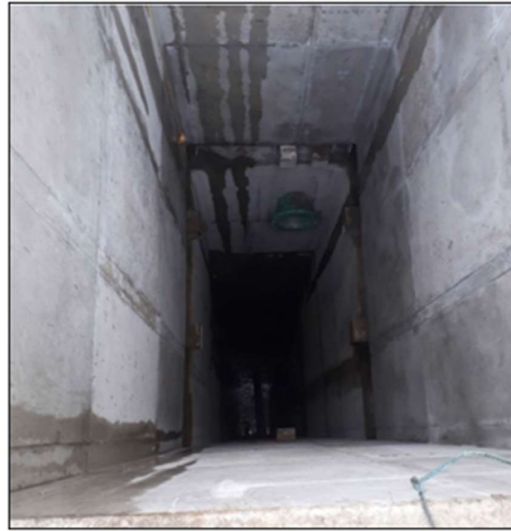
Figure 5. Lined fully ‘dry’ valve tower (looking down) (MMB)

The valve tower was structurally enhanced by lining internally with a combination of conventionally reinforced and fibre-reinforced concrete, and peripheral steel frames at the levels of the new platforms provided additional bracing. The permanent works, temporary works and construction sequence were developed in tandem to negate the need for structural temporary works. This involved removing the “feather” and installing the structural steelwork in short lifts from the top-down. See parallel paper by Teixeira et al. (2024) for more details.

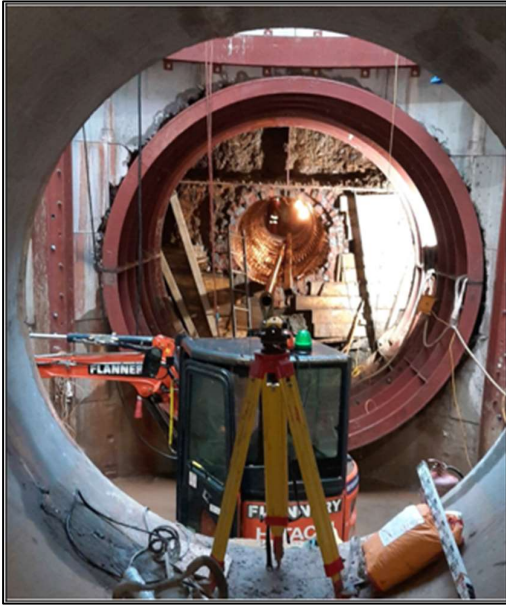
There was concern regarding water ingress into this length of existing tunnel. Internally sealing the tunnel by grouting between the steel liner and tunnel brickwork diverted ingress to the tunnel exterior, where left without intervention, it could lead to internal erosion failure of the dam. To reduce this risk, a sand filter was retrofitted around the exterior of the tunnel by driving a 4.3m diameter steel tunnelling heading from the shaft into the dam foundation material (Figure 6).

Figure 6. View from new tunnel through 7m shaft to existing tunnel during construction (MMB)

To enable the works to the length of tunnel that was to be retained under the embankment, and to route the new draw-off pipework outside the new dam profile, a 7m diameter shaft was sunk 11m vertically through the embankment shoulder to intercept the existing tunnel. This was utilised to drive the 1m diameter pipework sections into the 1.5m diameter tunnel under the downstream shoulder.

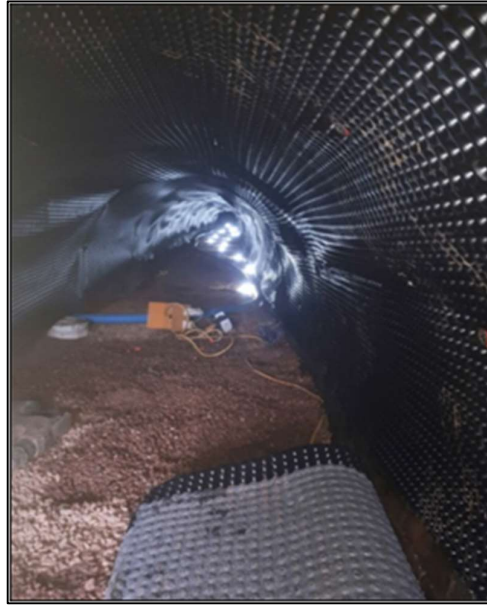
The remaining 160m of tunnel beyond the lined section was to be discontinued. As it had begun to deform, and the embankment stabilisation works would add more weight to the parts of the tunnel under the dam, this section of tunnel was required to be infilled. This was undertaken by adding drainage through the tunnel and infilling with an expanding polymer void filler (Figure 7). The downstream 80m of the existing tunnel not under the dam was dug down to, the tunnel soffit removed and the tunnel infilled with drainage and backfilled.

Figure 7. Drainage layer installed in tunnel prior to infilling (MMB)

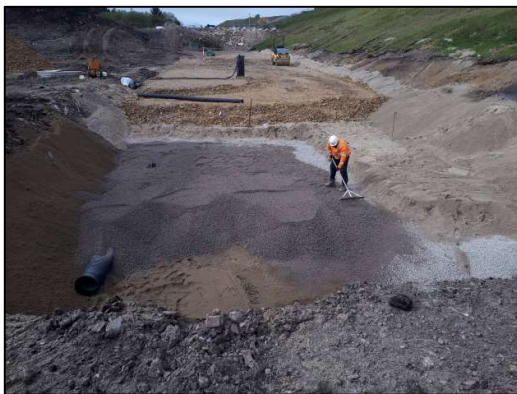
Figure 8. Installation of toe drain and filters (MMB)

The slackening detail included a fine and coarse granular filter placed at the interface between the prepared existing embankment shoulder and the imported granular material. The fine filter arrangement protects the dam against future internal erosion and potential failure, whilst the coarse filter acts as a drainage medium and to prevent the fine material entering the 6F5. A new toe drain within the coarse filter drain was installed (Figure 8) to help reduce the piezometric level in the downstream shoulder.

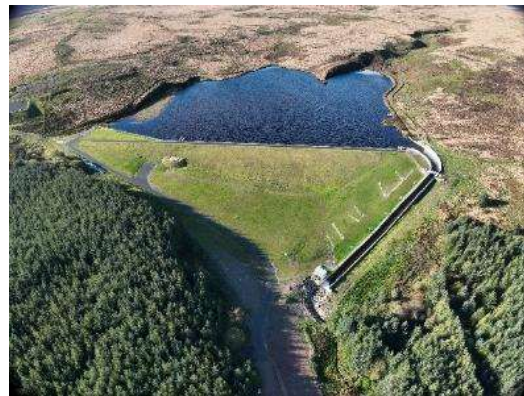
Figure 9. Works complete (DCWW)

The completed Upper Carno Asset Rehabilitation Scheme (Figure 9) included installation of a new full draw-off system, construction of a new spillway, and slope stabilisation works. The construction sequence and drawdown methods used reduced risk to the dam and managed the interfaces between the different elements of the work. The project was delivered over a two-year programme on site and MITIOS sign-off for the associated recommendations was received prior to the statutory date.

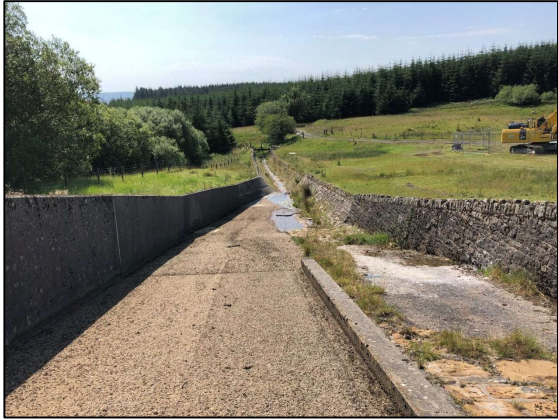
The original spillway at Upper Carno was constructed on the left abutment and formed of a 3.3m wide, rectangular masonry channel, transitioning to a parabolic channel roughly halfway along its 190m length (Figure 10). Spillway improvement works were undertaken in 1986 which included the replacement of the original tumble bay with a 21.5m long crump weir and concrete tumble bay area, narrowing to meet the original masonry channel approximately 30m downstream of the overflow. From this point, the spillway was modified to comprise a composite channel formed from the original 3.3m wide masonry channel invert and right-hand wall and a 2.7m wide reinforced concrete 'L section', with a 200mm high step dividing the left and right sides of the channel and at the top of the masonry section, such that low spillway flows were directed down the concrete (left) side of the spillway, and the masonry channel would come into operation only when flows exceeded 200mm depth. The composite spillway extended as far as the start of the original masonry parabolic section, which was not upgraded as part of the 1986 works.

A visual spillway condition assessment was undertaken by MMB in May 2018. The quality of the masonry was seen to be good, with sections of the invert which required the pointing to be reinstated. There were sections of the masonry invert that had been replaced by mass concrete. The reason for these repairs was unknown but presumably due to historic events of high flows plucking out masonry blocks. The concrete elements were seen to be in generally good repair.

A geophysical survey was undertaken in the spillway chute in June 2019 by Terradat, which indicated that the masonry invert was potentially laid directly on erodible made ground and showed signs of voiding. Cores and trial holes were excavated in the spillway in June 2019 to confirm the GPR results and to understand the presence, nature and detailing of the clay core and its interface with the spillway. The findings of the site investigation showed that the masonry blocks sat directly on erodible soils and no concrete bedding was provided under the masonry spillway. The presence of concrete backing to the masonry wall was limited. With this arrangement, the residual risk of failure of the masonry section of the spillway was considered to be greater than that of the concrete structure.

Figure 10. Previous composite spillway (MMB)

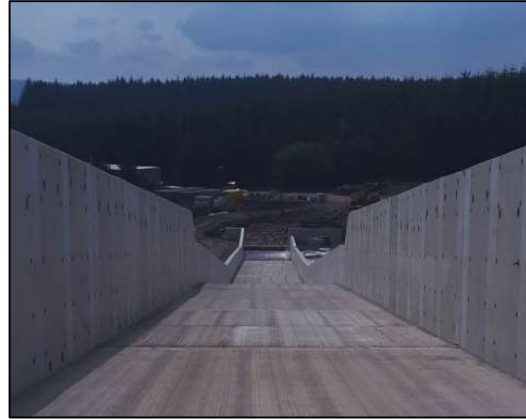
Figure 11. New reinforced concrete spillway (MMB)

As the gradients of the spillway were not overly steep, the construction methods were considered, and it was deemed appropriate to utilise a semi-precast system (Figure 11) with similar considerations as presented in the paper by Robson and Bull (2012). FLI Carlow precast panels with an in-situ base were used through the straight chute section, and the upstream end and stilling basin were constructed fully in-situ.
