Megget Reservoir: Investigation into potential internal erosion in an asphaltic concrete core rockfill dam

SYNOPSIS Megget Reservoir is an impounding reservoir in the Megget valley of the Scottish Borders, which is used to supply water to Edinburgh and the Lothians. The dam retaining the reservoir is a 56m high asphaltic core rockfill dam constructed in 1982, believed to be the only one of its type in the UK.

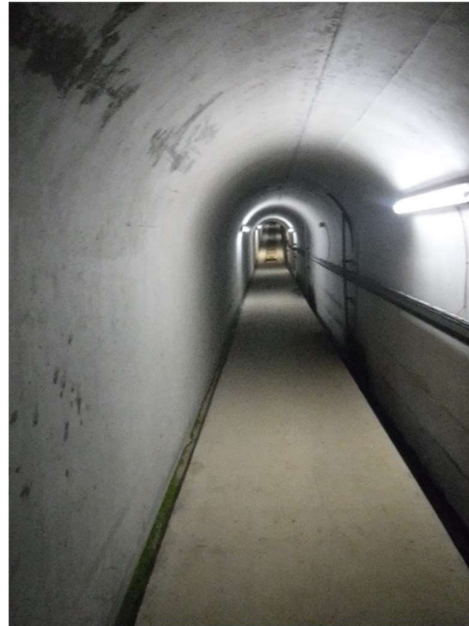
Figure 3. Photograph of drainage gallery

In 2021, during the visit for inspection under Section 47 of the Reservoirs (Scotland) Act 2011, the Inspecting Engineer observed dark fine silty deposits within the drainage gallery. Anecdotal evidence at the time suggested that the steady accumulation of these deposits had been managed for some time (potentially since construction). However, there was no mention of the deposits in previous inspection reports and no records were available of: the rate of accumulation, the frequency of clearance or nature and origin of the deposits.

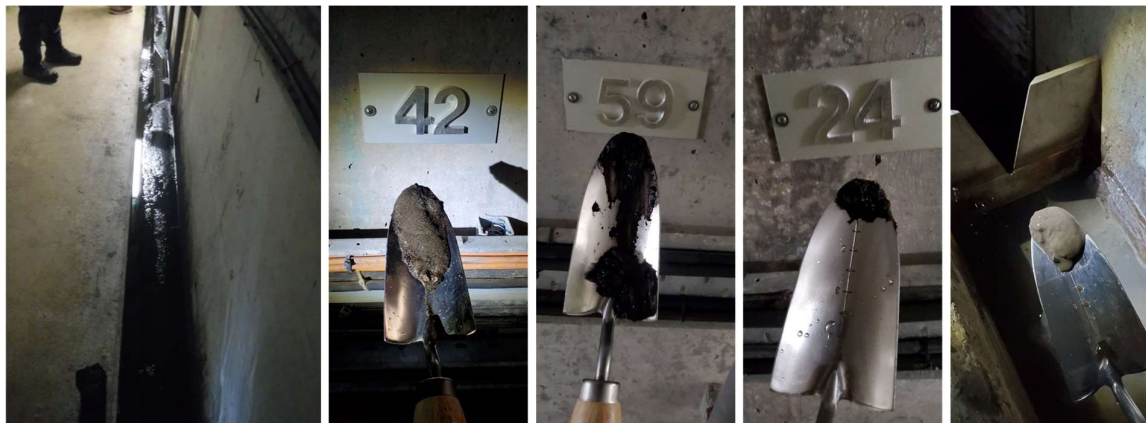
Figure 4. Photographs of dark sediments along the drainage channel

The north and south samples were collected from the drainage channel immediately upstream of V-notch Gauge 1 and 3. The north-mid [central] samples were collected from the drainage channel immediately upstream of Gauge . Figure 4 shows that the materials were visually more variable than originally observed.

Of note is the substantial percentage of “opaque debris” found in the north-mid sample. This was described as “[resembling possible manganese oxide] and precipitated calcite with lesser amounts of calcite grains, substantially altered rock (too fine to be fully distinguished) and traces of chert”. This material appeared opaque and black on the petrographic thin section images, meaning it could not be described. Approximately 29% by weight of this sample passed the 63µm sieve, with the <63µm fraction appearing to be very similar in appearance to the opaque debris.

The key finding from the second phase of investigation was that the opaque debris (and hence a large proportion of the sample) is clay-grade and predominantly manganese oxide, which would be opaque in the petrographic analysis and black to dark brown in the sample, both of which were found to be the case.

It is therefore important that, when making observations of any accumulation of deposits in the control gallery channel, attention is given to both the rate of accumulation and any noticeable change in the particle size distribution. There would be benefit in periodically collecting samples to confirm particle size distribution (sedimentation by pipette).

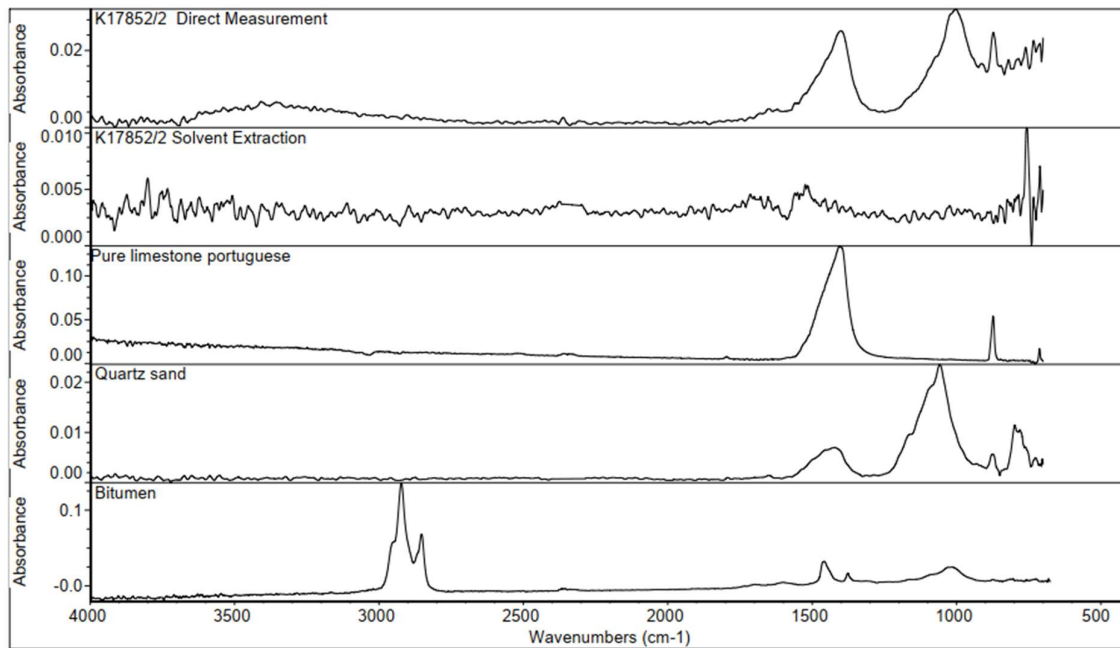
Figure 5. Fourier Transform Infrared Spectroscopy spectra for “north-mid” sample

The FTIR results indicated that no discernible polymeric/hydrocarbon material was present and bitumen was not found in the sample. The FTIR spectra indicated the presence of limestone and quartz in the sample. However, FTIR testing only detects certain compositions including organics. Materials including metals (such as possible manganese oxide) would not show up on FTIR spectra (Figure 5).

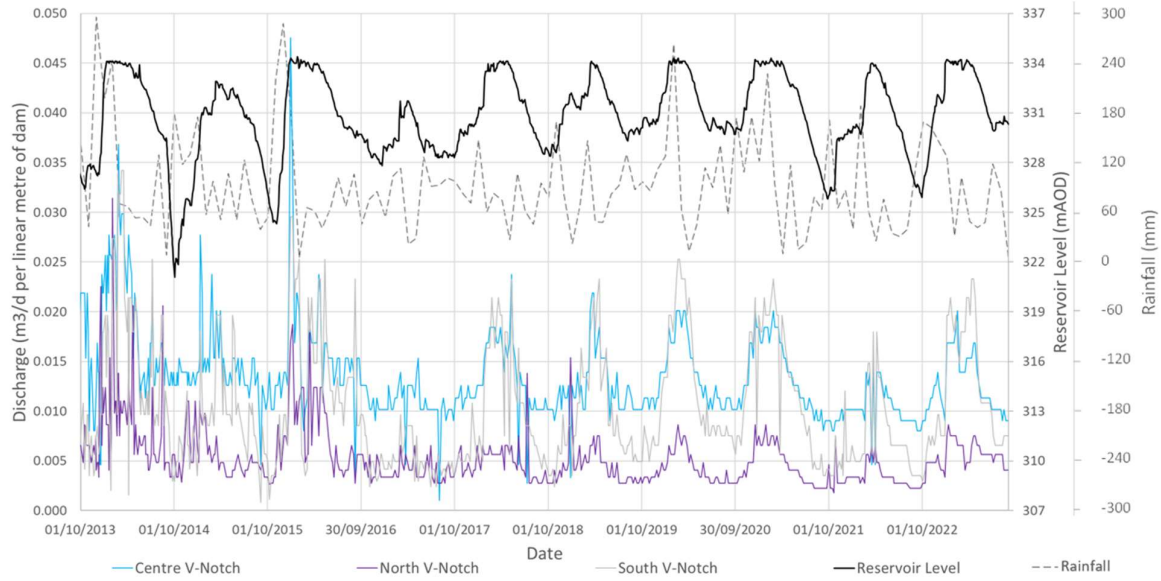
Figure 6. V-notch flow rates per linear metre of dam against reservoir level and rainfall

An opinion was reached that the V-notch flows in the gallery showed a strong response against reservoir level, with a secondary response to rainfall. The maximum recorded flows appear to be relatively consistent over the range of data, with no obvious signs of increasing flows.

The PCC for unit flows against reservoir level showed a strong correlation across all V-notches in the gallery over the five years prior to the study, however the correlations were much weaker when considering all the data. This might suggest seepages measured at the V-notches are becoming more responsive to changes in reservoir level over time (maybe as a result of increasing leakage). However, it was recognised that there was a lack of available data to calculate PCC over the last year as there were very few dates where data was collected for both variables. This explains why values such as 0.99 were obtained for the centre V-notch flow rate against rainfall between 2022 and 2023, as there were only three dates with data for both variables during this period. This means the value obtained is much less reliable and this should be used with caution when interpreting behaviour.

It should be noted that the maximum combined flow of all three V-notches in the gallery was recorded at 10m³/day in 2023 at top water level, whereas the certificate of efficient execution of works (LRC, 1995) mentions that seepage through the core was 290m³/day in June 1983 and decreased to 140m³/day in April 1987. The seepage flows through the core are therefore substantially less than they were.

Routine monitoring of flow rates across the v-notches in the drainage gallery will highlight any changes in seepage. Increased seepage rates may result in an increased rate of erosion of fine particles and possibly cause detachment and transportation of coarser particles. Given that the drainage material does not act as a filter, such internal erosion may over time lead to a

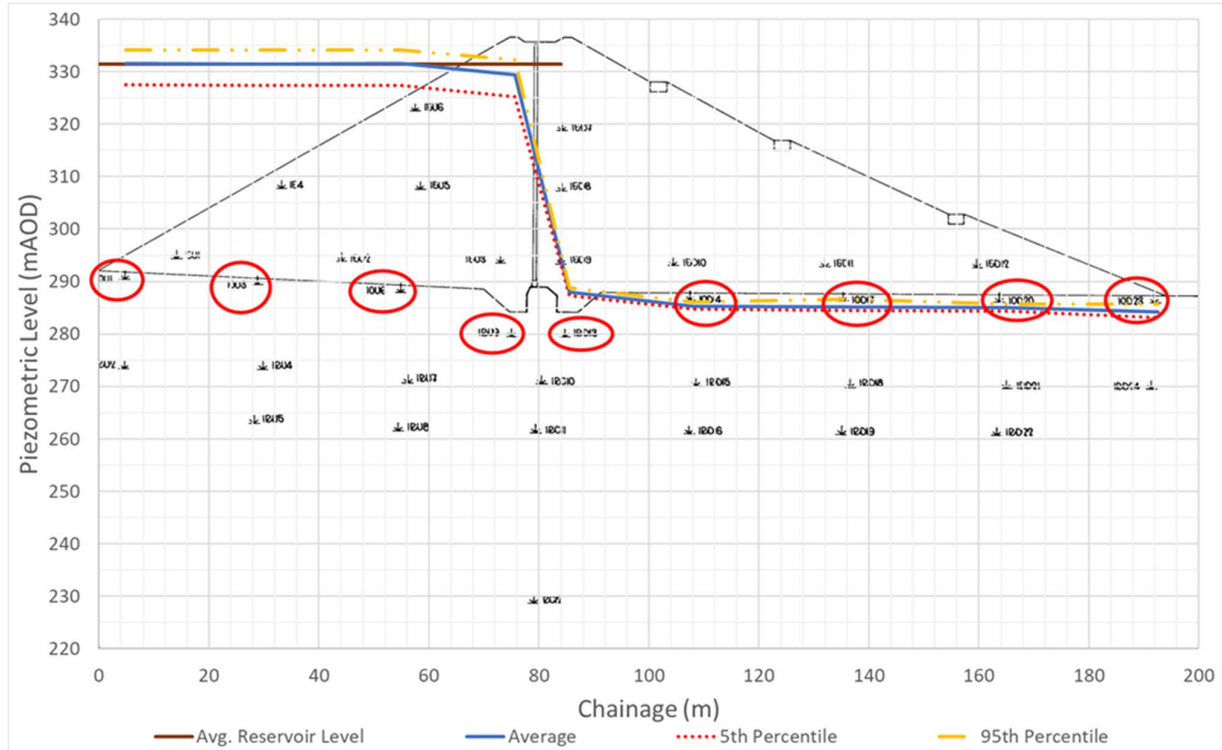
Figure 7. Mean, 5% and 95% confidence interval piezometric levels against average reservoir level through foundation piezometers

The plots indicate that the piezometers upstream of the core (within the foundation) had a strong response to changes in reservoir level, while downstream piezometers showed a much weaker response (at lower head levels). Both responses were very much expected and showed that the grout curtain and core are still effective (Figure 7). PCC was also calculated between piezometric level and reservoir level, which showed a much stronger correlation for piezometers upstream of the core as compared to the downstream piezometers.
