## Lessons Learnt from the First Inspections of Reservoirs (with capacities of 10,000m<sup>3</sup> - 25,000m<sup>3</sup>) in Wales

J NICOLLE-GAUGHAN, Dŵr Cymru Welsh Water  
S TUDOR, Cymru Welsh Water  
M CRAVEN, Cymru Welsh Water

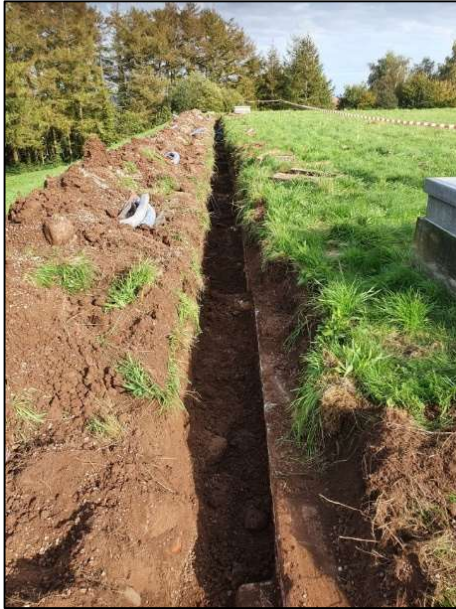
Radyr Service Reservoir is located in Radyr, approximately 5.5km northwest of Cardiff. Built around 1970, it is a 4.7m deep service reservoir with an escapable volume of around 19,000m<sup>3</sup>. The reservoir is retained by a reinforced concrete perimeter wall, with in situ concrete floor and roof. The first inspection under Section 8 (of compartment no.2) took place in June 2020, with the final compartment expected to be emptied and made available for inspection sometime later in 2020. However, compartment no.2 failed its flood test. Ingress was identified along the northwest joint between the roof and wall. In order to remediate this ingress, a 30m trench was excavated to expose the joint (Figure 1). This allowed the existing material to be removed, and a new bandage applied (Figure 2).

**Figure 1.** Excavation of the roof / wall joint at Radyr SRV. (Courtesy of DCWW).

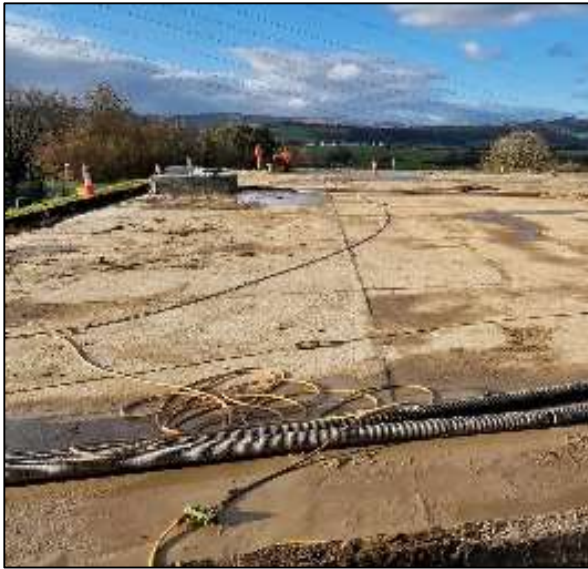
Prior to the first inspection in January 2022, compartment A failed a flood test along the dividing wall. Water quality concerns determined that the best course of action following the failed flood test and the area of the failure that the adjoining compartment should be isolated from the network and drained to eliminate potential water quality parameter failure.

Investigations determined the membrane installed in the mid 1990s was beyond repair and a membrane reinstallation was required. The excavation of the grass cover and membrane layers (Figure 3) permitted the Inspecting Engineer to undertake a thorough visual inspection of the roof during the subsequent inspection in February 2024, and to see firsthand the ingress repairs prior to the new membrane being installed (Figure 4). With over two years between the inspection of the two compartments, it was agreed that compartment A would be

**Figure 3.** The exposed roof slab at Sluvad No.2. (Courtesy of DCWW).

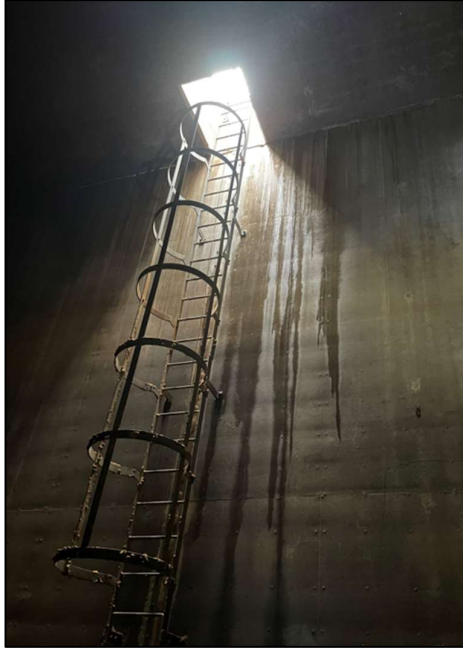
Immediately following the High-Risk designation of Tongwynlais No.1 (the inspection of which was completed in February 2021) it was decided the next stage would be to undertake the inspection of Tongwynlais No.2. Compartment 2B was taken out of service and inspected in July 2021. The inspection coincided with temperatures in South Wales reaching 30°C and an unusually prolonged period of dry weather resulting in the declaration of a drought by the Welsh Government. This brought difficulties mobilising sufficient tankers to facilitate the flood test as the tanker fleet was mobilised supplementing the network, and when the flood test was completed, the tank was shown to be suffering with significant ingress. Standard Welsh Water flood test procedure dictates that the roof is visibly saturated, and that a minimum flood depth of 25mm should be achieved over the top of the roof. The depth of water is confirmed by strategically dug trial holes that consider historic ingress repairs and the fall of the roof. Due to the temperatures and limited tankers, it was recognised that sustaining a 25mm flood was not achievable, and it was agreed that the upstands, hatches and the roof joints would be targeted. The targeted flooding showed that a number of upstands were not watertight and significant ingress was recorded (Figure 5). The secondary access hatch required sealing at the joint of the upstand and the roof. The existing bandage was removed, a layer of Natcem 35 was applied between the upstand and the roof and following a curing time a MasterSeal bandage applied along the joint (Figure 6).

**Figure 5.** Roof ingress at Tongwynlais No.2. (Courtesy of DCWW).

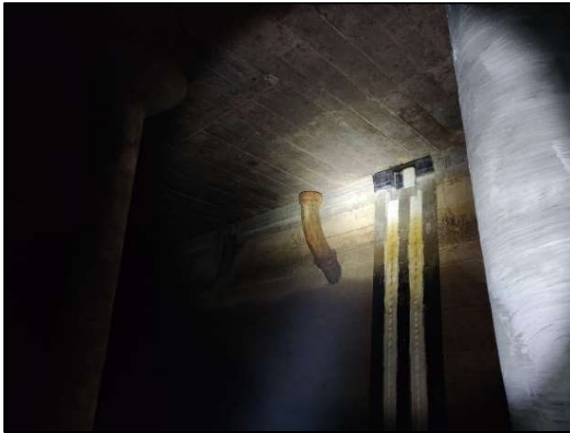
The reservoir was subsequently made available for inspection in November 2022. However, the challenges did not end there. We have a MITIOS that is proving difficult to conclude to the satisfaction of the QCE. Initial investigations have proven that the overflow (Figure 7) has insufficient capacity. In addition, it has not been possible to conclusively demonstrate that the overflow discharges to the assumed discharge point (Figure 8). Attempts to prove the discharge location have been inconclusive due to the distance 500m distance through third-party land and the lack of inspection chambers along the assumed route. Conventional next

**Figure 7.** The overflow at Stumpy SRV. (Courtesy of DCWW).

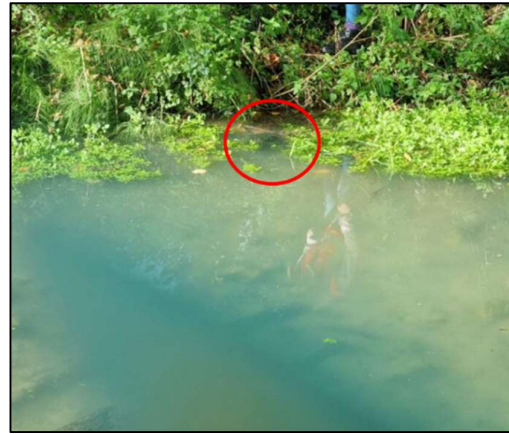
steps would be to empty the reservoir and undertake physical investigations from the point of overflow. However, this is considered as having high operational risk for the continuity of supply because the refilling of the reservoir during the winter of 2022 required supplementary tankers to maintain customer supply. As we approach the statutory due date of the MITIOS - which coincides with the high demand summer months - we find ourselves at an impasse. The alternative option of filling the tank to the point of overflow is considered a potential threat to water quality for the 15,000 properties and industrial customers.

**Figure 8.** The assumed discharge point at Stumpy SRV. (Courtesy of DCWW).
