## Re-establishing and Improving Scour Capacity at Daer Reservoir

R McHUGH, Mott MacDonald

K MURRAY, Scottish Water

**SYNOPSIS** Daer Reservoir was formed in the 1950s by the construction of a 43m high, 790m long earthfill embankment dam with a concrete corewall.

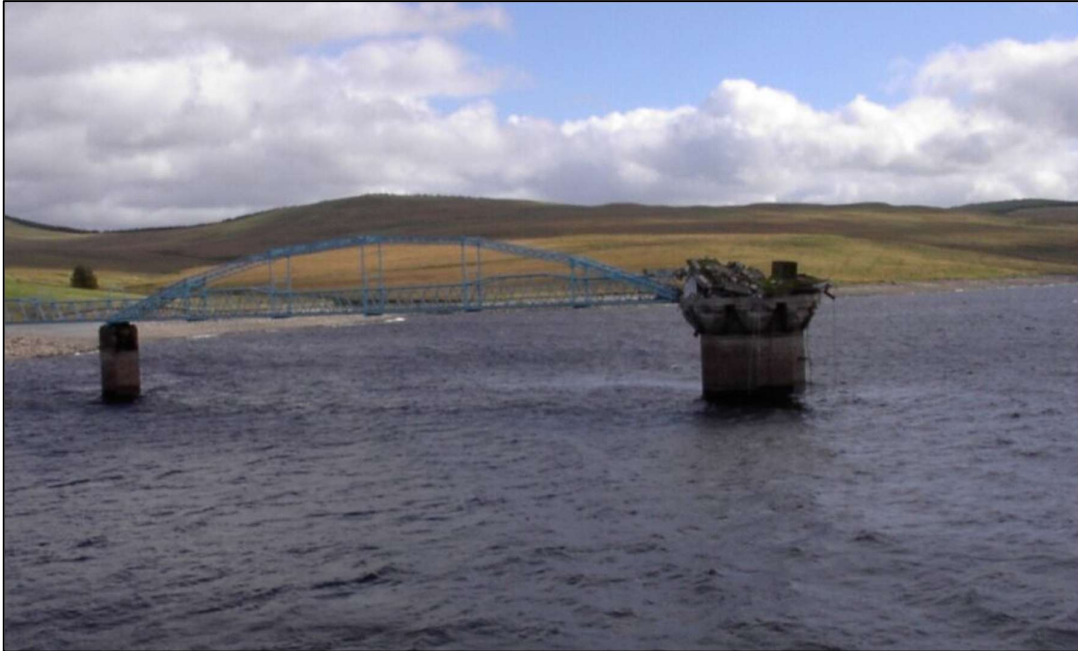
**Figure 3.** Valve Tower House Collapse

The reduced scour capacity was found to be due to rubble which had fallen into the pipe when the valve tower house suddenly and catastrophically collapsed in 2005 (Figure 3). As discussed in the paper by McHugh et al (2023), the initiating event of the collapse was unidentified; however, poor bed jointing between the pre-cast corbels which resulted in long term over stressing and cracking, coupled with ongoing deterioration due to water ingress and freezing, was attributed as the primary cause of failure.

The rubble was cleared from within the scour pipe in 2023 and, while the pipe was empty, the opportunity was taken to partially dismantle the needle valve and replace seals and re-grease. During the strip down, cracks were noted on the valve internals as well as extensive cavitation damage to the valve body (Figure 6 and 7). The crack is thought to have been caused by rubble impact and the cavitation damage is thought to have been caused by mis-operation with the valve never fully closed, instead remaining at 1% open, outwith the operational range for the valve. There was a risk that this damage could have caused the valve to seize open, which would have prevented the turbines from operating and resulted in issues with providing compensation flows, or seize closed, which would render the scour unusable for drawdown capacity. As the valve is built into the concrete foundation of the turbine building, with restricted access, and is encased in concrete it is unable to be removed and in-situ repairs were not possible (the needle valve in operation is shown in Figure 8). A decision was therefore made to remove and replace the needle valve.

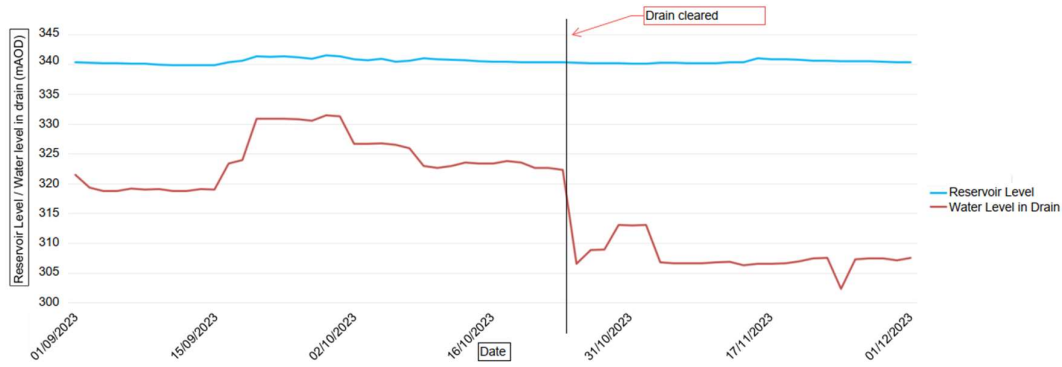
At the time of writing, all (approx. 100) drains have been worked on and a further five drains remain to be cleared using the drilling rig method. The impact of clearing deeper obstructions in the drains on the water level in drain 23, which is located within the wet area, is shown in Figure 4.

**Figure 4.** Impact of drain clearing on water level within drain

During the clearing works, some larger obstructions were encountered which could not be cleared using the 3" diameter hose of the vacuum evacuator. Some of the drains had the concrete cap from the drain lodged in them at a shallow depth (around 2m) and others had bricks / blocks at greater depths (up to 30m). For the drain covers lodged at shallow depths, the embankment was locally excavated to remove the obstruction by hand. For deeper

obstructions, a drilling rig was setup on the crest to break up the obstruction which could then be removed by vacuum excavator.

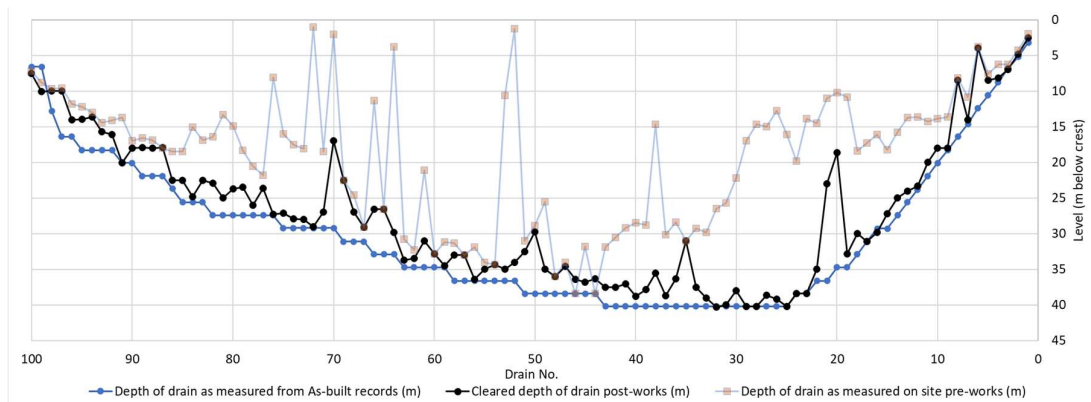
After clearing the drains, a clear reduction in the water level in the drains was observed which indicates the works have been successful in restoring drainage capacity. Due to the inoperable scours at the site, the water level in the reservoir has been held in a range of between TWL-1.25m and TWL-1.5m since the drain clearing works were started. The impact of the drain clearing works when the reservoir is at TWL is therefore not yet fully known and will be monitored when the scours are rehabilitated and the reservoir level allowed to return to TWL. A longitudinal section is plotted in Figure 5 showing: the depth to the base of the drain before any clearing works, the depth to the base of the drain after clearing works, and the as-built depth measured from record drawings. This shows the extent of the infilling and the beneficial impact of the drain clearing. The plot was produced ahead of the final stage of drilling works to tackle drains 20, 21, 35, 50, and 70 which is ongoing at the time of writing.

**Figure 5.** Longitudinal section through dam showing original depth vs cleared depth with as-built depth of drains

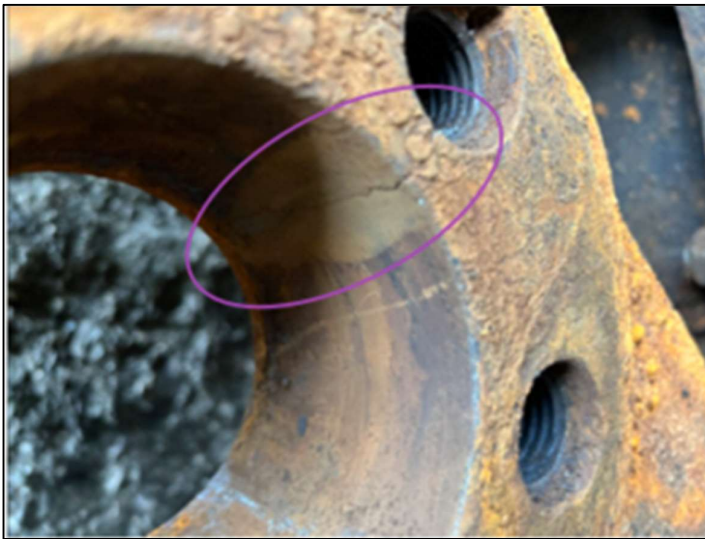
Figure 6. Cracking to valve internals

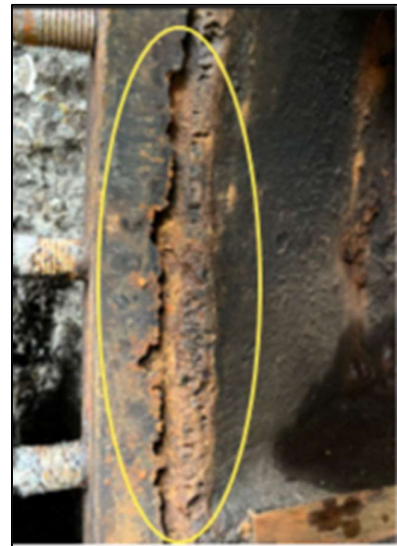
Figure 7. Cavitation to valve body

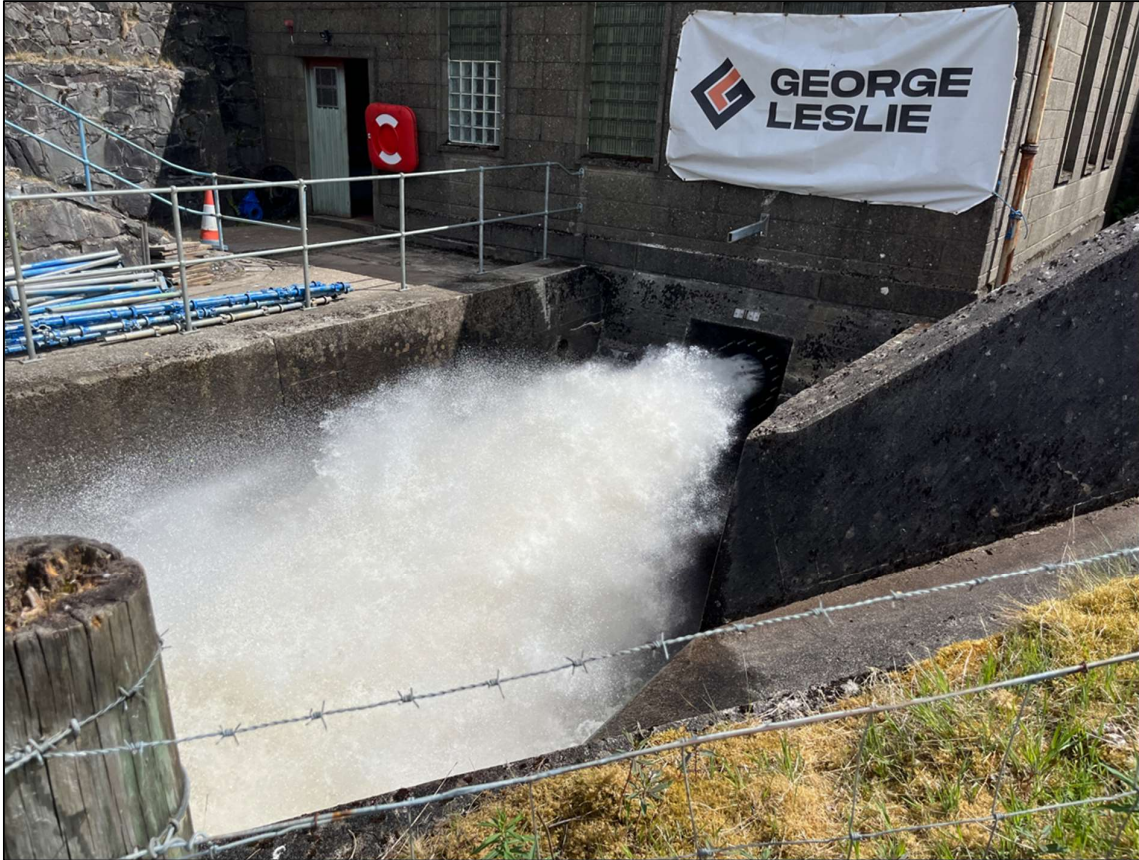
Figure 8. Needle Valve in operation in foundation of turbine building

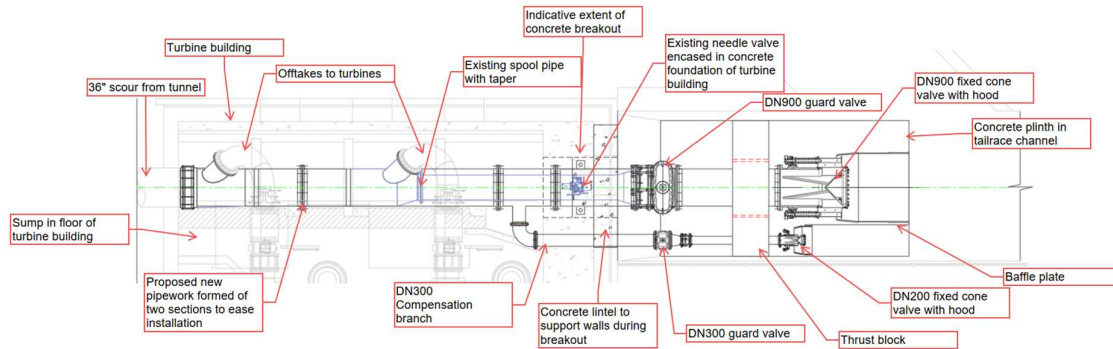
Figure 9. Scour upsizing works

The existing and proposed arrangement of the pipework at the turbine house is shown in Figure 9. The existing 36" scour passes through the back wall of a sump under the floor of the building before tapering to a 900mm diameter spool pipe with two offtakes for the turbines. The existing spool pipe has an integral taper (to 24") welded as part of the second offtake and connects to the original scour line downstream which discharges through the needle valve cast into the foundation of the turbine building.

In order to upsize the needle valve to 900mm diameter, all in-line pipework on the scour line within the turbine house is to be replaced. From discussions with the turbine installer, the spool pipe was installed ahead of the turbines, and it is not clear if it is able to be removed through the doors of the building with the turbines still in place. The proposed pipework is therefore in two sections to for ease of installation / removal. Even with this increased flexibility, it will be difficult to fully fabricate the pipe offsite to match the angle, length, and orientation of the offtakes. It is, therefore, proposed to offer the pipe up and tack weld the offtakes in-situ before taking the pipe away for final fabrication.

The existing needle valve is to be replaced with a fixed cone valve with hood which directs the discharge flows to within the downstream channel. The new valve is to be installed within the channel downstream of the building to make future maintenance easier. To facilitate this, a new concrete plinth was installed within the channel to provide a support for the valve and act as a working area for the valve removal works.

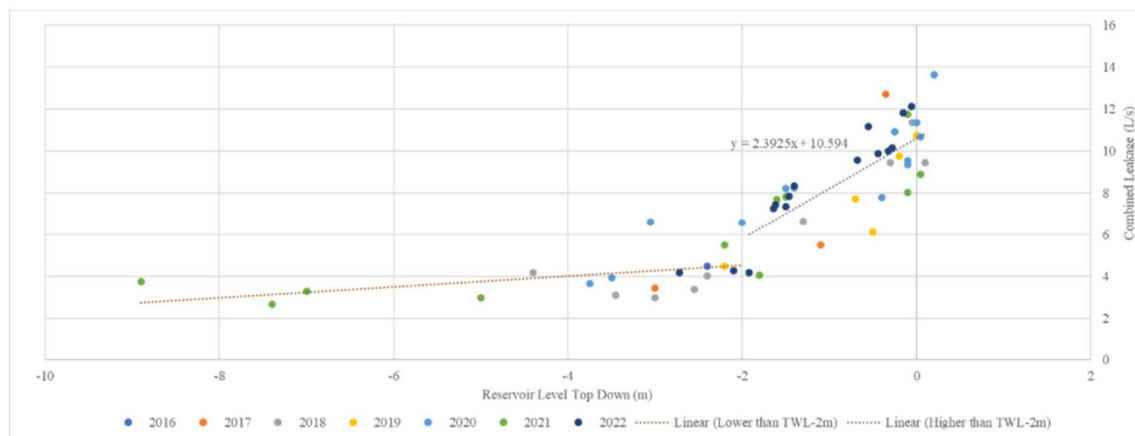
When the reservoir level is plotted against recorded leakage, there is a step change in the relationship at around TWL-1.5m to TWL-2.0m. Figure 10 shows the leakage measured at the two measuring chambers at the toe (rainfall effects have been removed by only considering data points for which the total rainfall for the previous three days was less than 1mm). This shows a step change in behaviour at around TWL-2.0m. This change is shown at different levels at other monitoring points, hence the range provided. The top 2m of drawdown is therefore key in reducing the leakage through the dam and the installation of penstock gates would be beneficial in reducing the water level in the reservoir to this 2m threshold, or as close to it as possible.

Figure 10. Leakage vs Reservoir Level

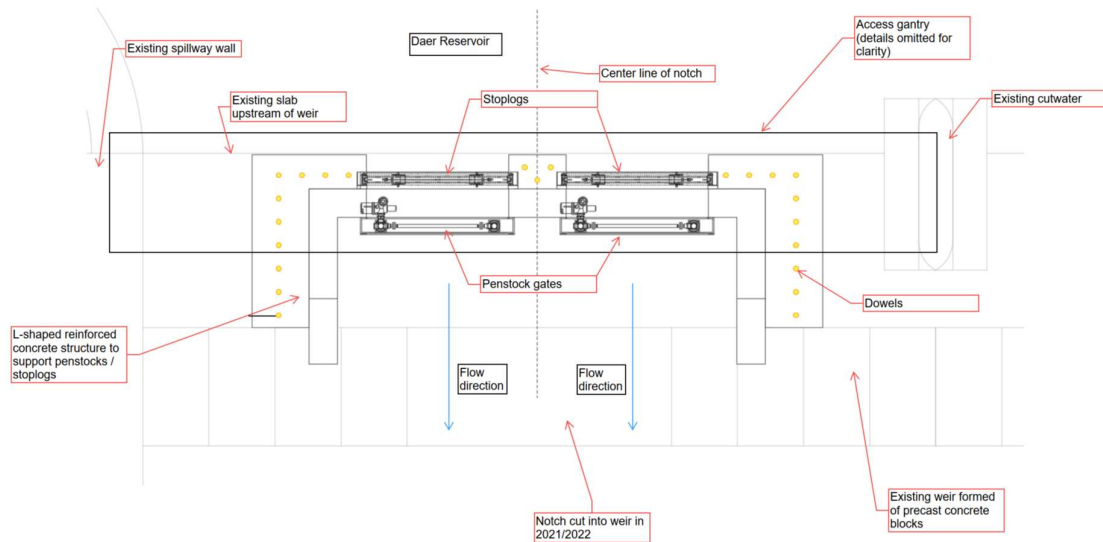
**Figure 11.** Penstock Design

In order to maximise the size of the opening and utilise an existing concrete baffle wall to support an access gantry, a new concrete structure was formed upstream of the notch formed in the weir. The penstock gates are to be fixed to the downstream side of the wall with stoplogs (to allow maintenance on the penstocks) installed at the upstream side. There is a removable section of floor at the gantry and a lifting beam to allow the stoplogs to be lowered into position. The gantry is also covered by open mesh fencing to allow operations staff to safely access the gantry during adverse weather, with a section left uncovered to allow the stoplogs to be lifted onto the gantry from the adjacent roadway. Under normal conditions, the penstocks will be operated from a control panel within a new kiosk adjacent to the spillway channel. The supply to this kiosk is backed up by a site generator in the event of a mains power failure and if the onsite generator also fails, the penstocks can be operated by hand

from the gantry. The penstock design is shown in Figure 11. At the time of writing, the penstock installation works are due to commence in June 2024.

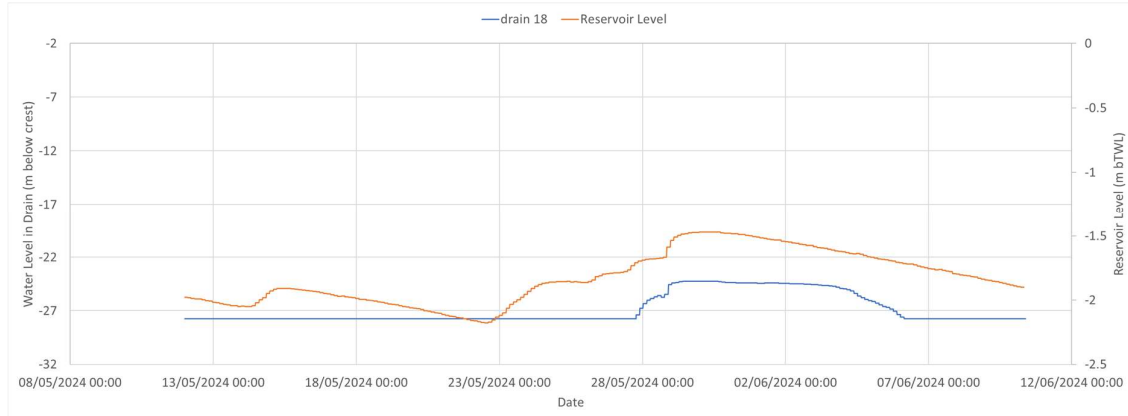
Pressure transducers were installed at 20 of the core drains, selected as those which show a clear link to changes in reservoir level. For measurement of leakage flows, V-notch boxes and ultrasonic sensors were installed at three of the headwalls and at the measuring chambers at the toe. Pressure transducers were also installed at piezometers 17 and 19 which are in the line of the 2013 slip and close to the wet areas previously identified. A raingauge will also be installed with the aim of being able to remove the effects of rainfall on the leakage monitoring model; currently radar rainfall records are used. At the time of writing, the readings from the remote sensors are currently being calibrated against manual reads to ensure continuity. Having the remote sensors in place during the refill will provide real time information on the behaviour of the dam. The output from the sensors is included in Figure 12 and shows the response in the drain to the changes in reservoir level when the reservoir reaches around TWL-1.7m.

Figure 12. Example Monitoring Plot
