Improving the emergency drawdown reliability at Llyn Brenig reservoir – Part II

G CARRUTHERS, Mott MacDonald Bentley
M MCAREE, Mott MacDonald Bentley
S SHAKESPEARE, Dŵr Cymru Welsh Water

SYNOPSIS This paper builds on the paper published and presented by Tudor and Morgan (2018) at the 20th BDS Biennial Conference in Swansea for the design of improvements of emergency drawdown reliability at Llyn Brenig.

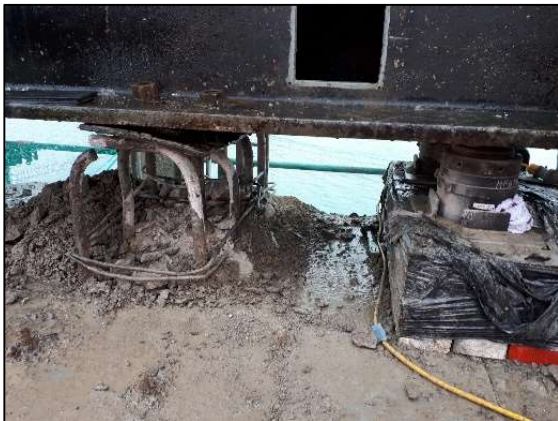
The crane operates on two rails fixed to a steel structure and is supported by six concrete plinths. Following a structural assessment, the support structure was proven to be salvageable, however it required replacement of four of the six reinforced concrete supports. Temporary works were required to prop the 26t crane and support steelwork and jack the existing gantry crane and support steelwork up circa 3mm to allow the safe removal and installation of the new plinths (Figure 1). Once all the plinths had been replaced the existing crane was removed and the new one put in place, utilising the floating barge and associated lifting activities, including a 100t crane (Figure 2). The working platforms had to be anchored to the reservoir bed and a suitable weather window identified to carry out the removal and installation activities (Figure 3). Operative training was carried out following construction completion (Figure 4) and commissioning completed, should the need arise to install isolations for reservoir safety purposes.

Figure 1. Hydraulic jack supporting crane during plinth replacement (MMB)

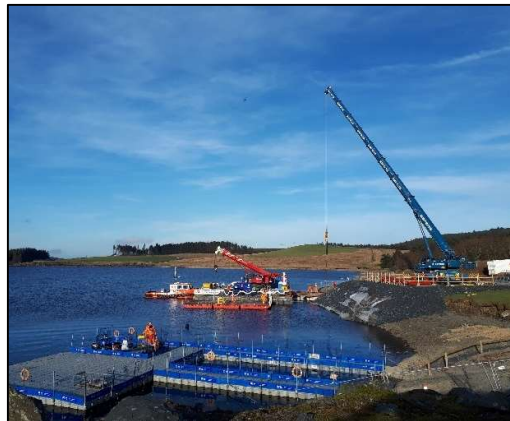
Figure 2. Temporary quay constructed to allow installation of pontoons and lifting apparatus (MMB)

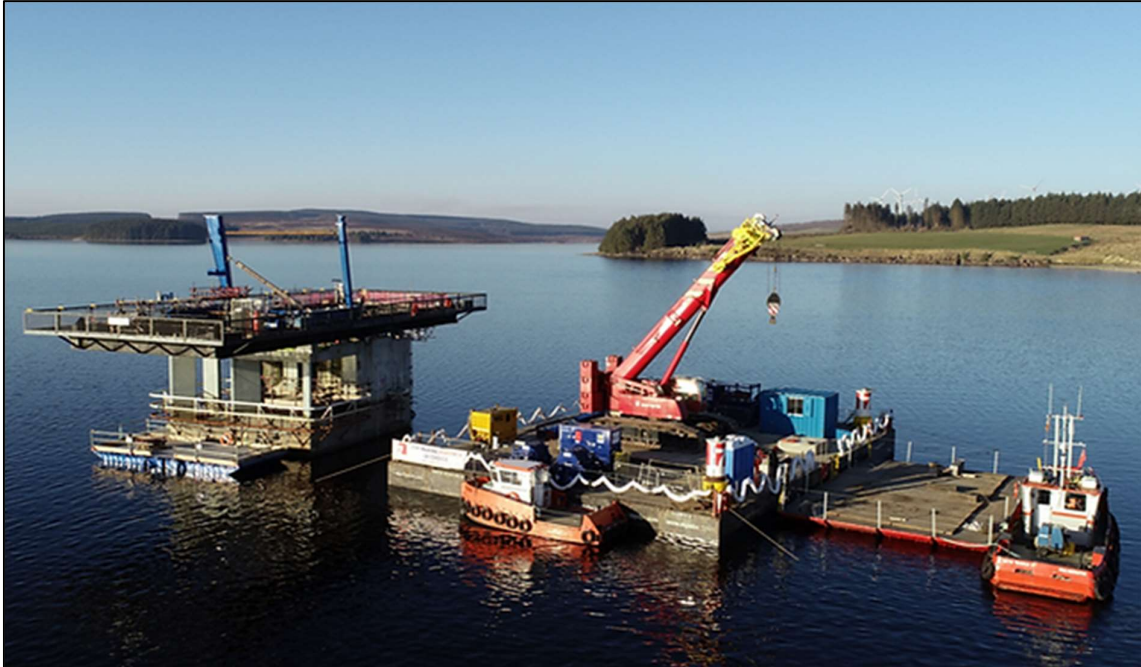
Figure 3. Pontoon in position and crane replaced (MMB)

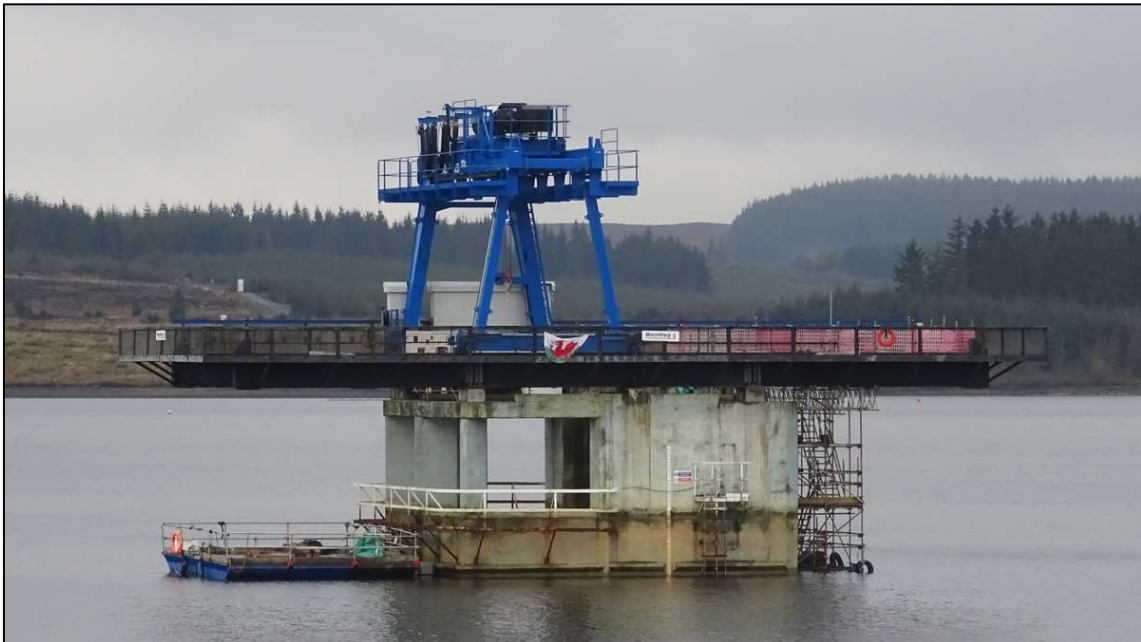
Figure 4. Completed crane installation (ARUP)

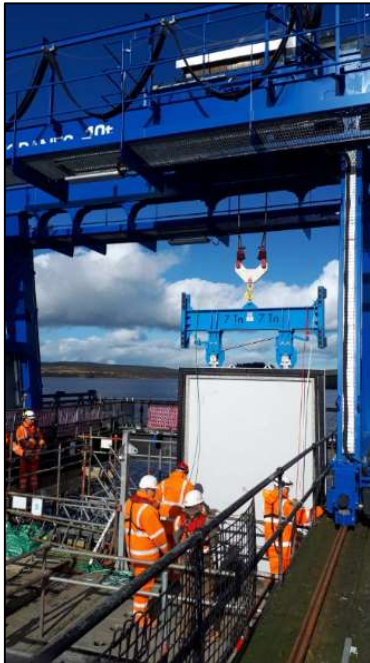
downstream. The decision was taken to isolate the tower from the reservoir body by utilising the provisions in the original design; namely to install the scour bulkhead gate (Figure 5). Given the age of the existing steel gate and condition of the assets, at a little under 50 years old, it was decided to replace the scour bulkhead gate in order to provide a guaranteed factor of safety (FOS) of 3 against failure. Finite element modelling was completed in order to provide confidence in the design and testing was carried out to prove strength and durability prior to installation. The new gate weighs 5.3t and was manufactured in Spain by Orbinox. With the existing scour bulkhead in place, a baseline for leakage flows passing the bulkhead was established as 6l/s/m. On replacing the gate with the newly fabricated gate, leakage flows were again measured and compared to that of the original gate. Leakage was established as 6l/s initially, however over a period of 10 days, the flows reduced to 3.1l/s as the seals bedded into the structure (Figure 6). In addition to replacing the scour bulkhead, work was programmed such that two points of proven isolation with continuous bleed and monitoring were maintained throughout the project.

Figure 5. New Scour Bulkhead being lowered into position (MMB)

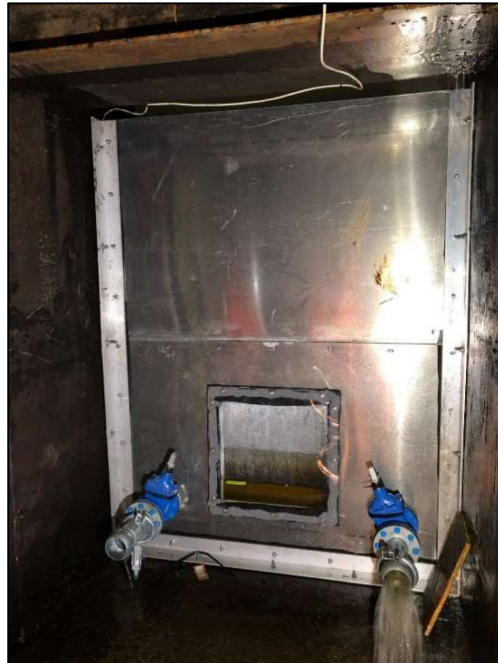
Figure 6. Scour Bulkhead – leakage monitoring station.
Note window for visual check

Over the course of developing the temporary works for the scheme, the team developed an aluminium screen (Figure 6) which help to control a number of risks for the primary gate installation. The primary purpose of the screen was to monitor the existing leakage rate passing the bulkhead gate; this was completed by installing a throttled valve on each side of the aluminium screen and a float switch connection to a visual and audible alarm. 24hr CCTV monitoring was also in place to assess the condition of the work area prior to entry, and throughout the working day by a confined-space-trained 'top-man'. The second risk was to protect the bulkhead gate from any damage from debris, which was achieved through a robust but manoeuvrable aluminium screen. The third risk/complication was managing the existing leakage water during concreting/grouting works, something overcome by installing two temporary valves within the aluminium screen to direct/pipe incoming waters around the working area.

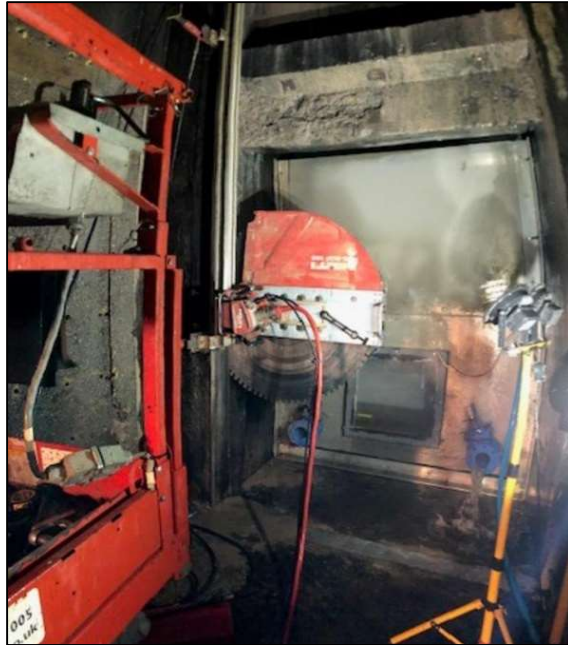
In anticipation of undertaking works to the primary gate, the project team was faced with the challenge of developing a methodology for removing the concrete surrounding the existing primary scour gate whilst working behind single isolation (Figure 8). This was required to allow replacement of the existing gate and frame. Following extensive review and development of temporary works, where the objective was to focus on the removal or reduction of risk for operators working under single isolation, the team worked closely with a specialist demolition subcontractor to develop a method to remove the concrete with engineering precision using remote/robotic control whilst being able to monitor the structure. This methodology was utilised for the secondary gate as a precursor to the primary gate works.

Figure 8. Installation of primary scour gate

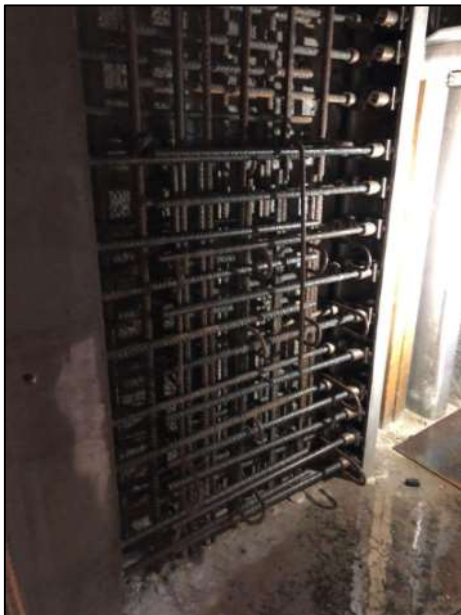
void, securing the gate into position (Figures 9 and 10). During this process leakage flows around the existing primary gate and new bulkhead gate were constantly monitored for changes. All works were carried out under DCWW's Gold command system to monitor progress and resolve any identified issues. Following installation, the gate was commissioned and tested against full reservoir head.

Figure 9. Completed reinforcement assembly prior to concrete profiling installation (MMB)

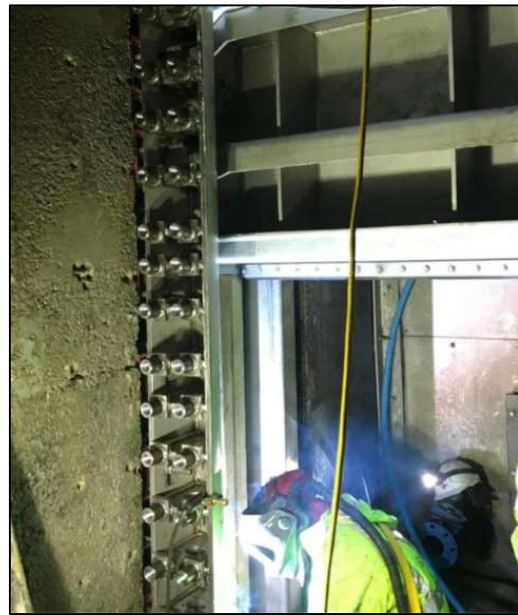
Figure 10. Welding of primary gate to existing tower structure (MMB)

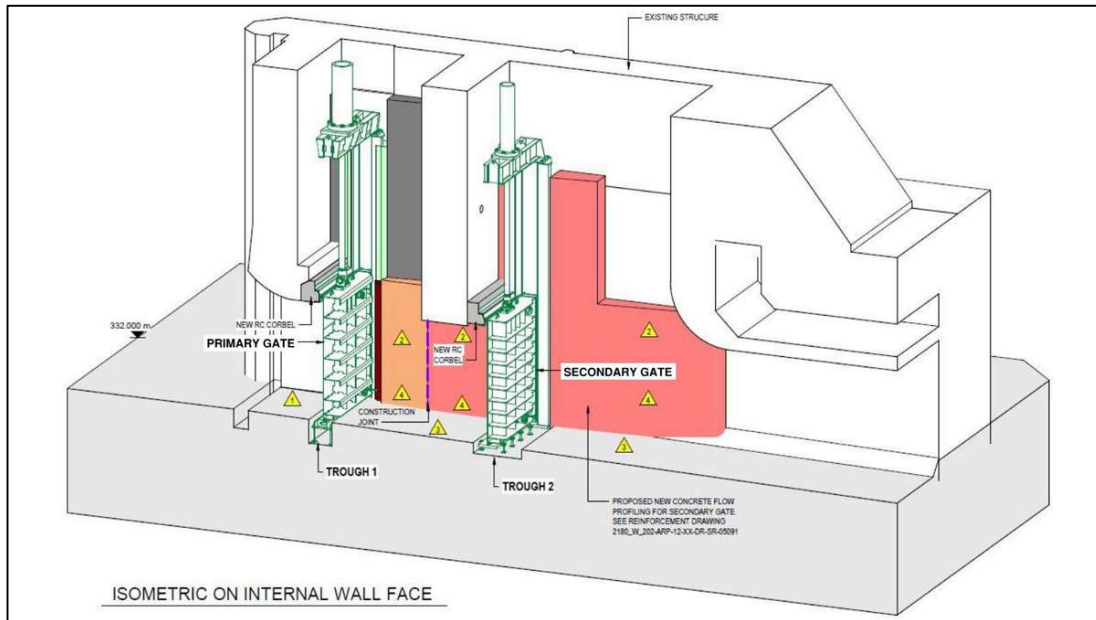
Upon installation of the two new gates, flow profiling was installed using reinforced concrete to assist in preventing cavitation from occurring as flow passes at high velocity (Figure 11). The reinforcement for the flow profiling was anchored into the existing structure utilising around 1000 steel dowels, each of which required a 30mm hole to be drilled 300mm deep. Remote operated plant was utilised to carry out the drilling activities.

Figure 11. Chanel profiling (ARUP)
