Managing risks associated with the infilling of the adit at Tunstall Reservoir

B AGUILAR, Stantec
N ASHCROFT, Stantec
I CARTER, Stantec

SYNOPSIS Significant leakage was observed on the left flank of Tunstall Dam upon first filling of the reservoir. A concrete-filled cut-off wall was extended into the abutment in 1879, which significantly reduced the flow but did not resolve the problem. In a further attempt to manage leakage, the adit and shaft that had been used to form the cut-off wall was repurposed and extended with additional drifts cut into the hillside to capture and transfer leakage flow.

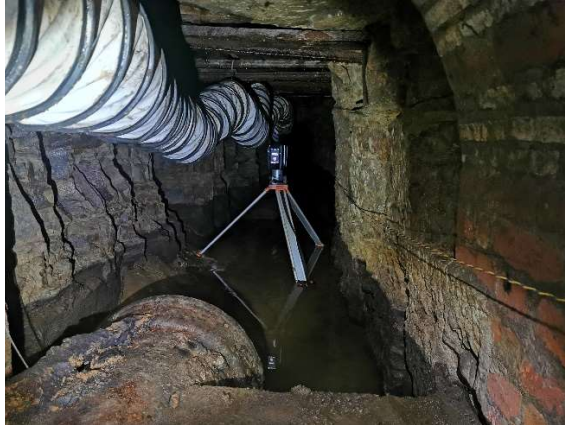
Figure 2. View of pipe inlet and weir. Note standing water on the invert of the adit.

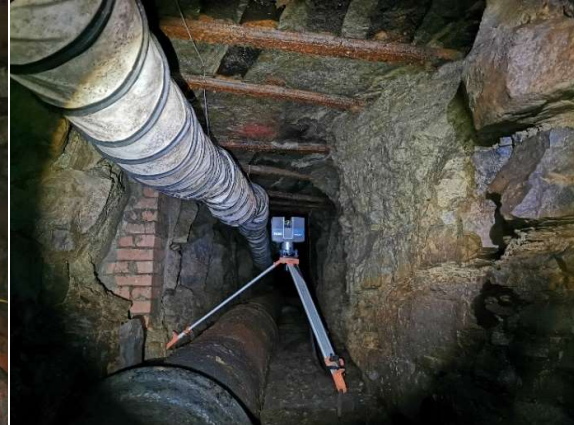
The initial 9m long brick arch section at the adit entrance is unlined and unsupported as far as the 90° bend, apart from occasional steel beams in the soffit (Figure 3). The section between the bend and the inlet to the 18-inch diameter drainage pipe is also brick lined, but thereafter the tunnel is unlined. The adit dimensions vary but are generally about 1.7m high by 1.4m wide. The maximum cover to ground level below the dam is 16m but increases up to 40m as the adit extends into the hillside. A forced air ventilation system (Figure 3) was installed in 2001 but the Undertaker has restricted entry to essential works since 2016.

Figure 3. View in the unlined section of the adit. Notice the beams across the soffit.

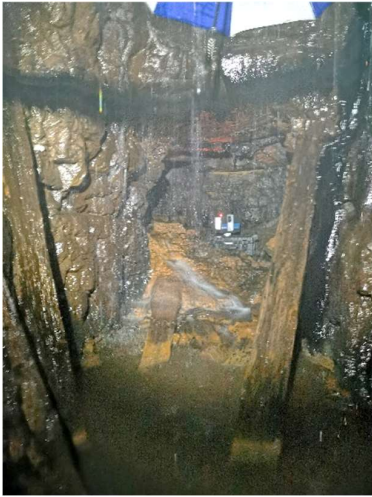
Figure 4 shows the leakage entering the adit predominantly through the shaft near its eastern end. Flows in the adit are closely related to reservoir water level. They decrease significantly when the water level falls 6m below the top water level (TWL). Figure 5 shows the correlation between reservoir levels and recorded flows in both the 18-inch drainage pipe and the 9-inch perforated collector drain, collecting flows from the bellmouth overflow.

Figure 4. View of flow cascading down the shaft.

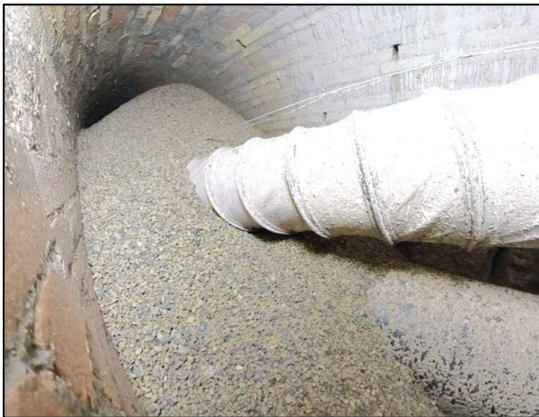
Figure 6. View of the pea gravel mound.

Drilling commenced from the downstream end of the adit, where the cover was smaller, and the first six holes were drilled successfully. However, as the holes became deeper, the risk of missing the adit increased, and the injection hole at the 90° bend had to be attempted three times before it could be successfully completed. The inspection point at the far end broke through close to the side wall and the pea gravel injection hole was off centre, allowing a window in the mound, as can be seen in Figures 6 and 7.

A practical and acceptable alternative was found: the injection points were re-positioned, and the two points closest to the internal adit weir were re-purposed. One point was used to convey stone to create a pea gravel barrier, while the adjacent point became an observation point. Pea gravel was introduced via a tremie pipe to form a mound within the adit to stop the advance of the expanding geopolymer upstream (Figure 6). A basic CCTV camera was introduced into the inspection point to monitor the progress of the geopolymer foam.

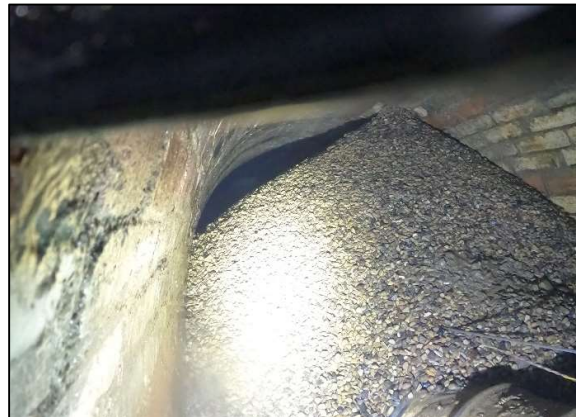
It was critical that the drainage pipe remained free-draining and unobstructed. Given the limited quality offered by basic cameras, the project team monitored the foam advance using high resolution cameras with improved lighting. The improved imagery confirmed that there was a gap between the pea gravel mound and the soffit which would have allowed the foam to overtop the barrier. Fortunately, the high-resolution cameras allowed the advancing front of polymer foam to be closely monitored, and infilling to be stopped before it reached the window in the barrier, as illustrated in Figure 7.

Figure 7. Post injection view of the mound with foam just visible beyond the gap.

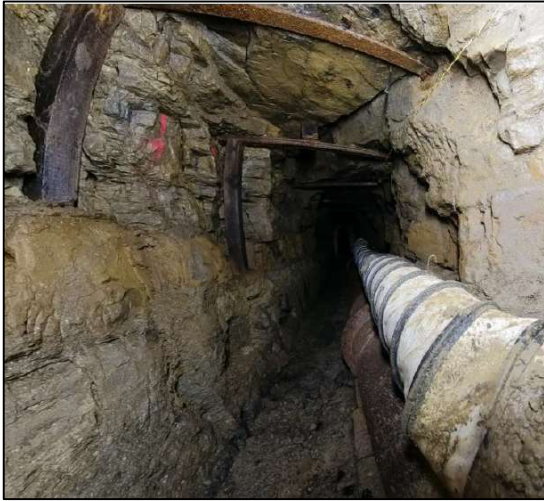
Figure 8. Adit view before start of drilling.

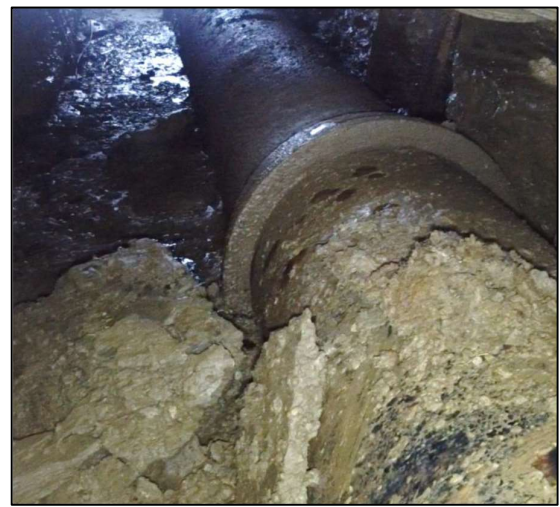
Given the reticence of the Contractor, Designer and Undertaker to authorise a further confined space entry into the adit, the QCE sought evidence that drilling operations had not damaged the pipe. Drone surveys were attempted but met with mixed success due to the limited space and obstructions therein, not to mention signal communication in the underground environment. However, insofar as could be determined visually, the survey confirmed that the downstream section of the pipe was in good condition with no obvious defects. In addition, high-resolution cameras were inserted at each injection point to inspect the pipe at spot locations. Figures 8 and 9 show examples of pre- and post-drilling surveys.

Figure 9. Minor roof fall after drilling of hole.

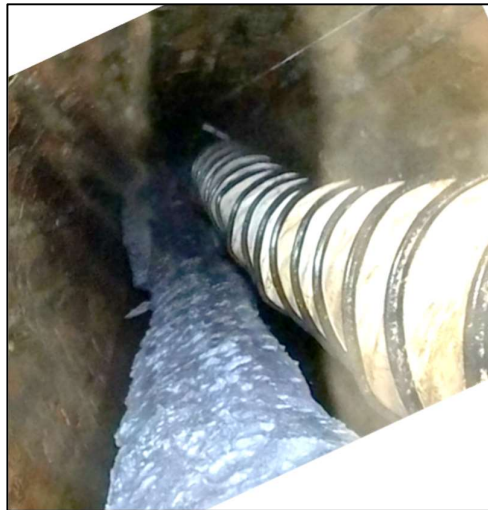
Adit infilling progressed at about 10m/day. Given its nature, once injection of the expanding geopolymer starts, then it needs to continue until the next injection point is reached. A downhole camera was used to confirm the position of the geopolymer foam front and to stop the injection before blocking the next injection point. Quality assurance was made more challenging by the steam generated by the geopolymer expansion process and the poor light. The expertise of the subcontractor in this matter was key to a successful outcome. Figure 10 shows a view of the geopolymer advancing through the adit.

Figure 10. Expanding geopolymer foam in the adit
