Valve Tower GRP Lining - Llyn y Fan Fach Refurbishment

A HANDLEY, Arup.
C WALTERS, Dŵr Cymru Welsh Water
L FERGUS, Arup
S FISHER, Morgan Sindall

SYNOPSIS A Section 10 inspection on Llyn y Fan Fach dam led to MITIOS, one of which was to arrest the structural cracking and eliminate leakage into the draw-off shaft. This paper covers the investigation that was done into the causes of cracking, including finite element modelling; the different options that were looked in to, such as decommissioning, demolition and rebuild, less intrusive repairs and structural lining, and why the chosen solution was lining the tower with a structural FRP liner and its design. The paper then looks at the construction, including procurement, delivery, installation and how it functions in place.

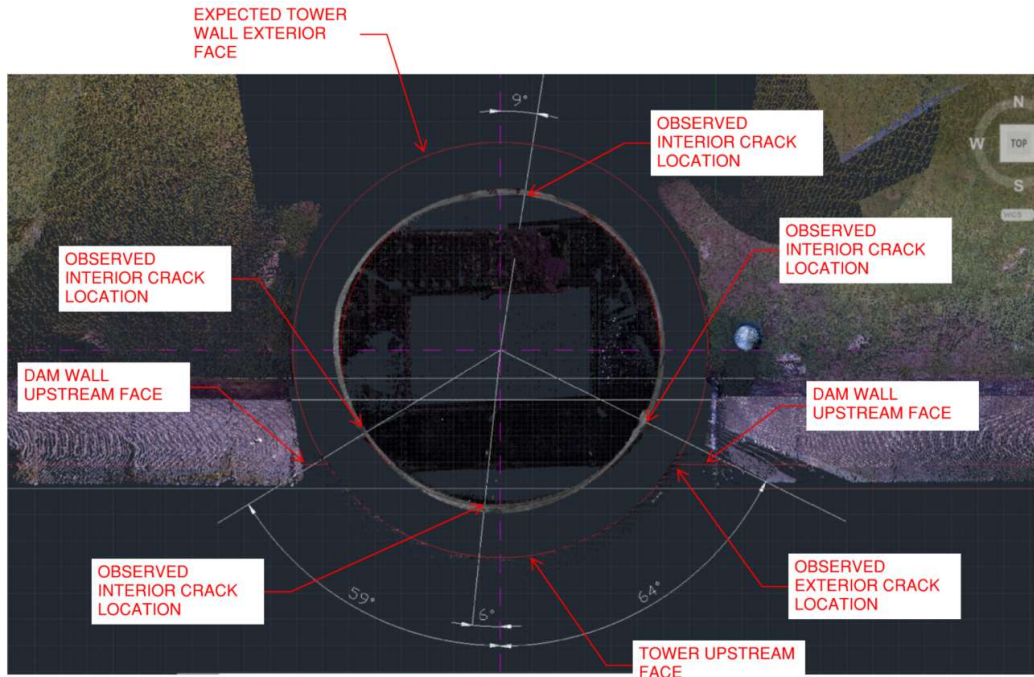
There are records of the cracks that go back to 1965. These were repaired in 1980, and a report in 2010 noted that three dominant cracks were suffering leakage. An inspection report

in 2019 speculated that freeze-thaw action and temperature variations led to the cracking of the structure. A 3D scan of the valve tower interior was undertaken in 2021, which was used to inspect the location and extents of the cracking (Figure 2)

Figure 2. Observed locations of leaking cracks in valve tower wall

Assessing the likely causes of cracking in the assumed unreinforced gravity structure led the team to hypothesise that cracking has originated due to volumetric changes in the adjacent dam walls exerting pressure on the valve tower.

Comparison with the results of the model and the point cloud data concluded that there was significant evidence that volumetric change of the dam walls that connect to the valve tower was inducing tension stresses in the shaft walls causing cracking. Tension areas predicted by models of this action correlated well with the observed real-world cracking.

It is also possible the cracking was contributed to via differential lateral movement of the dam wall and valve tower under the cyclic operational loading as a secondary driver.

The acceleration of leaking in the most recent years may be due to exacerbating factors associated with the cracks fully penetrating the section, such as the water inflow washing out fines, freeze-thaw action occurring in and around the newly exposed faces of the cracks, and debris ratcheting the open cracks preventing them from closing.

A full height liner made from a designed GRP material. A void was left between the GRP liner and the existing tower to allow for installation tolerances and this void was filled with a cementitious grout. The liner was a full annulus piece with no penetrations that would allow water ingress. Fixings were built into the liner to accept connections from the internal access staging that is required in the permanent case. The GRP liner was designed to withstand the

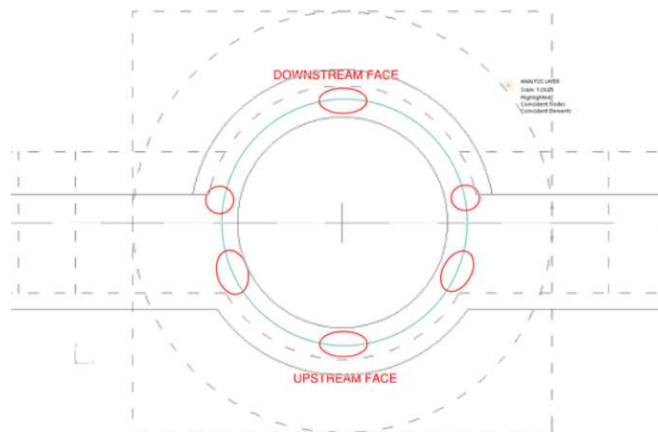
A finite element model of the structure was built to provide supporting evidence for this hypothesis. Volumetric change was considered in the longitudinal axis of the dam wall only, and the investigation acknowledged there were limitations to the analysis. These limitations were acceptable as the analysis was only used to demonstrate locations in which tension stresses were being developed. The structure was first analysed with 1D elements, based on the results the zones in Figure 3 should be presenting cracking:

Figure 3. Crack locations predicted by 1D analysis

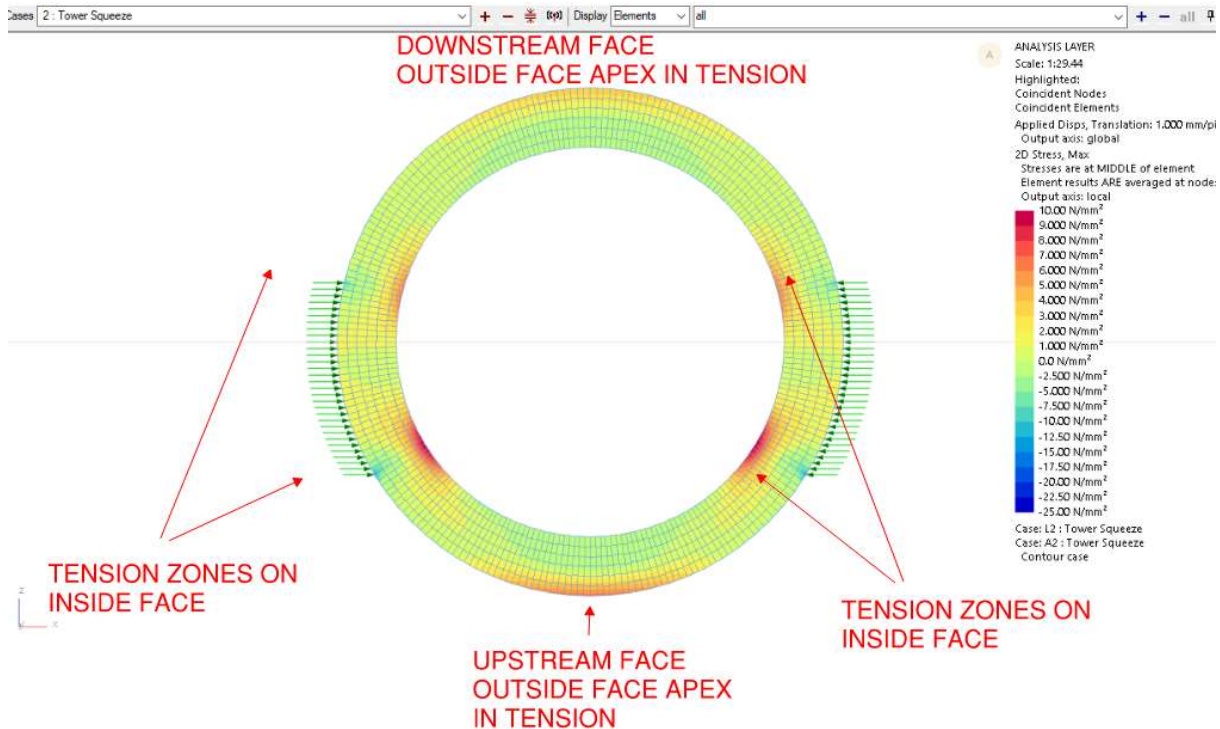
For further investigation, a 2D analysis was undertaken in GSA and similar results were found but show more detail on the location and development of the stresses (Figure 4).

Figure 4. 2D Stress results for dam wall expansion

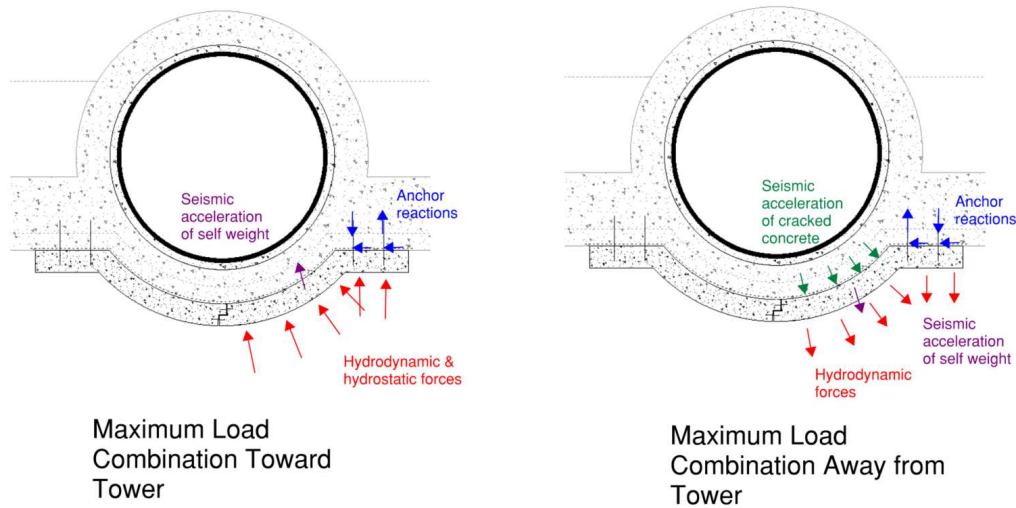
A robust approach to the design of this external structure was adopted where both the GRP liner and the external structure were designed ignoring favourable effects from one another, i.e. both structures were designed to resist hydrostatic, hydrodynamic and seismic

acceleration loads (Figure 5). In the case of the GRP liner, these loads were defined and communicated to the GRP supplier for design, which was in turn checked by Arup.

In the case of the external casing structure, it was as a horizontal cantilever fixed back to the dam wall with post-fixed fasteners. It was designed to resist the cracked concrete from displacing during a seismic event in one direction and to resist hydrostatic and hydrodynamic forces in the other. The structure was modelled as a 2D shell in FEA software with the anchors as pin supports.

Figure 5. External structure load cases

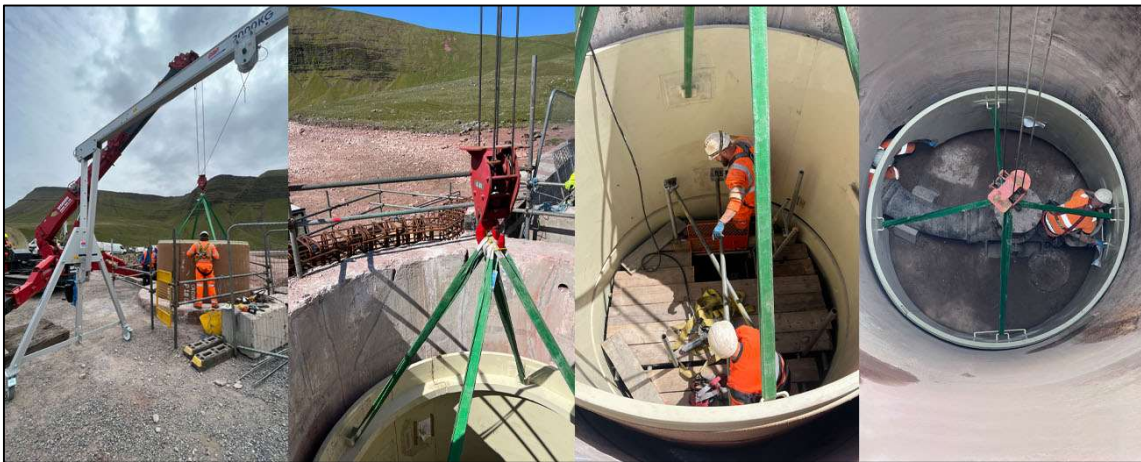
Figure 6. Installation of GRP Lining

A significant constraint was the low clearance and low capacity bridges on approach to the site. This restricted the size of plant that could be transported to site and, in turn, the size of components that could be handled. Therefore, a large number of precast concrete units were required to make up the spillway structure with a considered and minimised use of in situ stitches. Another example where this constraint influenced delivery was that the tower required GRP sections with a 2.7m internal diameter being transported over a 2.4m wide bridge. The rings were therefore formed in half sections and assembled in-situ (Figure 6).

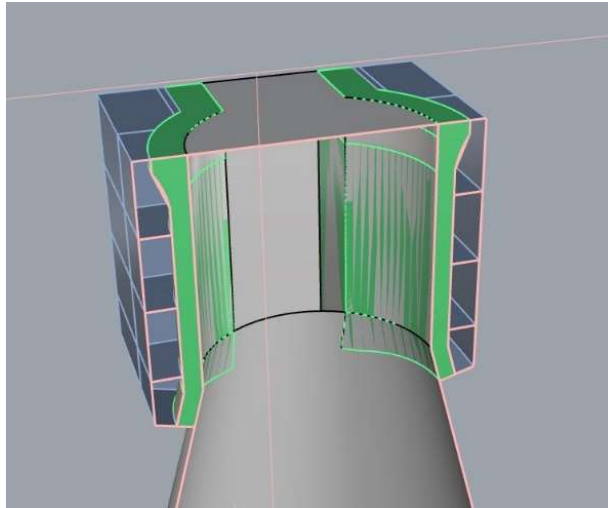
Figure 7. 3D external formwork

The site team utilised Filcour90 from Cordek expand polystyrene shuttering (Figure 7) to make the external repairs to the drawdown tower and dam face. This innovative shuttering solution used the output from 3D surveys to fabricate the intricate curvature of the existing tower and corbel detail and then mould the shuttering off site, allowing delivery to site in manageable sections. Given the location of the dam, with the poor weather conditions at times which the

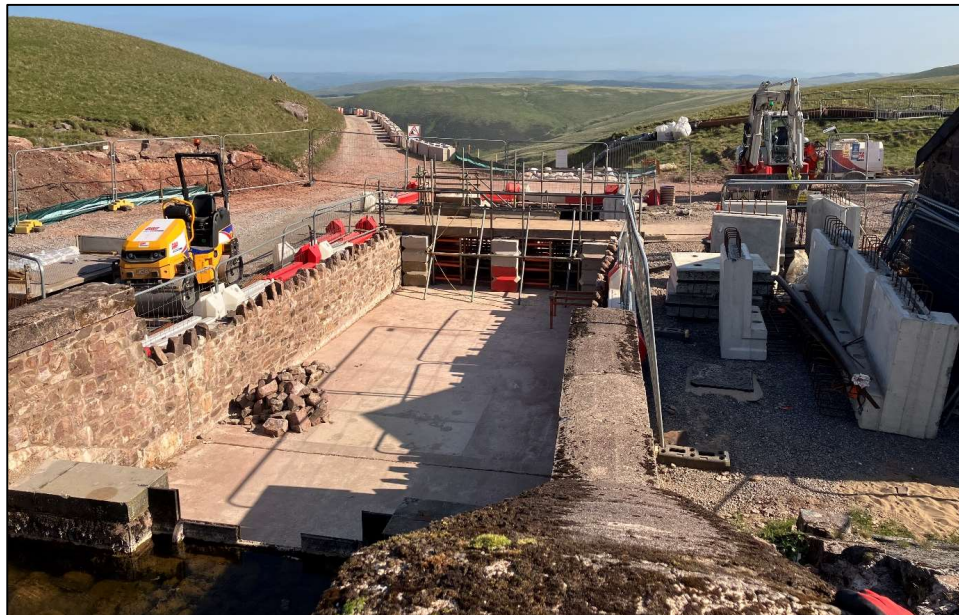
Figure 8. Spillway construction and lining

Demolition and reconstruction of the spillway was the most critical aspect of the project due to the inherent risks on the dam structure from scouring if it were to spill during construction (Figure 8). Water levels in the reservoir were lowered to provide a minimum storage capacity for a 1 in 150 year storm event as was stipulated by the Welsh Water Dam Safety Team and the QCE. To ensure that water levels were managed in the reservoir throughout the scheme, a temporary storm pumping system was established using 12" electric pumps. The pumps were located on floating pontoons on the reservoir to keep them off the reservoir bed to avoid silt issues. Due to the criticality of the works, a Dam Safety Construction Management Plan was developed to control any increased risk to the safety of the dam during construction. Duty - standby pumps and generators were installed with auto-changeover facility and telemetry systems that automatically called personnel in the event of an issue.

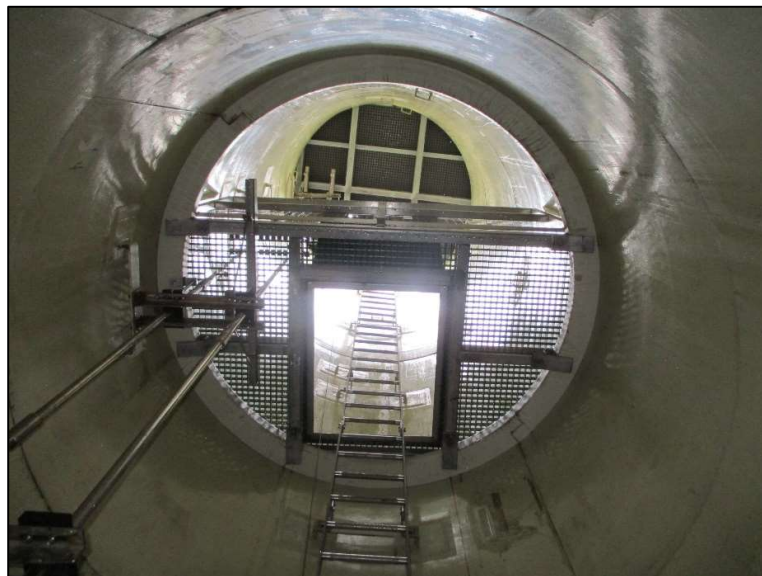
Figure 9. GRP Lining Installed

The use of the GRP liner has provided a robust, corrosion resistant solution to arrest the structural cracking of the tower, providing a flexible solution that will withstand both the varying seasonal conditions at the site and the extreme load-cases that it could be subjected to (Figure 9).
